HISTORIC BRIDGE ALTERNATIVE ANALYSIS REPORT

REPLACEMENT OF MERCER COUNTY BRIDGE NO. 230.3 (STRUCTURE #1100-0072) CARRYING MINE ROAD OVER STONY BROOK, Township of Hopewell, Mercer County, New Jersey

Prepared by:
IH Engineers, P.C.
103 College Road East,
First Floor,
Princeton, New Jersey 08540

Date:
August 2018

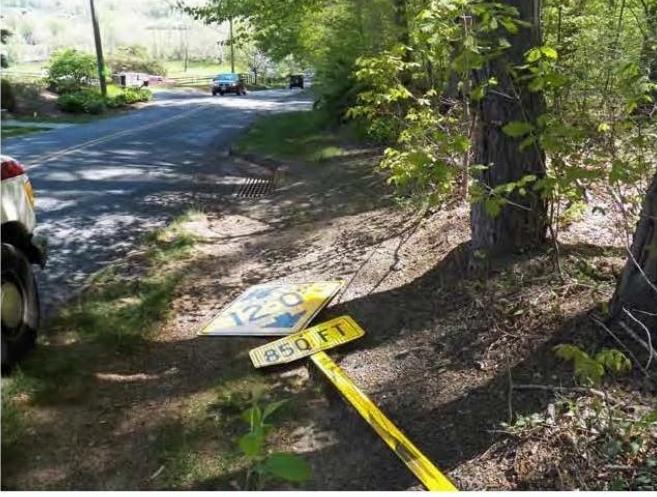
Location: Vertical clearance warning sign of the west approach, looking east.	
Description: Broken post of sign 850 feet from bridge.

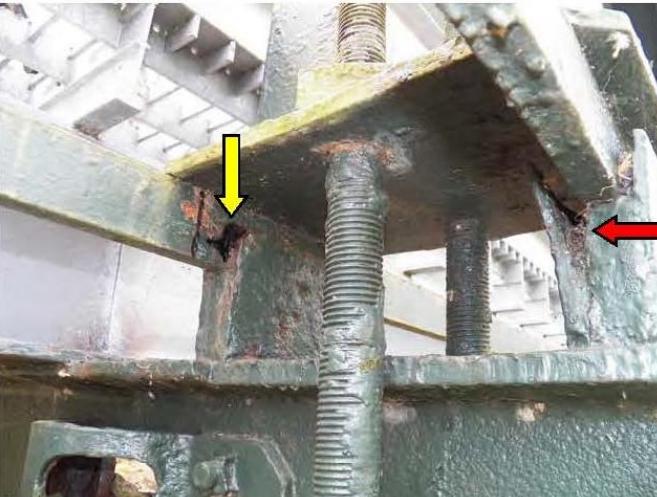
Location: Bottom chord of the north truss connection to floorbeam FB 1, looking southwest.	
Description: The inner bar has an area of section loss behind the guide block due to pack rust (yellow arrow). The outer guide block is cracked and bent due to pack rust (red arrow).

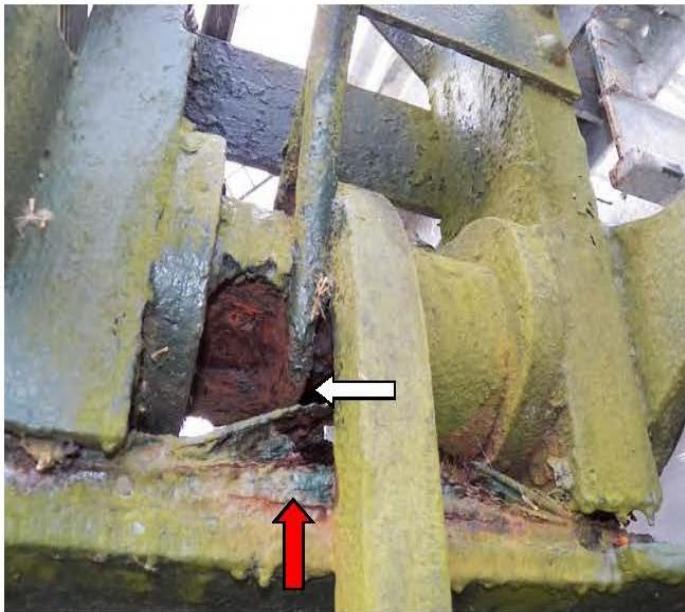
Location:	Bottom chord pin at L5 of north truss connection to floorbeam FB5, looking east.
Description:	The pin has an area of section loss due to pack rust below the protective sleeve. The counter-action rod has heavy section loss (white arrow). Note the severe pack rust and section loss of the shim plates on the top flange of FB5 (red arrow).

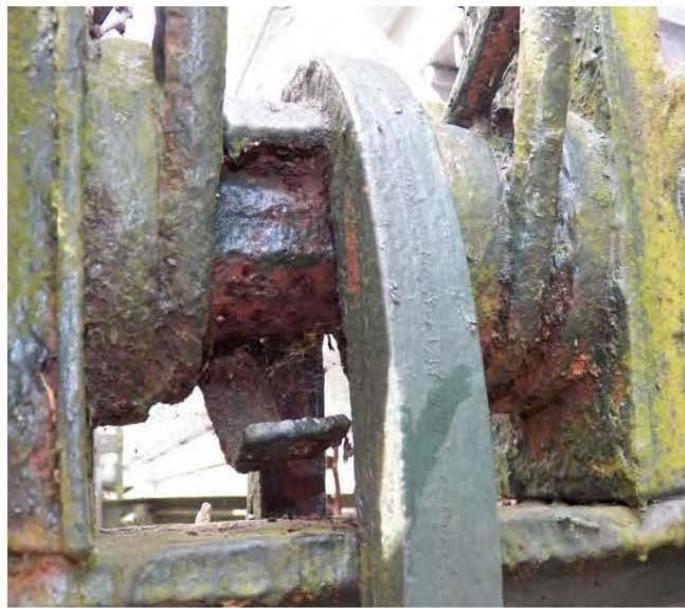
Location:	Bottom chord pin at L3 of south truss, looking west.
Description:	The pin has section loss due to pack rust which was previously below the protective sleeve (bent down to reveal the pin).

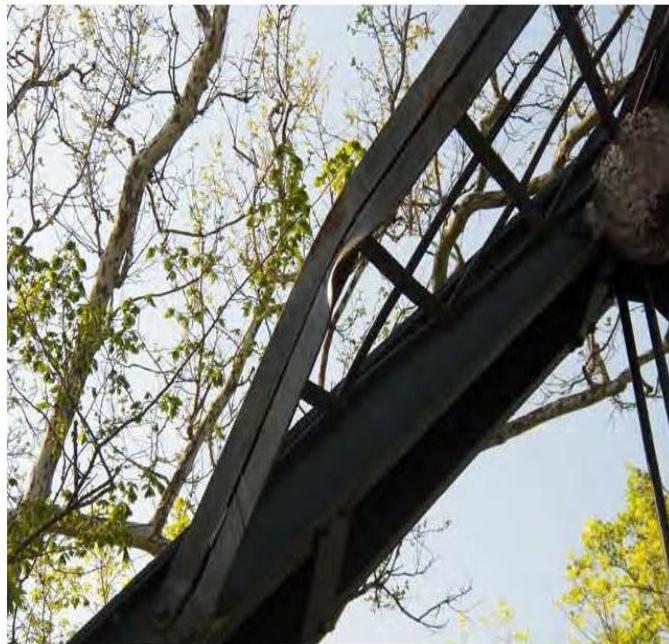
Location: East portal member near the south truss, looking south.

Description: Moderate collision damage.

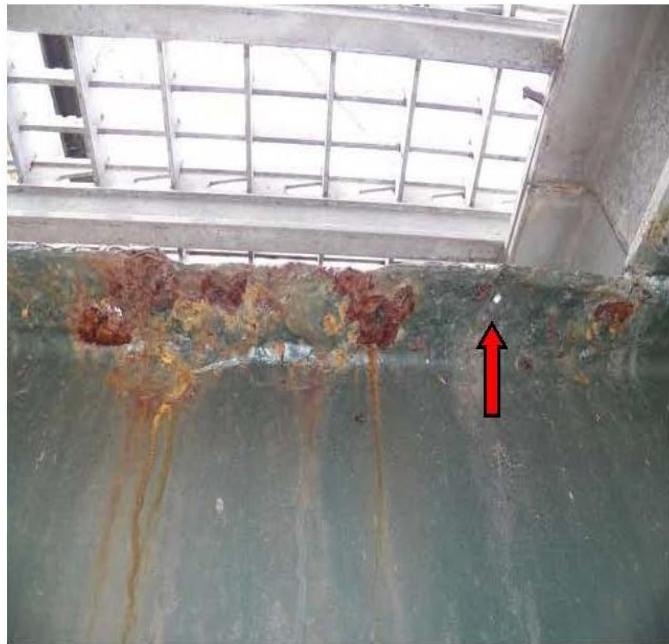
Location: Floorbeam FB2 east face, looking west.

Description: Heavy corrosion has caused section loss to the top flange with knife edging and a pin hole (red arrow).

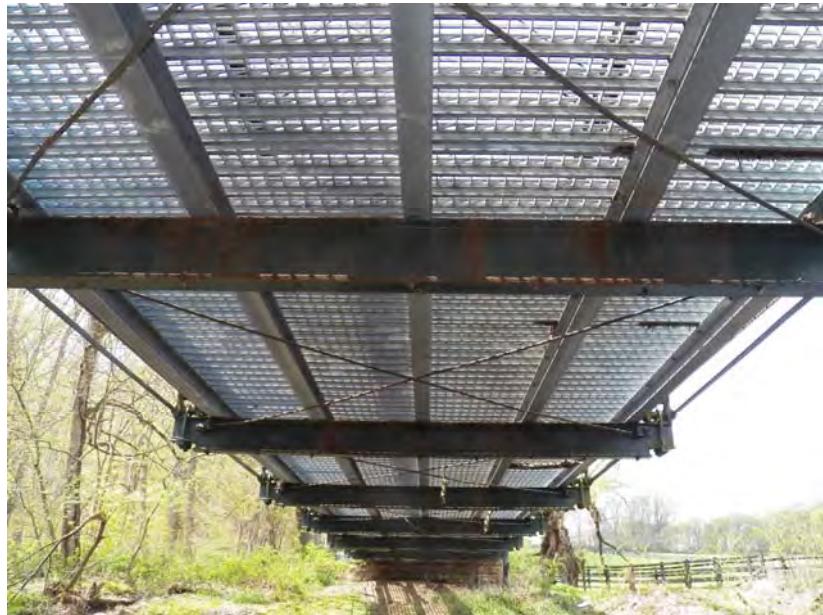
Photo No: 16-07

Location:	Superstructure and underside of deck, looking west.
Description:	General view. Note moderate laminar corrosion on the webs of floorbeams.

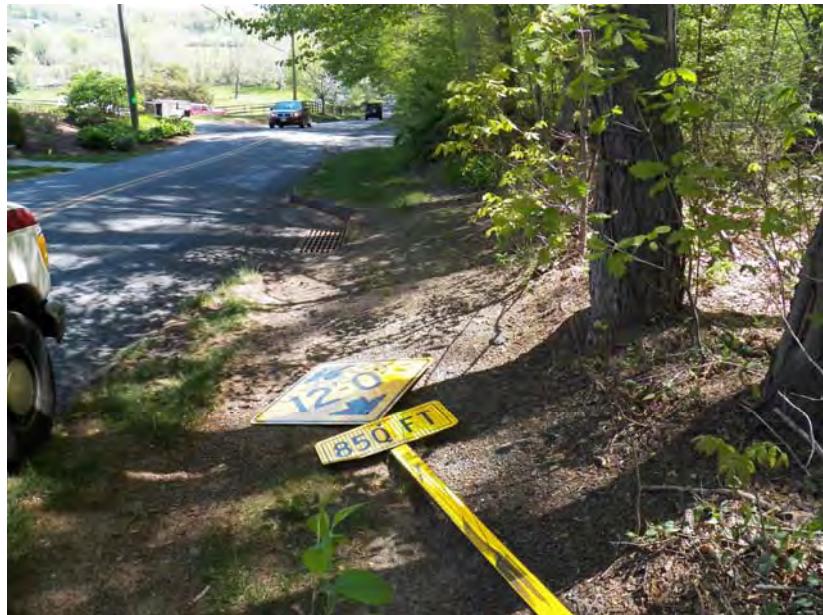
Photo No: 16-08

Location:	Vertical clearance warning sign of the west approach, looking east.
Description:	Broken post of sign 850 feet from bridge. Refer to Priority repair letter 1100072_20150501cy16_PR1_01 .

Repair the broken clearance posting sign post:

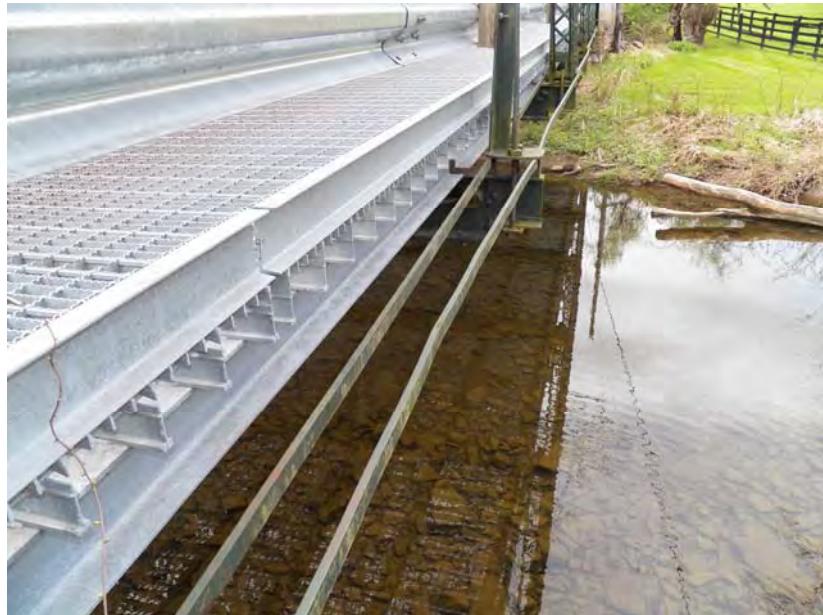
Photo No: 16-09

Location:	Bottom chord of the north truss, looking west.
Description:	The outer bar section is slightly bent due to large trees washing downstream during flood event.

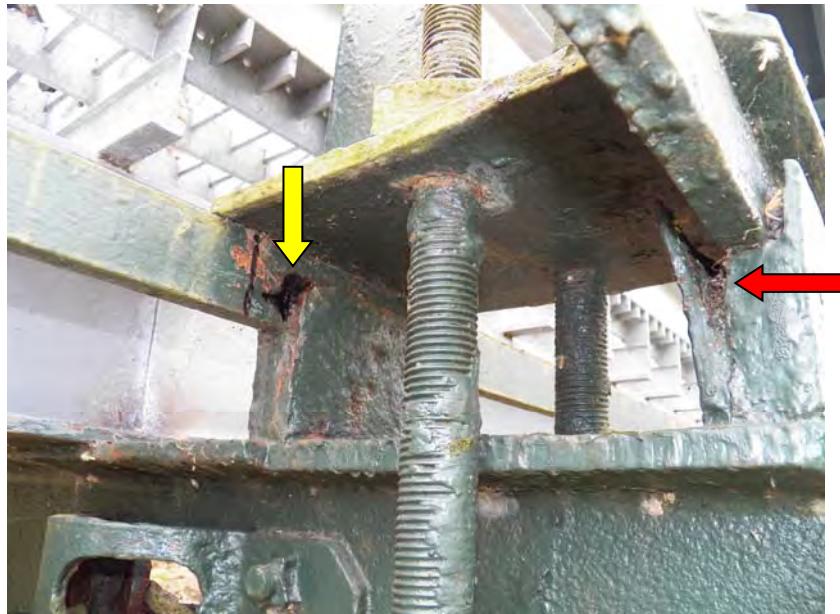
Photo No: 16-10

Location:	Bottom chord of the north truss connection to floorbeam FB1, looking southwest.
Description:	The inner bar has an area of section loss behind the guide block due to pack rust (yellow arrow). The outer guide block is cracked and bent due to pack rust (red arrow).

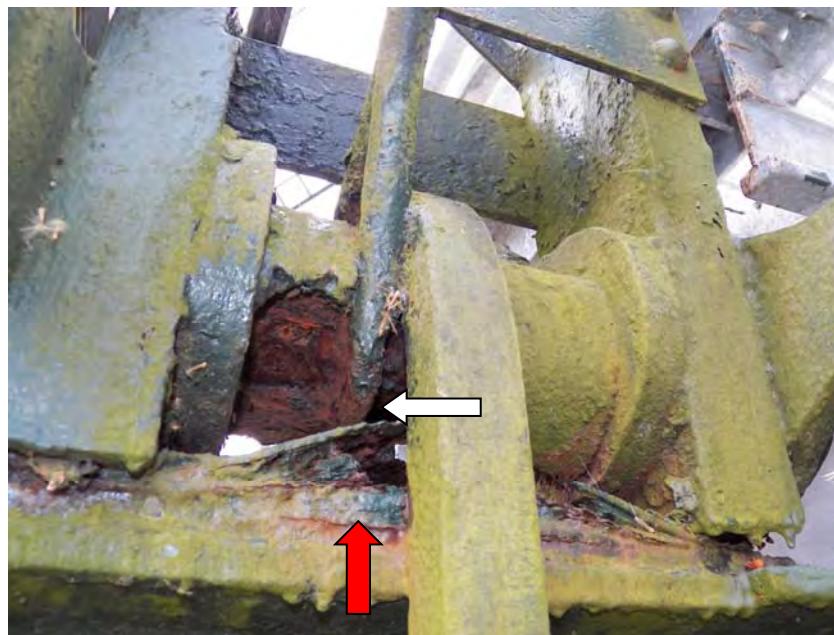
Photo No: 16-11

Location:	Bottom chord pin at L5 of north truss connection to floorbeam FB5, looking east.
Description:	The pin has an area of section loss due to pack rust below the protective sleeve. The counteraction rod has heavy section loss (white arrow). Note the severe pack rust and section loss of the shim plates on the top flange of FB5 (red arrow).

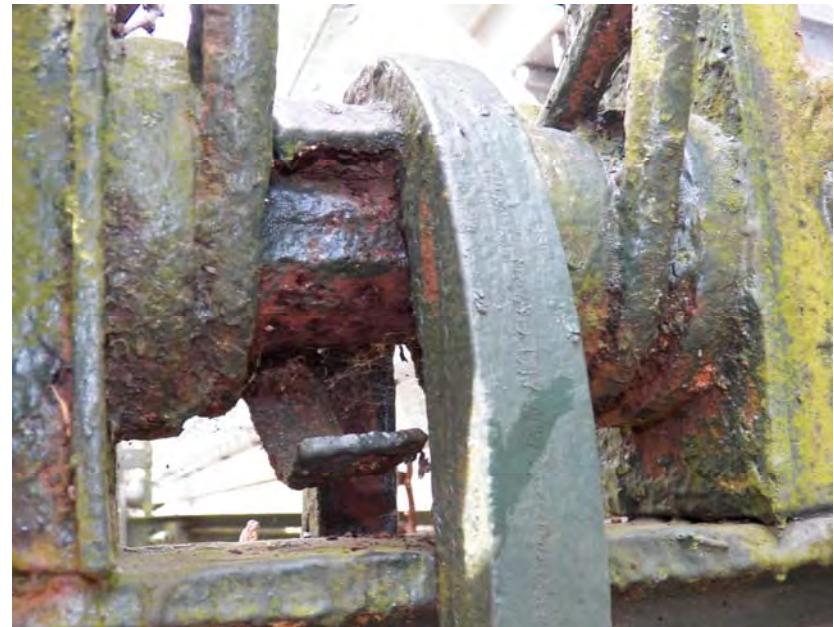
Photo No: 16-12

Location:	Bottom chord pin at L3 of south truss, looking west.
Description:	The pin has section loss due to pack rust which was previously below the protective sleeve (bent down to reveal the pin).

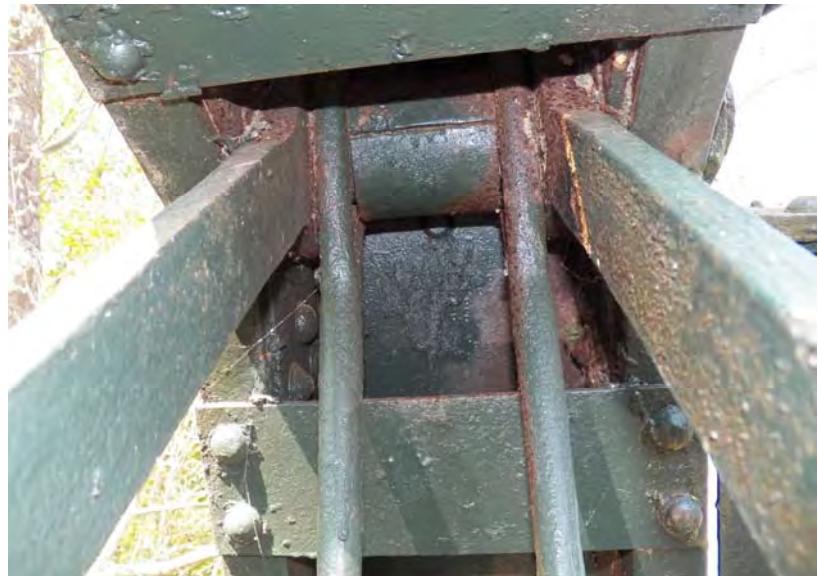
Photo No: 16-13

Location:	Top chord pin U1 of the south truss, looking west.
Description:	Moderate granular corrosion on the unpainted surfaces.

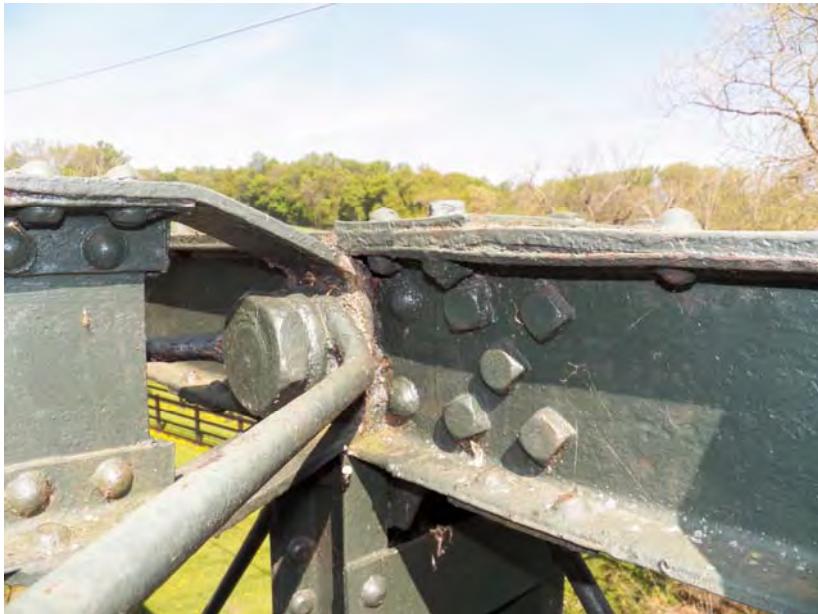
Photo No: 16-14

Location:	Top chord at U4 of north truss, looking northwest.
Description:	Moderate pack rust between the channel and the top plate at the top plate bolted splice connection.

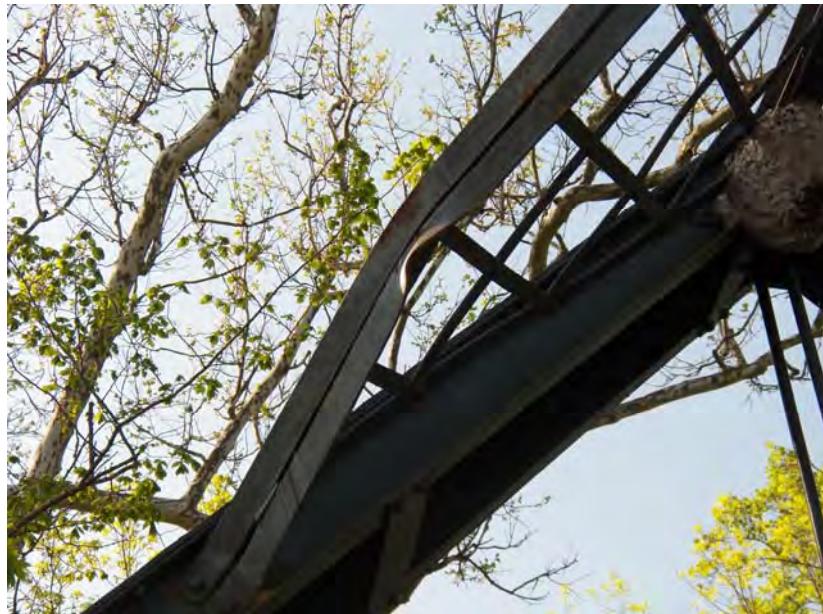
Photo No: 16-15

Location:	East portal member near the south truss, looking south.
Description:	Moderate collision damage.

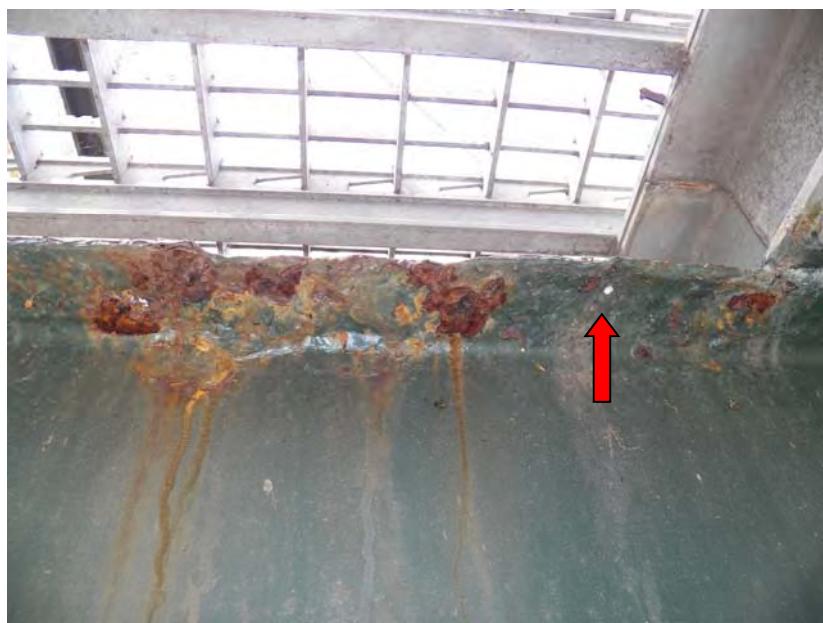
Photo No: 16-16

Location:	Floorbeam FB2 east face, looking west.
Description:	Heavy corrosion has caused section loss to the top flange with knife edging and a pin hole (red arrow).

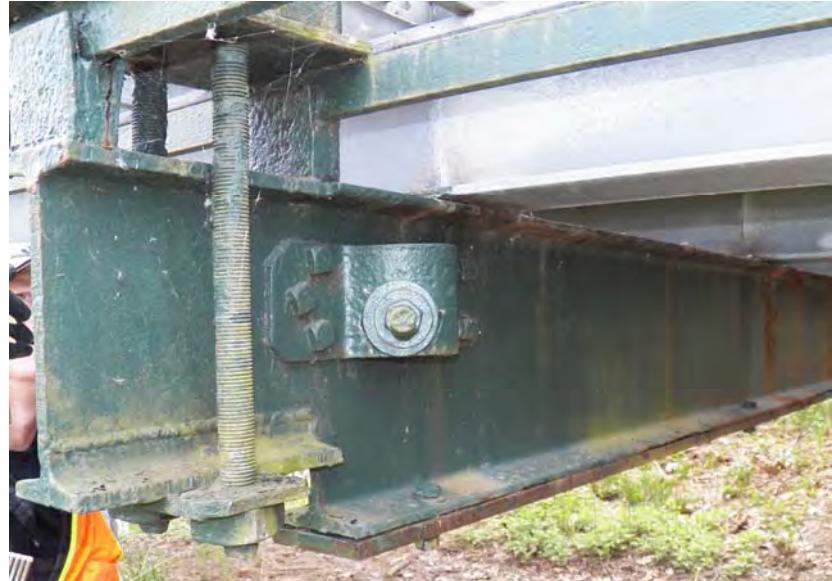
Photo No: 16-17

Location:	Floorbeam FB1 at the north end, looking southeast.
Description:	Typical retrofit of floorbeams used for past re-construction. Beam depth cut down (coped) and flange widths cut down (coped) to accommodate the U-bolts. Bolted cover plate added on the bottom flange.

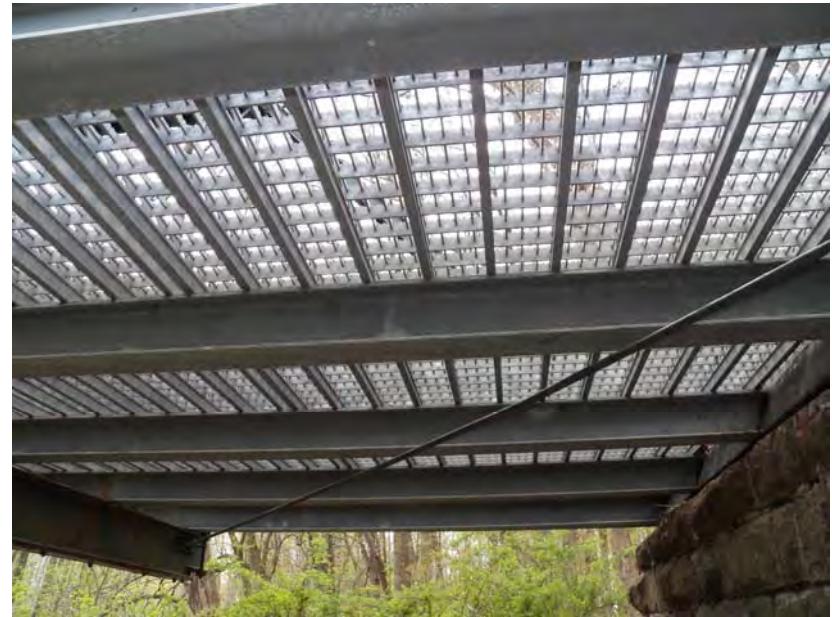
Photo No: 16-18

Location:	First bay from west, looking south.
Description:	Missing lateral bracing tie rod.

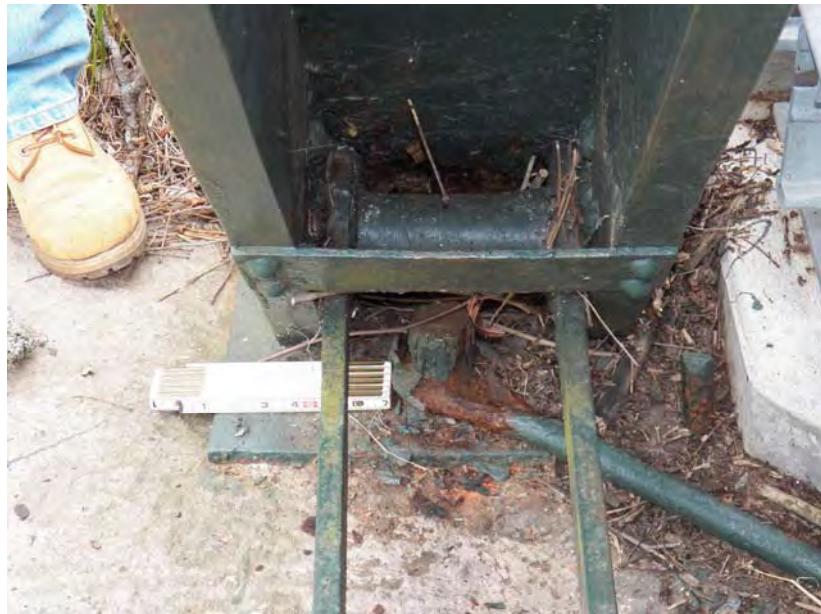
Photo No: 16-19

Location:	North east bearing, looking east.
Description:	Heavy corrosion with section loss on the eye bar and anchor bolt nut.

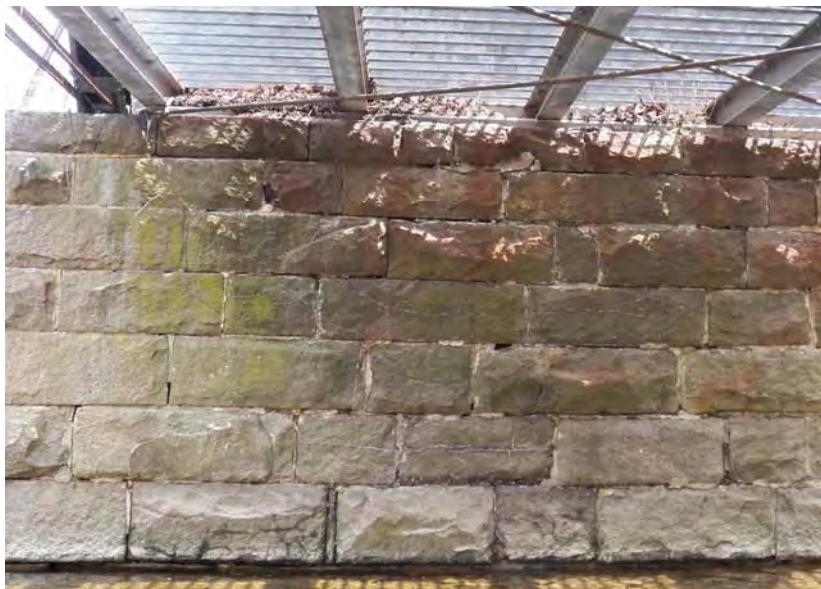
Photo No: 16-20

Location:	East masonry abutment, looking east.
Description:	Missing joint mortar (pointing).

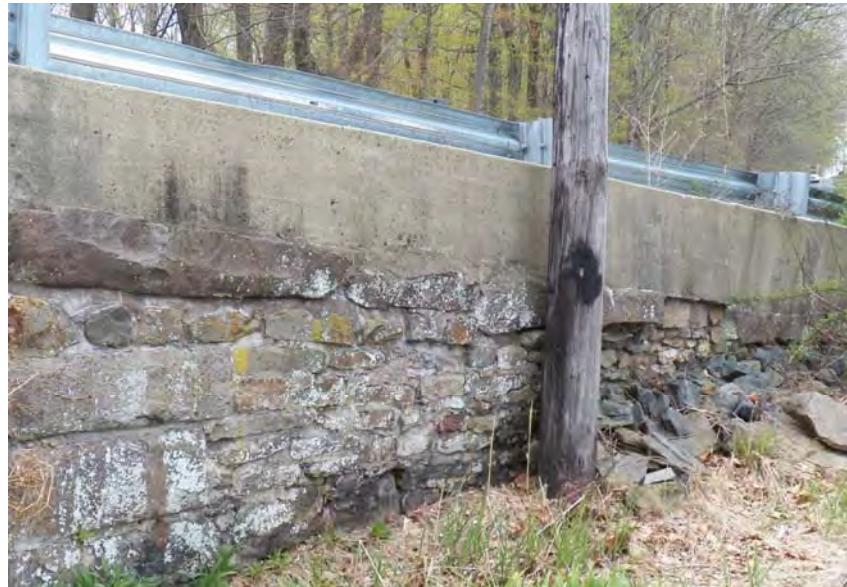
Photo No: 16-21

Location:	Northwest masonry wingwall, looking southwest.
Description:	Missing joint mortar (pointing).
