**INTENSIVE-LEVEL ARCHITECTURAL SURVEY
AND PHASE IB ARCHAEOLOGICAL SURVEY
2500 PENNINGTON ROAD
BLOCK 78, LOT 17
HOPEWELL TOWNSHIP
MERCER COUNTY, NEW JERSEY**

**DLUR #1106-08-0012.1
HPO PROJECT #18-0614-1**

APRIL 2023

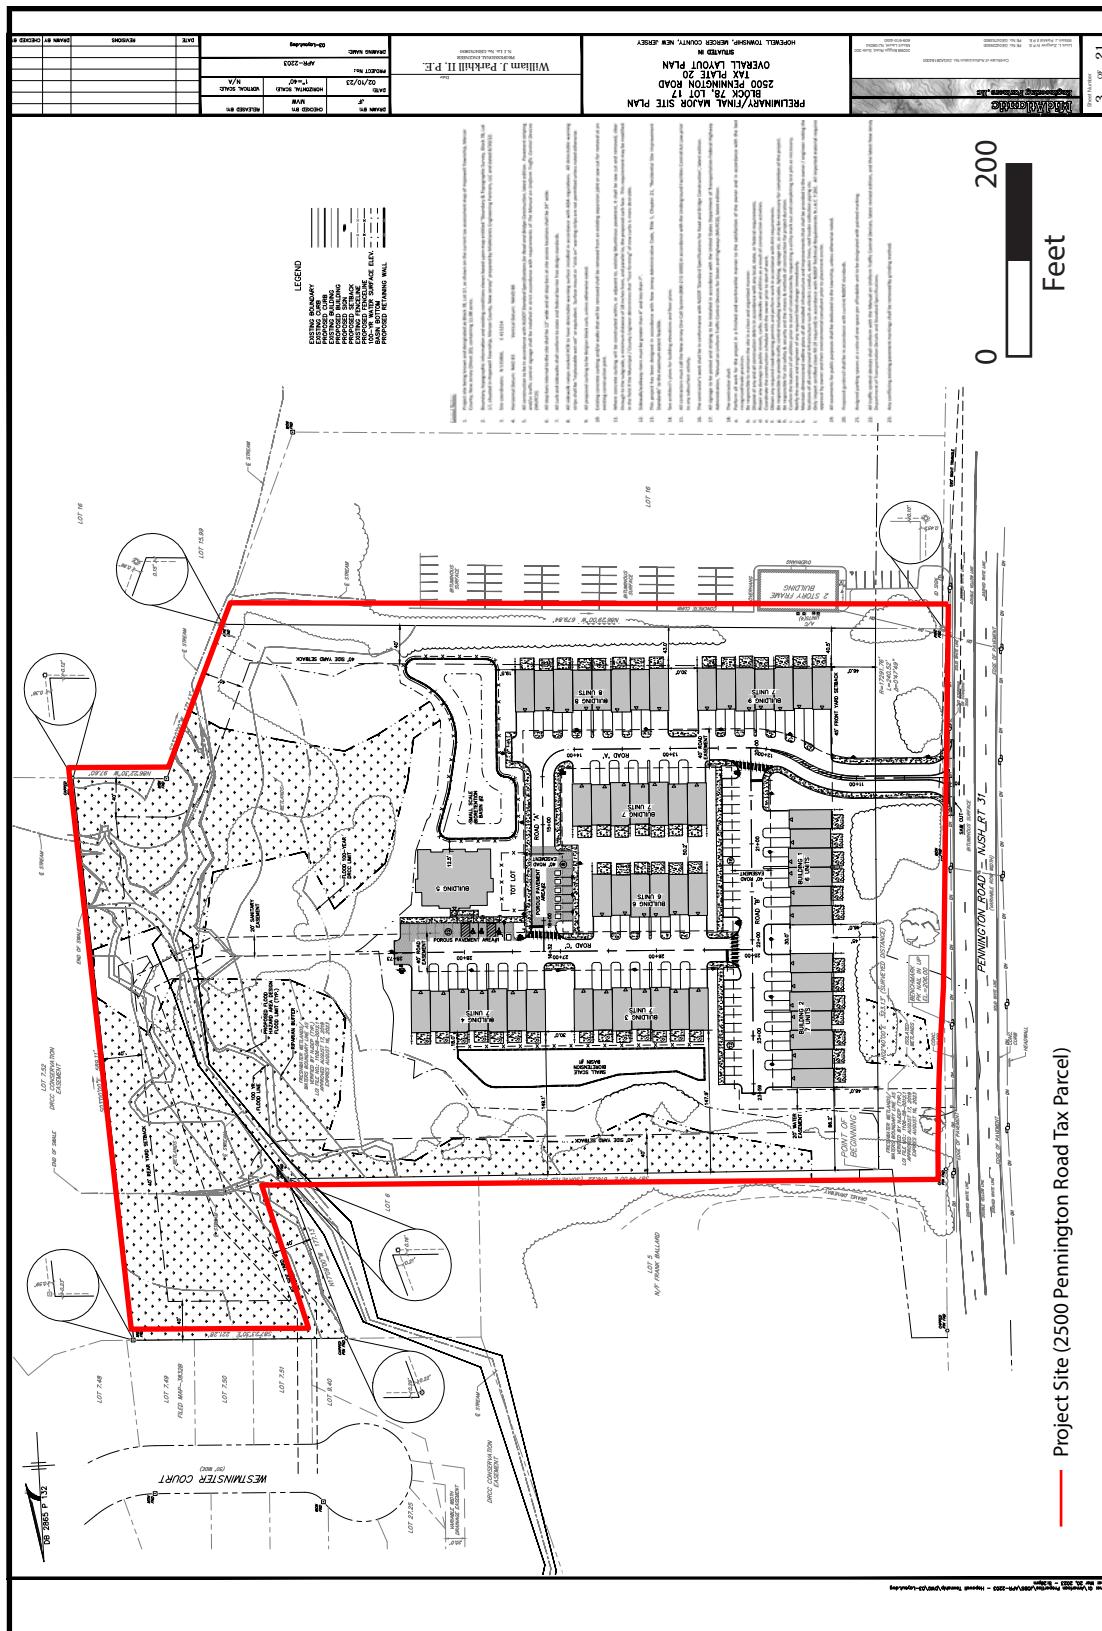
Figure 1.3. Overall Layout Plan. Source: MidAtlantic Engineering Partners, Inc. 2022.

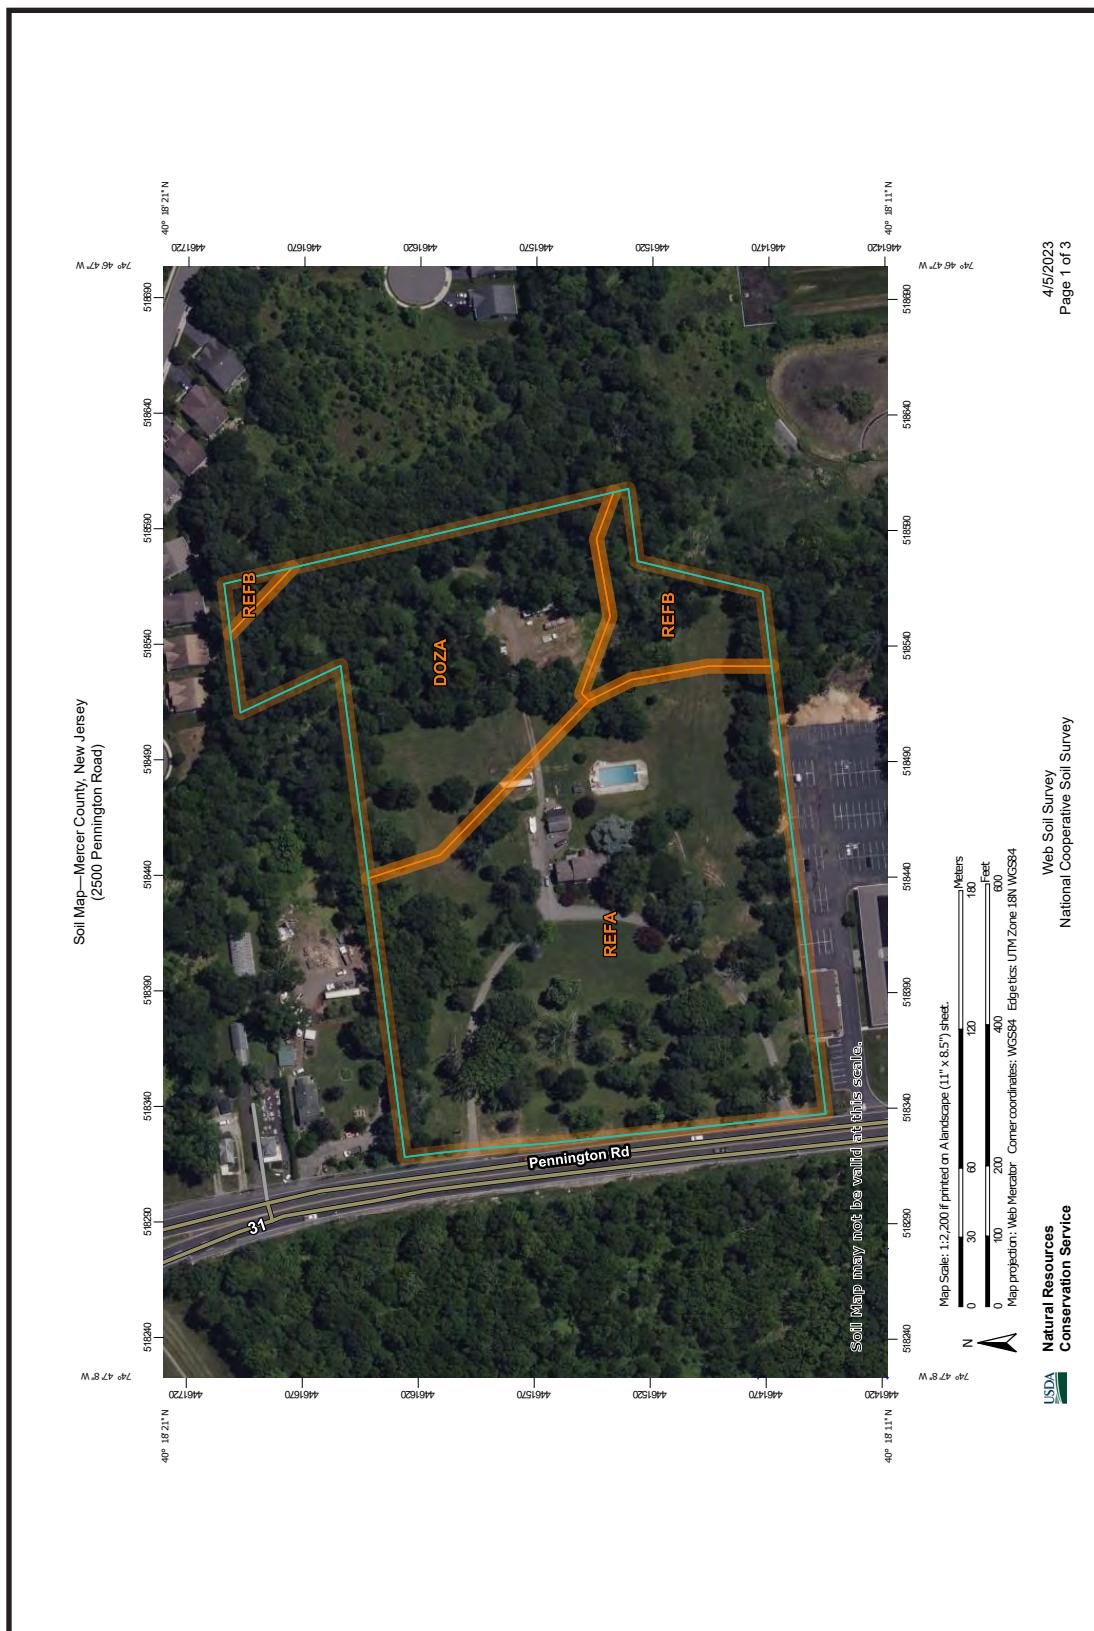
Figure 2.2. Soils Map of the Project Site. Source: NRCS 2023. Key: DOZA = Doylestown and Reaville variant silt loam, 0 to 2 percent slopes; REFA = Readington and Abbottstown silt loams, 0 to 2 percent slopes; REFB = Readington and Abbottstown silt loams, 2 to 6 percent slopes.

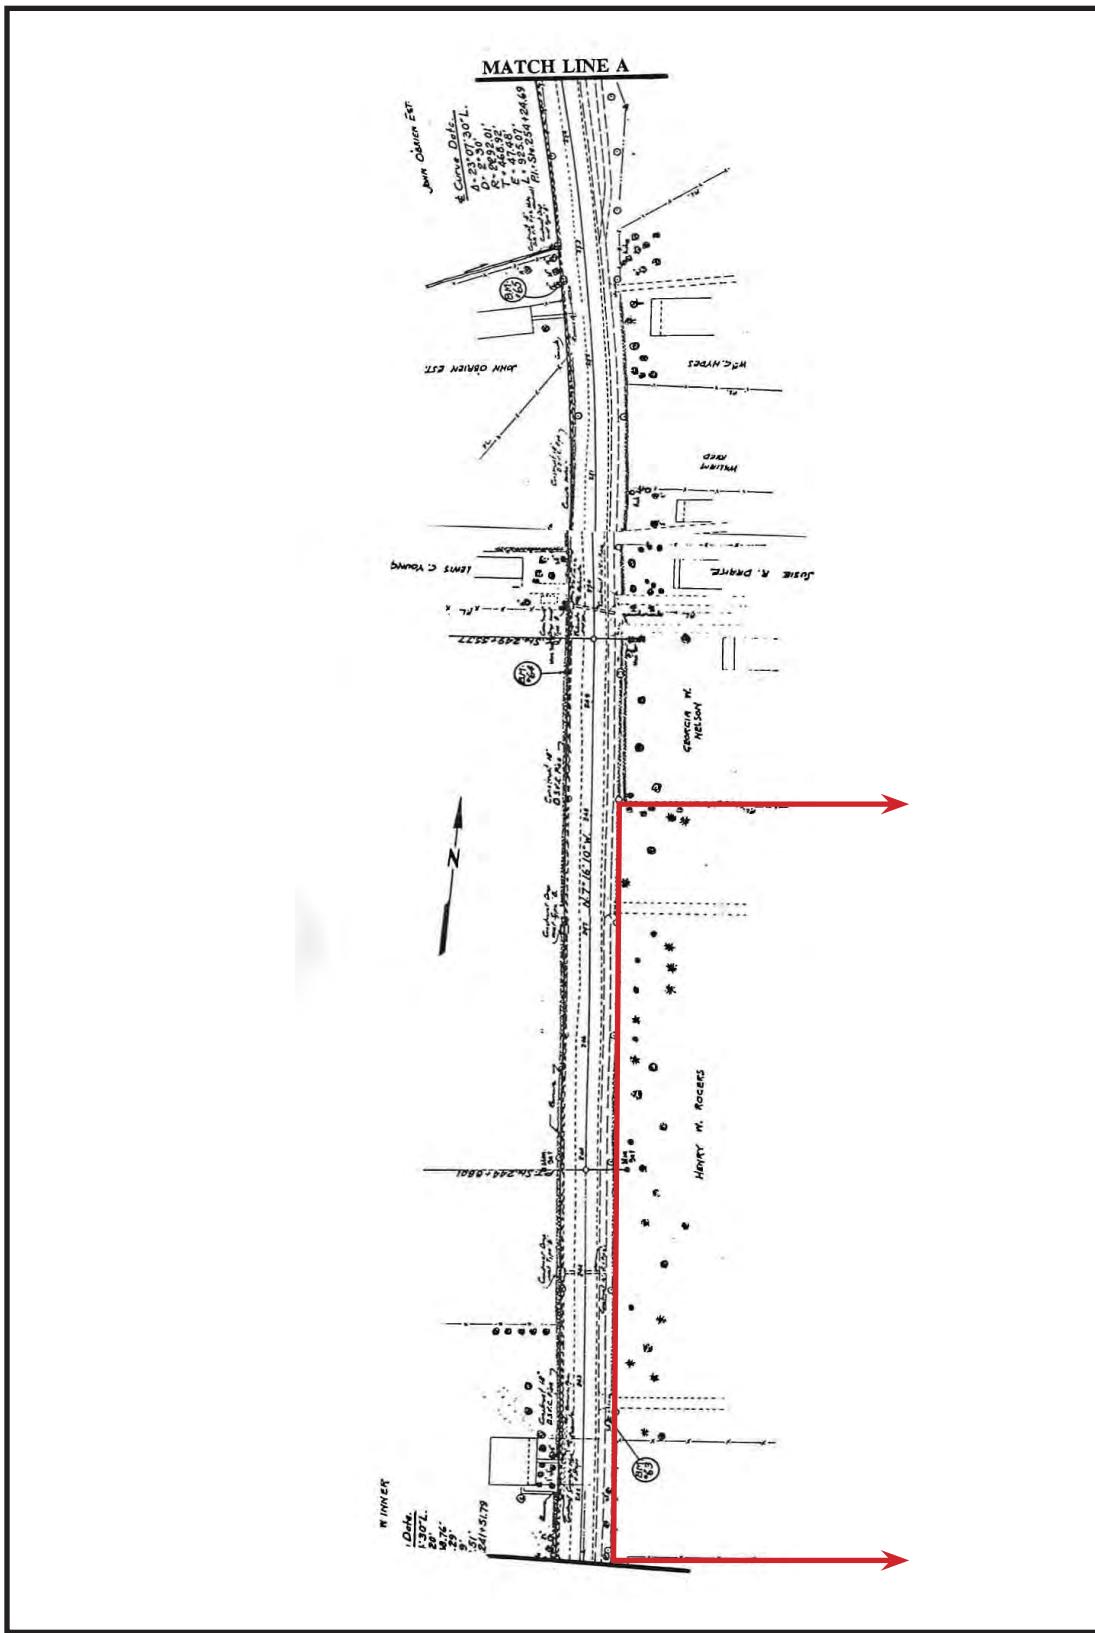
4.8. State of New Jersey Highway Department. As-Built Plans of Trenton-Pennington Road, Mercer County. Section extending south of present-day Pennington Circle (Sheets 1118-019 and 1118-020). 1926. Location of project site indicated. Scale: 1 inch = 170 feet (approximately).

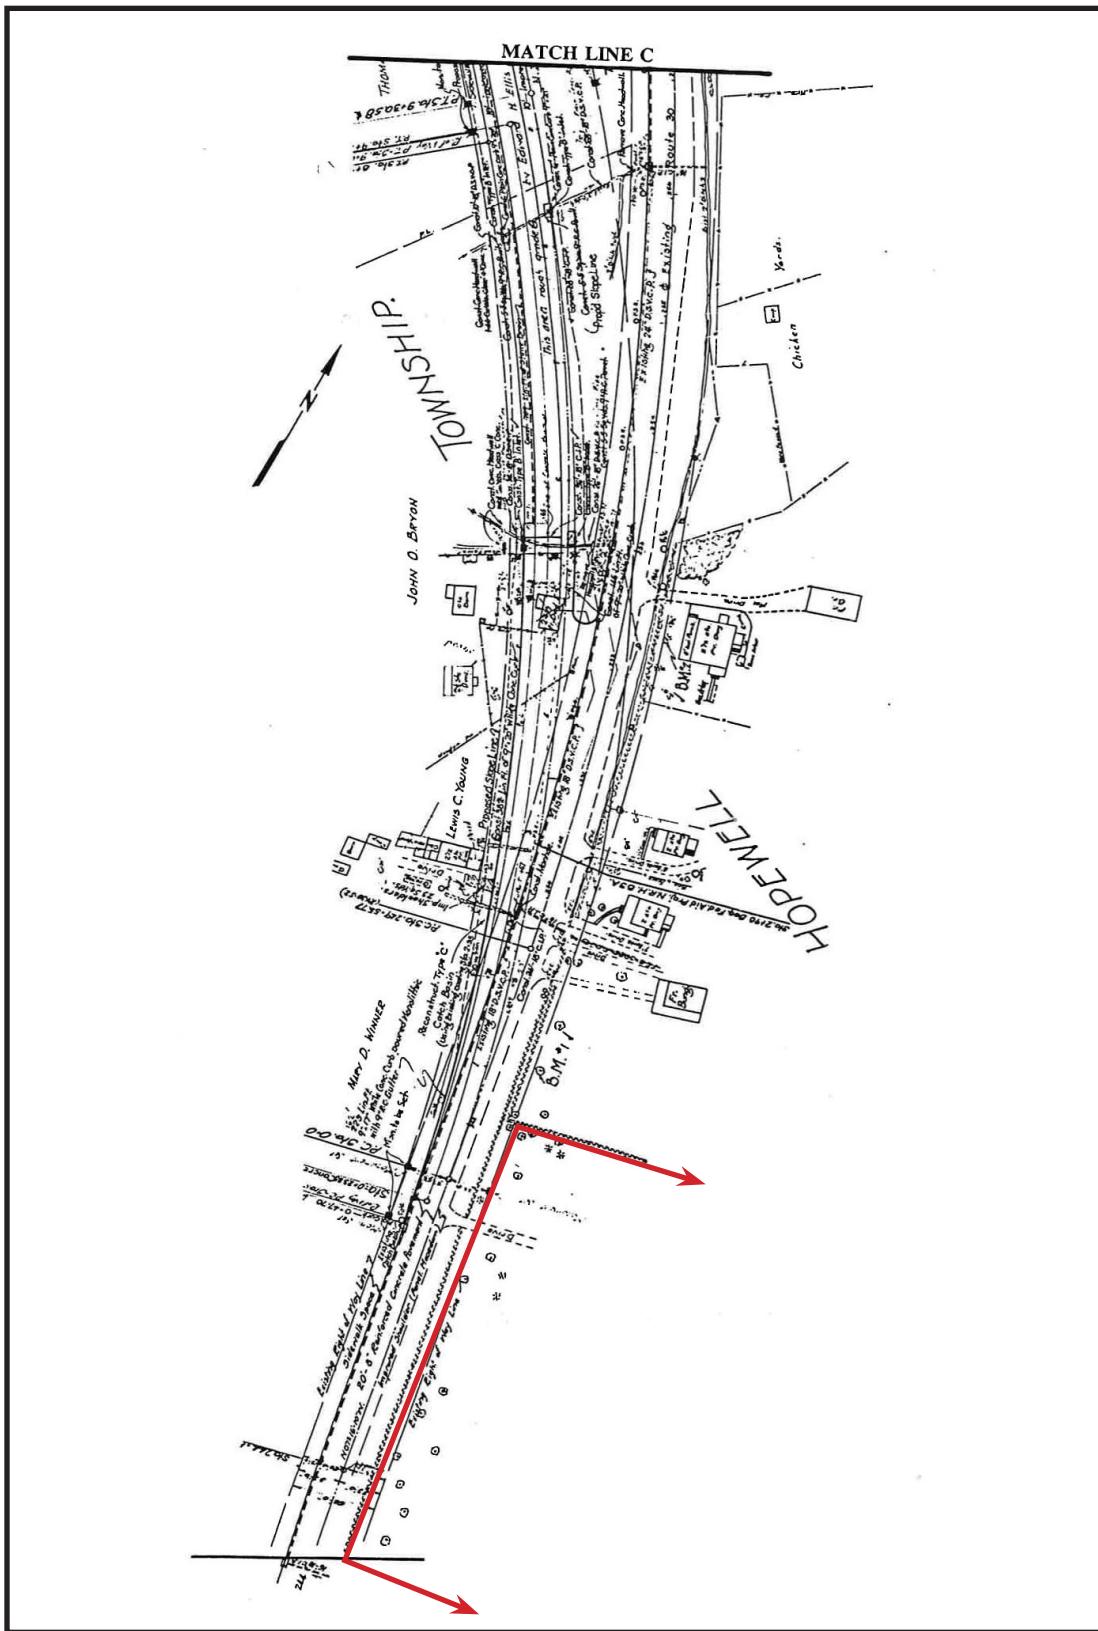
4.10. State of New Jersey Highway Department. As-Built Plans of Route 30, Section 10, Pennington By-Pass, Mercer County. Section immediately south of present-day Pennington Circle (Sheet 1119-003). 1933. Location of project site indicated. Scale: 1 inch = 85 feet (approximately).

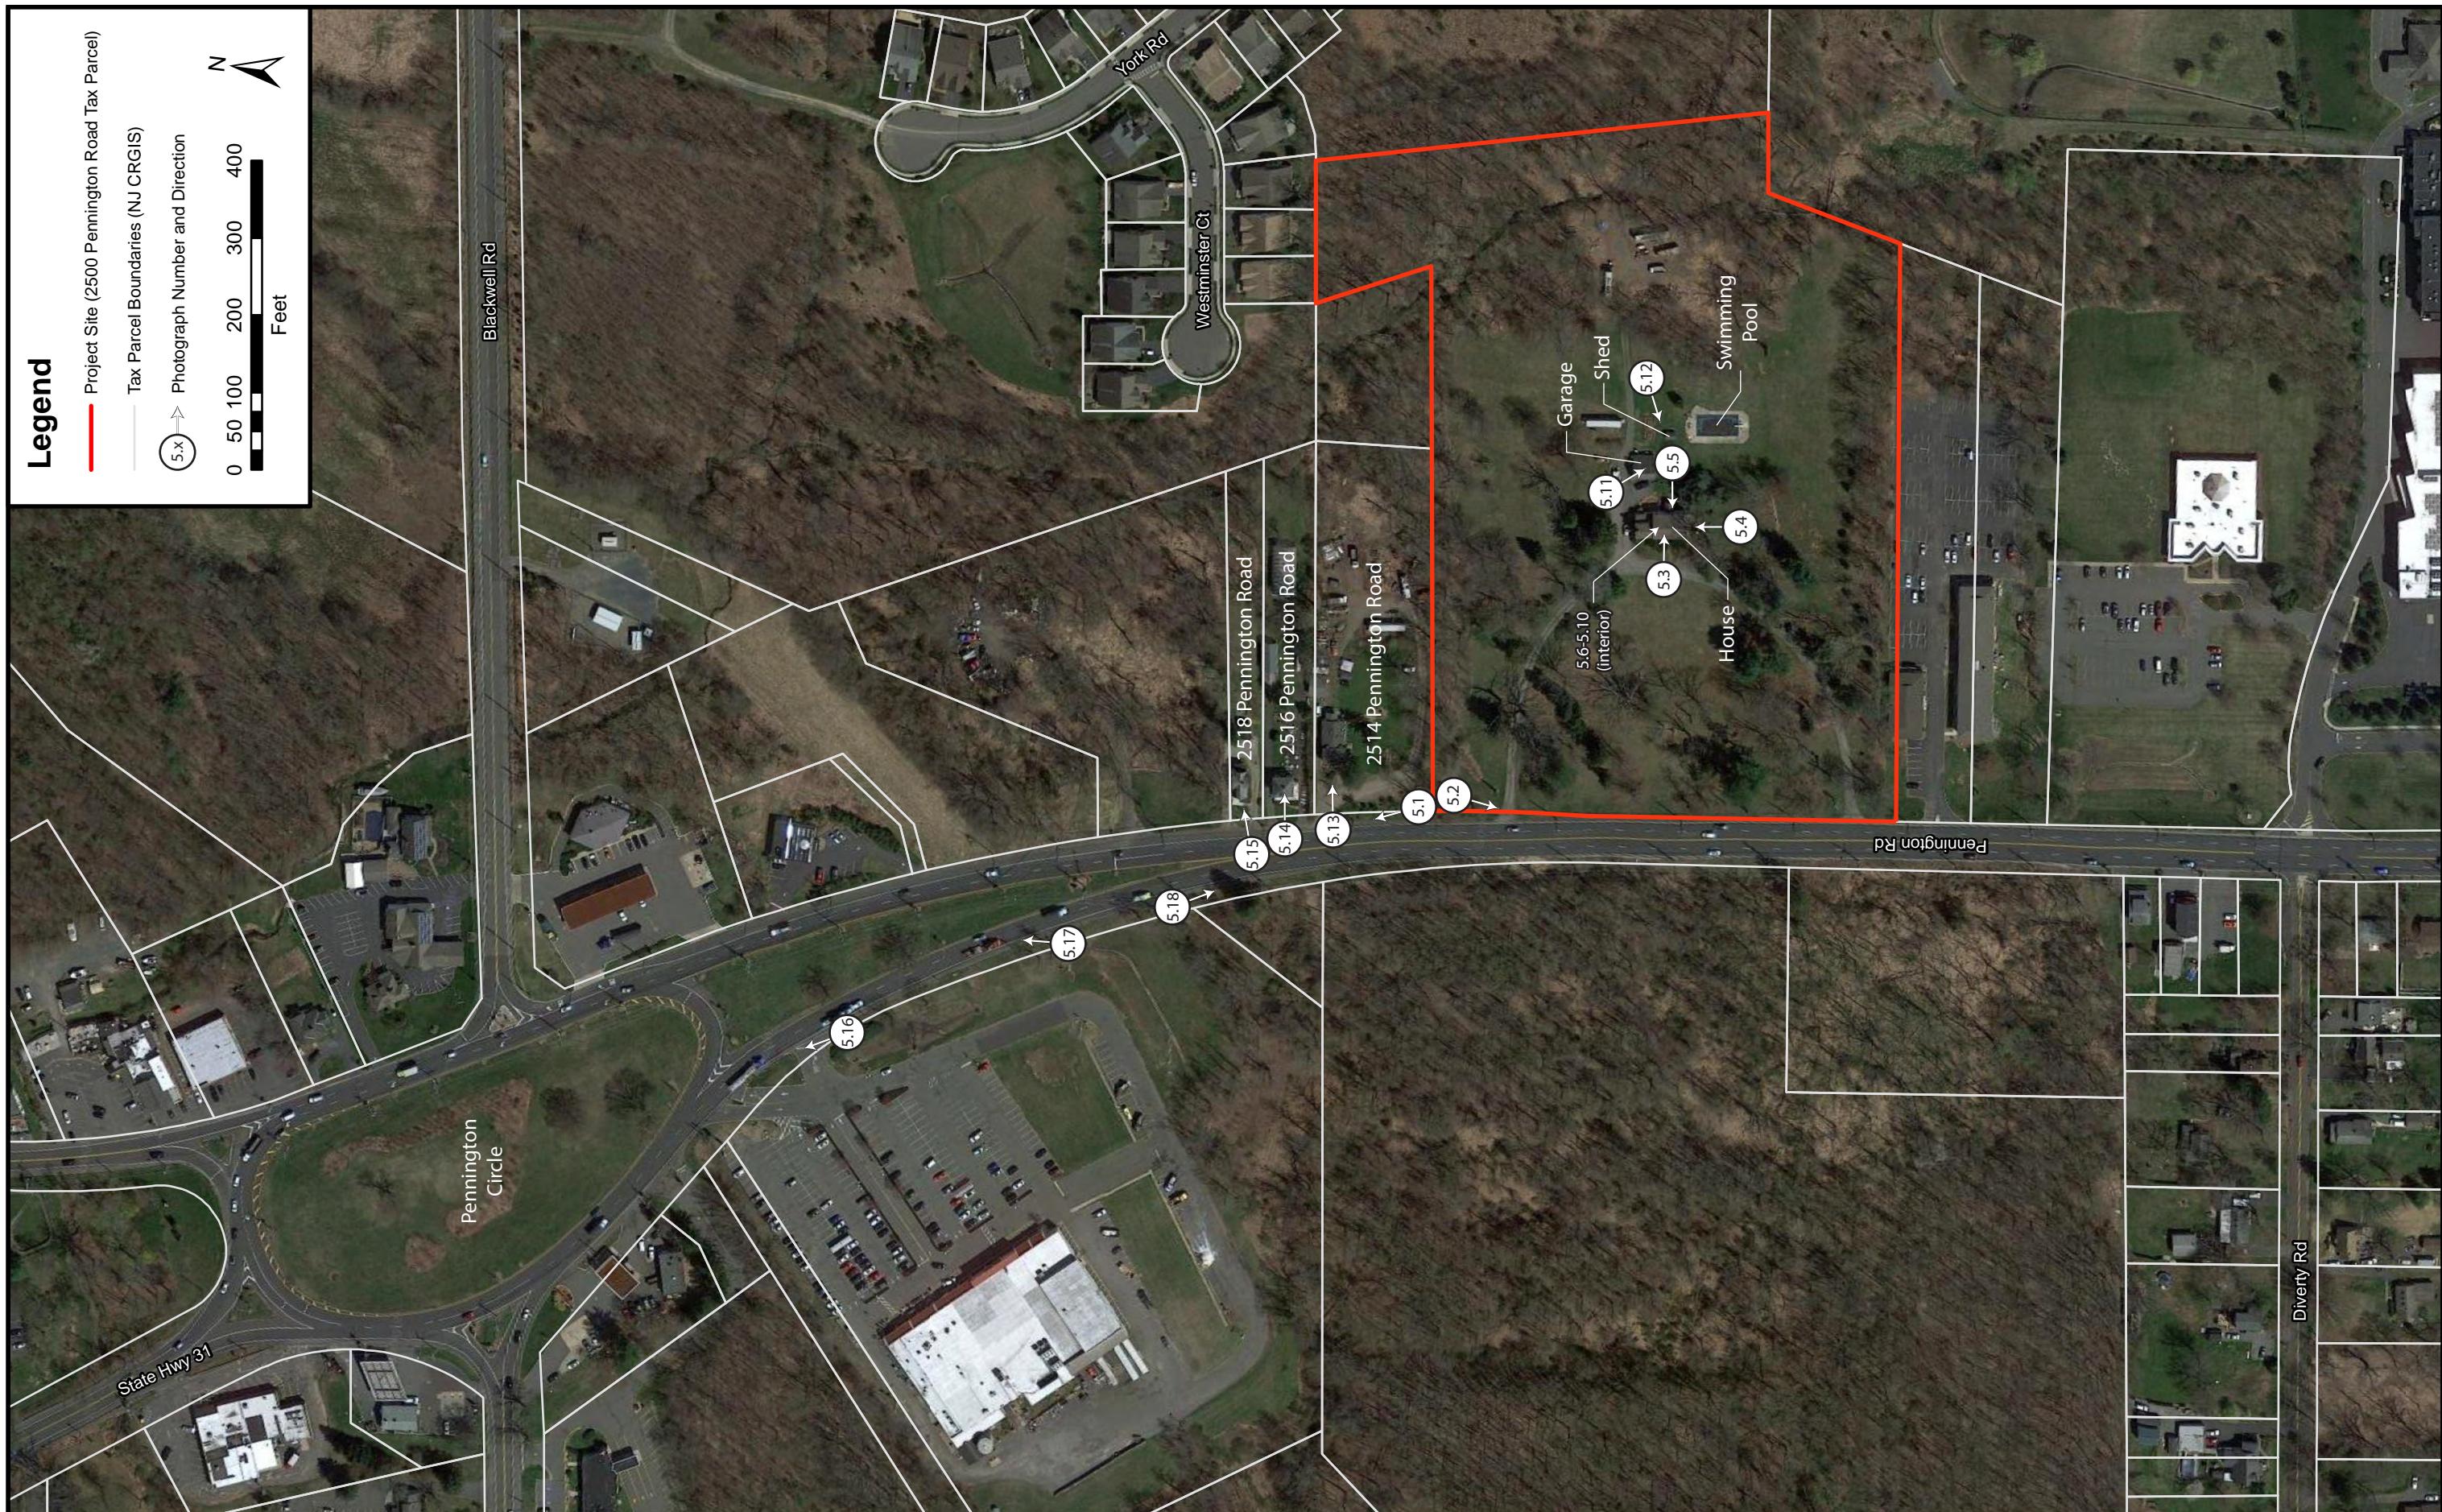
Figure 5.1. Aerial Map of Project Site Showing Locations of Surveyed Architectural Resources over 50 Years of Age and Photographic Views.

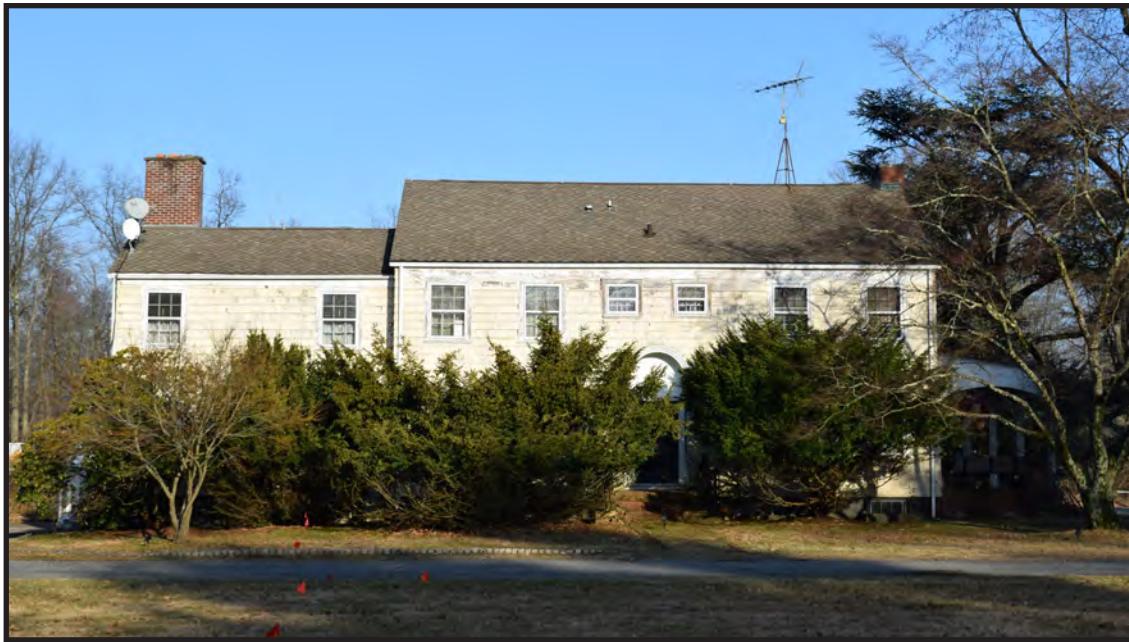
Photograph 5.3. The front (west) elevation of 2500 Pennington Road, looking east (Photographer: Rachel Craft, February 2023) [HRI Neg. # 23011/D1:073].

2500 Pennington Road (Block 78, Lot 17) (Photographs 5.3-5.12) is a building complex consisting of a house, garage and shed set back from the highway a distance of between 350 feet to 475 feet. A semi-circular, single-lane drive creates a formal entrance reaching its apex near the house's front door. Aside from the drive, the landscaping is not formal consisting of a scattering of mostly mature trees shading a lawn and overgrown shrubs shielding the house. The complex consists of the house facing west with a three-car garage, a shed and an in-ground swimming pool located to the house's east or rear.

The house is two stories, six-bays wide, two-bays deep, side-gabled and Colonial Revival in style. To the main block's north is a shorter, two-story, three-bay wide, two-bay deep, side-gabled wing. The house, both main block and wing, was constructed *circa* 1926-27 and first owned by John Ogden Winner III and his wife, Marion. The roof is clad with replacement asphalt shingles and the exterior is clad with wood shingles. An exterior brick chimney is centered on the south side elevation, and a larger interior chimney located at the north end of the wing's ridge line. The latter chimney is oddly oriented with its long axis parallel to the ridge; an interior inspection discovered that it does not serve any fireplaces but likely is oriented to accommodate a furnace flue from the basement. Windows are replacement 6/6 wood sashes surrounded by plainly molded lintels and trim with the exception of fanlights at the attic story. The center-hall entry is defined by a six-panel. A Colonial Revival-style, wood door and surround is capped by a recessed, semi-circular fan set atop fluted corbels. A shed-roof, one-story, open porch with a brick and concrete deck spans the depth of the south side. A front-gabled, classical portico shields a rear center-hall doorway. According to the current owner, the vinyl-sided portico was added *circa* 1995. A one-story, shed-roof addition in-fills the rear elevation of the wing. The dwelling rests on a poured concrete foundation.

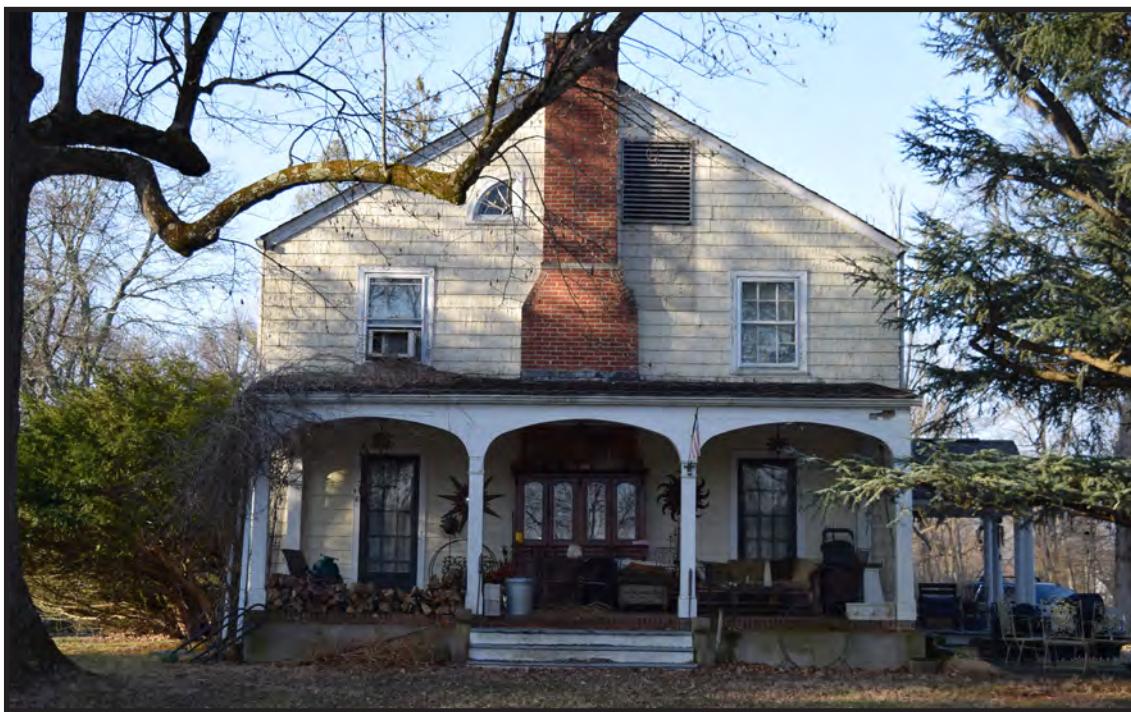
Photograph 5.4. The side (south) elevation of 2500 Pennington Road, looking north (Photographer: Rachel Craft, February 2023) [HRI Neg. # 23011/D1:069].

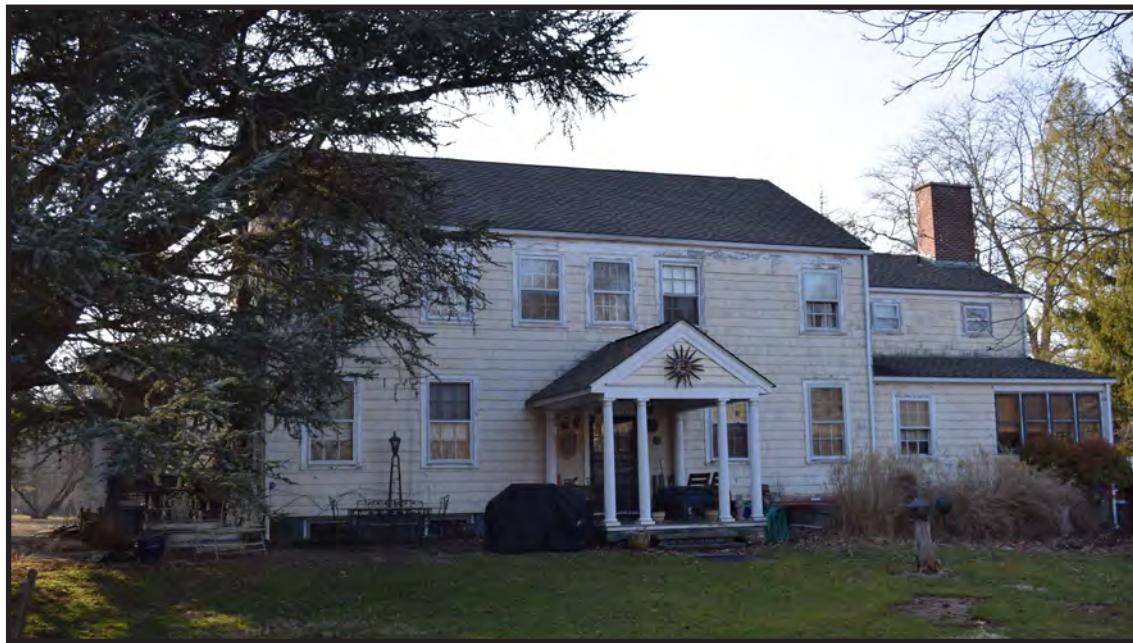
Photograph 5.5. The rear (east) elevation of 2500 Pennington Road, looking east (Photographer: Rachel Craft, February 2023) [HRI Neg. # 23011/D1:068].

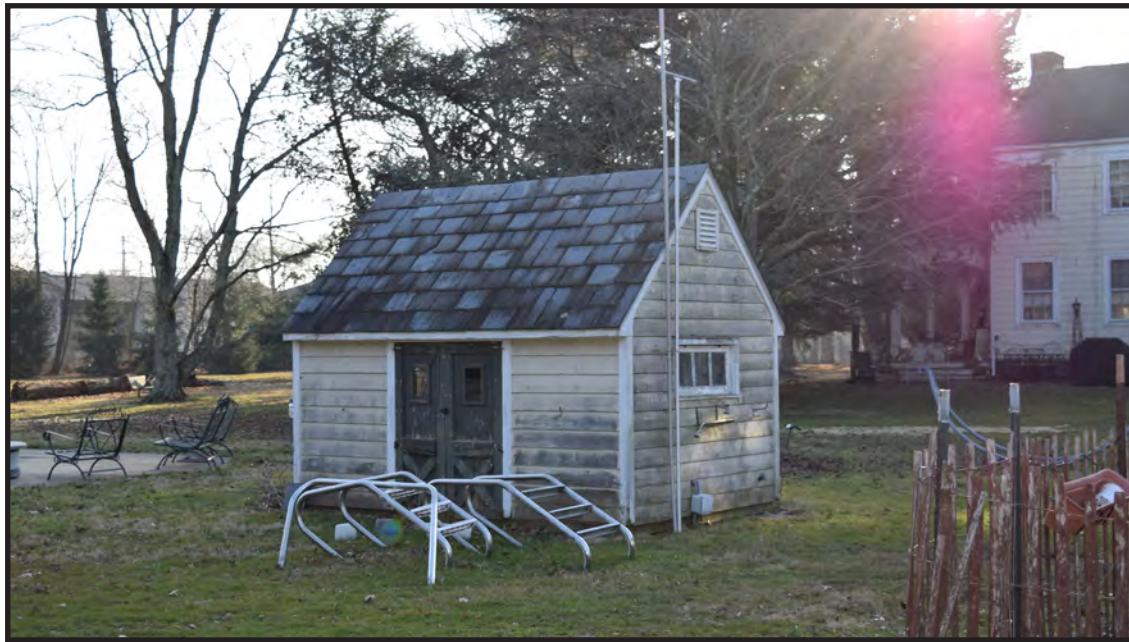
Photograph 5.12. The shed at the rear of the dwelling at 2500 Pennington Road, looking southwest (Photographer: Rachel Craft, February 2023) [HRI Neg. # 23011/D1:079].

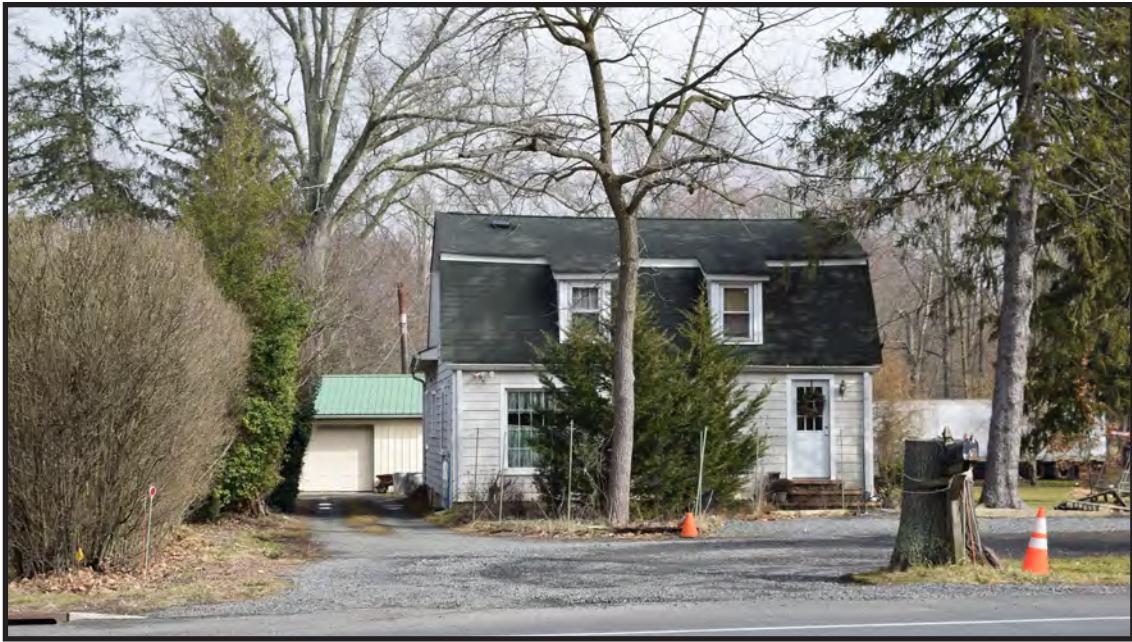
Photograph 5.13. 2514 Pennington Road, looking east (Photographer: Rachel Craft, February 2023) [HRI Neg. # 23011/D1:027].

2514 Pennington Road (Block 78, Lot 5) (Photograph 5.13) is a modest, one-and-one-half-story, two-bay, side-gambrel, side-hall, Dutch Colonial Revival-style dwelling that was constructed *circa* 1950 based on aerial photographs and architectural style. Its roof is covered with asphalt shingles and its exterior is clad with non-original vinyl siding. The dwelling's side-gambrel roof is punctured by two shed-roof dormers on its front (west) elevation. Windows are mostly comprised of vinyl replacements, and a replacement door fills the right-bay entry. The dwelling rests on a concrete foundation. A one-story, shed-roof addition to the dwelling's rear (east) elevation was completed

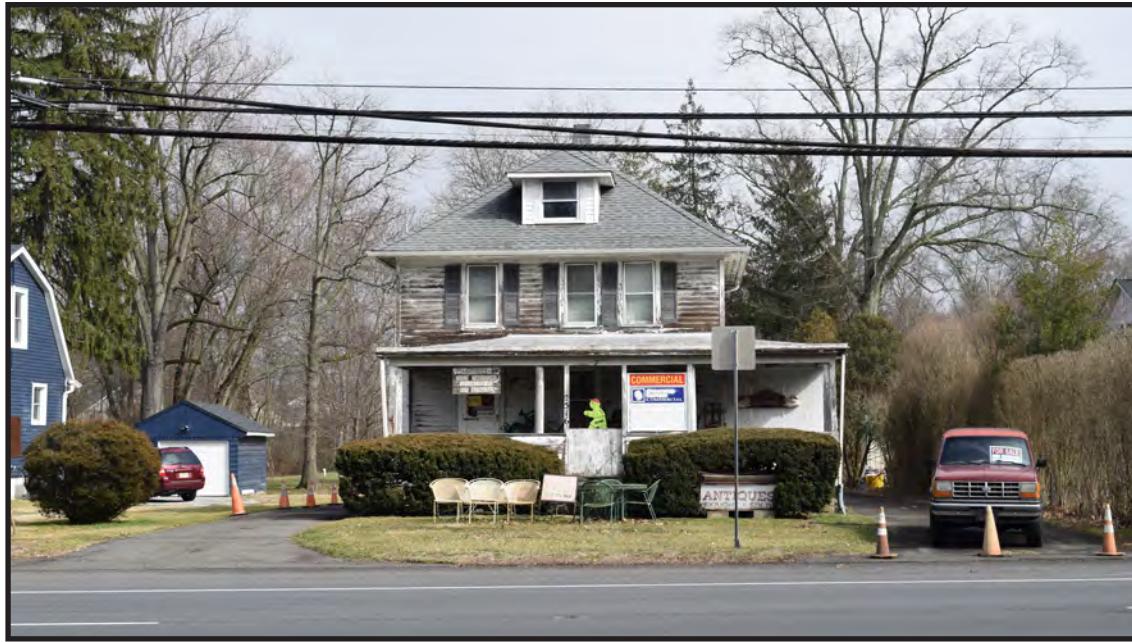
Photograph 5.14. 2516 Pennington Road, looking east (Photographer: Rachel Craft, February 2023) [HRI Neg. # 23011/D1:022].

2516 Pennington Road (Block 78, Lot 3) (Photograph 5.14) is a two-and-one-half-story, three-bay, pyramidal-roof, Four Square-form dwelling that was constructed *circa* 1920 based on its architectural form. Its roof is covered with replacement asphalt shingles and its exterior is clad with wood clapboard siding. A hipped dormer sided with vinyl and containing a 1/1 vinyl sash punctures the front (west) roof elevation. A parged brick chimney is located on the rear (east) roof slope. Other windows are 1/1 wood sashes. The dwelling's front elevation features a wraparound, open, wood porch that has been partially enclosed on its southern side. The main entry in the left bay is concealed by a modern storm door. The dwelling rests on a parged foundation. Two outbuildings are located on the property to the rear of the dwelling. Outbuilding #1 is a one-story, two-bay, front-gabled building that appears to have been constructed contemporaneously with the dwelling. Outbuilding #2 is a one-story, one-bay, prefabricated metal building with an arched roof that was added to the property *circa* 1990. See Appendix B for an Intensive-Level Architectural Survey Form and Eligibility Worksheet for 2516 Pennington Road.

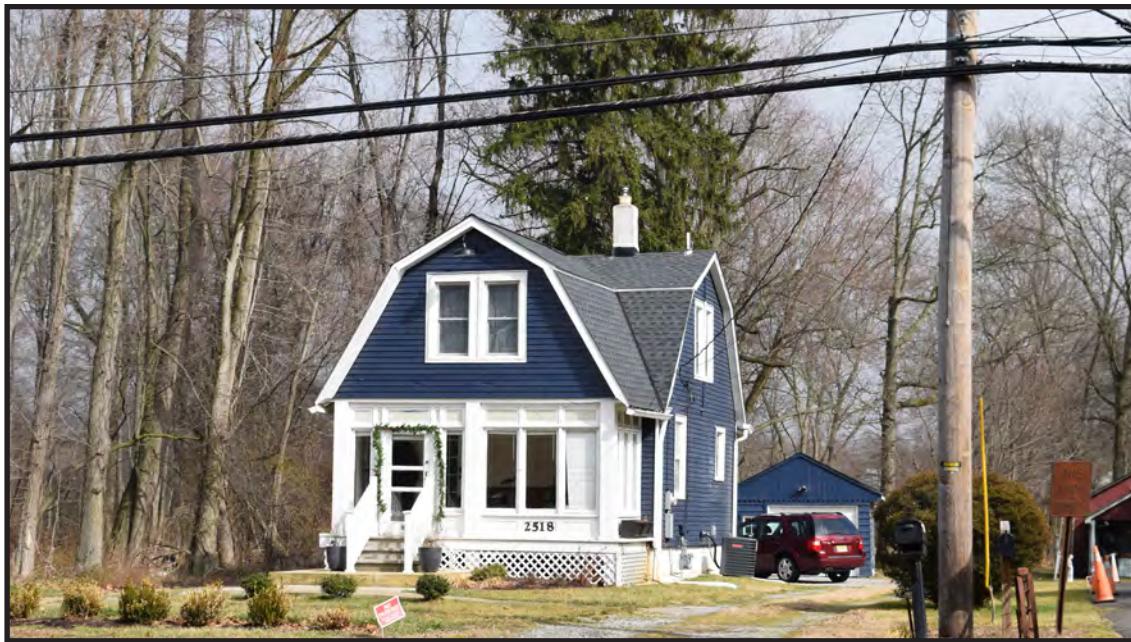
Photograph 5.15. 2518 Pennington Road, looking northeast (Photographer: Rachel Craft, February 2023) [HRI Neg. # 23011/D1:017].

2518 Pennington Road (Block 78, Lot 4) (Photograph 5.15) is a modest, one-and-one-half-story, two-bay, cross-gambrel dwelling with Dutch Colonial Revival-style influences that was constructed *circa* 1920 based on architectural style. Its roof is covered with asphalt shingles and its exterior is clad with non-original vinyl siding. A parged chimney is located on the roof ridge of its south-facing cross-gable. Windows are paired at the half-story level and are filled by double-hung, 1/1, replacement vinyl sashes. The front elevation features a full-width porch enclosed with fixed panes set in wood frames and surmounted by wood panels. The windows and doors are separated into segments of

three by plain, square columns. A glazed door with a wood frame is set in the left-bay entry. The dwelling rests on a parged foundation. A one-story, two-bay, front-gabled garage is located off of the southeast corner of the dwelling and appears to have been constructed contemporaneously with the dwelling. See Appendix B for an Intensive-Level Architectural Survey Form and Eligibility Worksheet for 2518 Pennington Road.

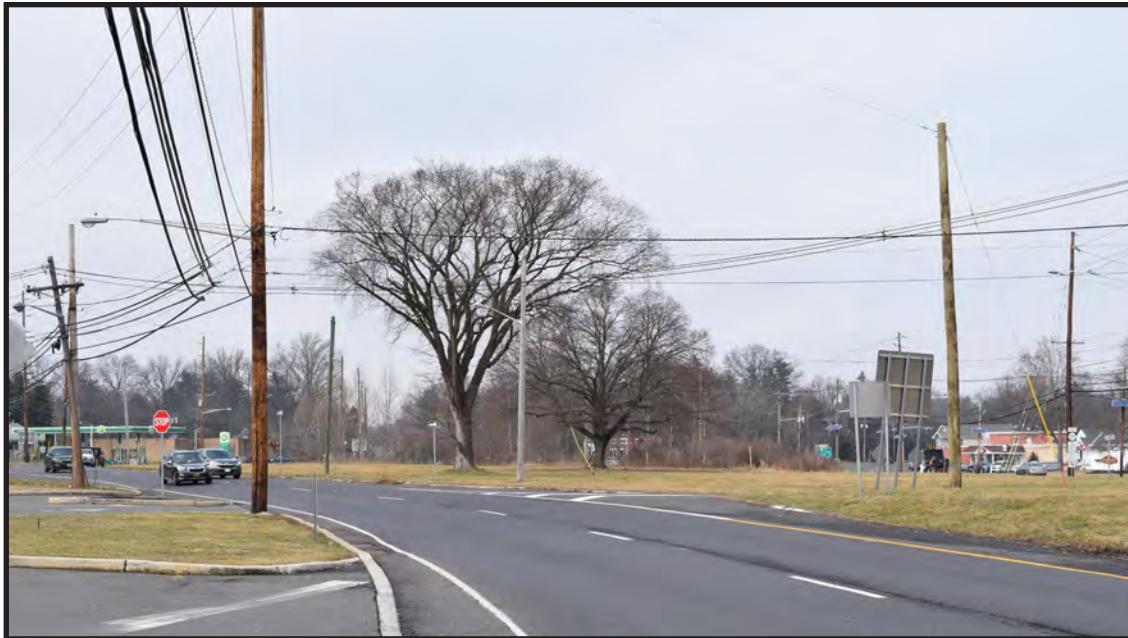
Photograph 5.16. The Pennington Circle, looking northeast toward the center of the circle from a commercial property driveway apron (Photographer: Rachel Craft, February 2023) [HRI Neg. # 23011/D1:008].

New Jersey Route 31 Circle (Pennington Circle) (Photographs 5.16-5.18) was developed in 1933-1935 in Hopewell Township, approximately 0.43 miles to the south and outside of Pennington Borough (see above, Figure 4.10). A circular, grassy infield and copse of mature trees creates the circular traffic pattern, joining the five roadways that meet at its edges: New Jersey Route 31 to the northwest, Pennington Road to the northeast, Blackwell Road to the east, Washington Crossing-Pennington Road to the west, and New Jersey Route 31/Pennington Road to the south. Other triangular-shaped, grassy infields separate acceleration and deceleration lanes into and out of the circle. The two-lane, asphalt-paved roads within the circle are marked with modern signage and traffic signals. Modern commercial development fronts and surrounds the circle, including a grocery store, gas stations, a bank and a medical facility, among other commercial properties.

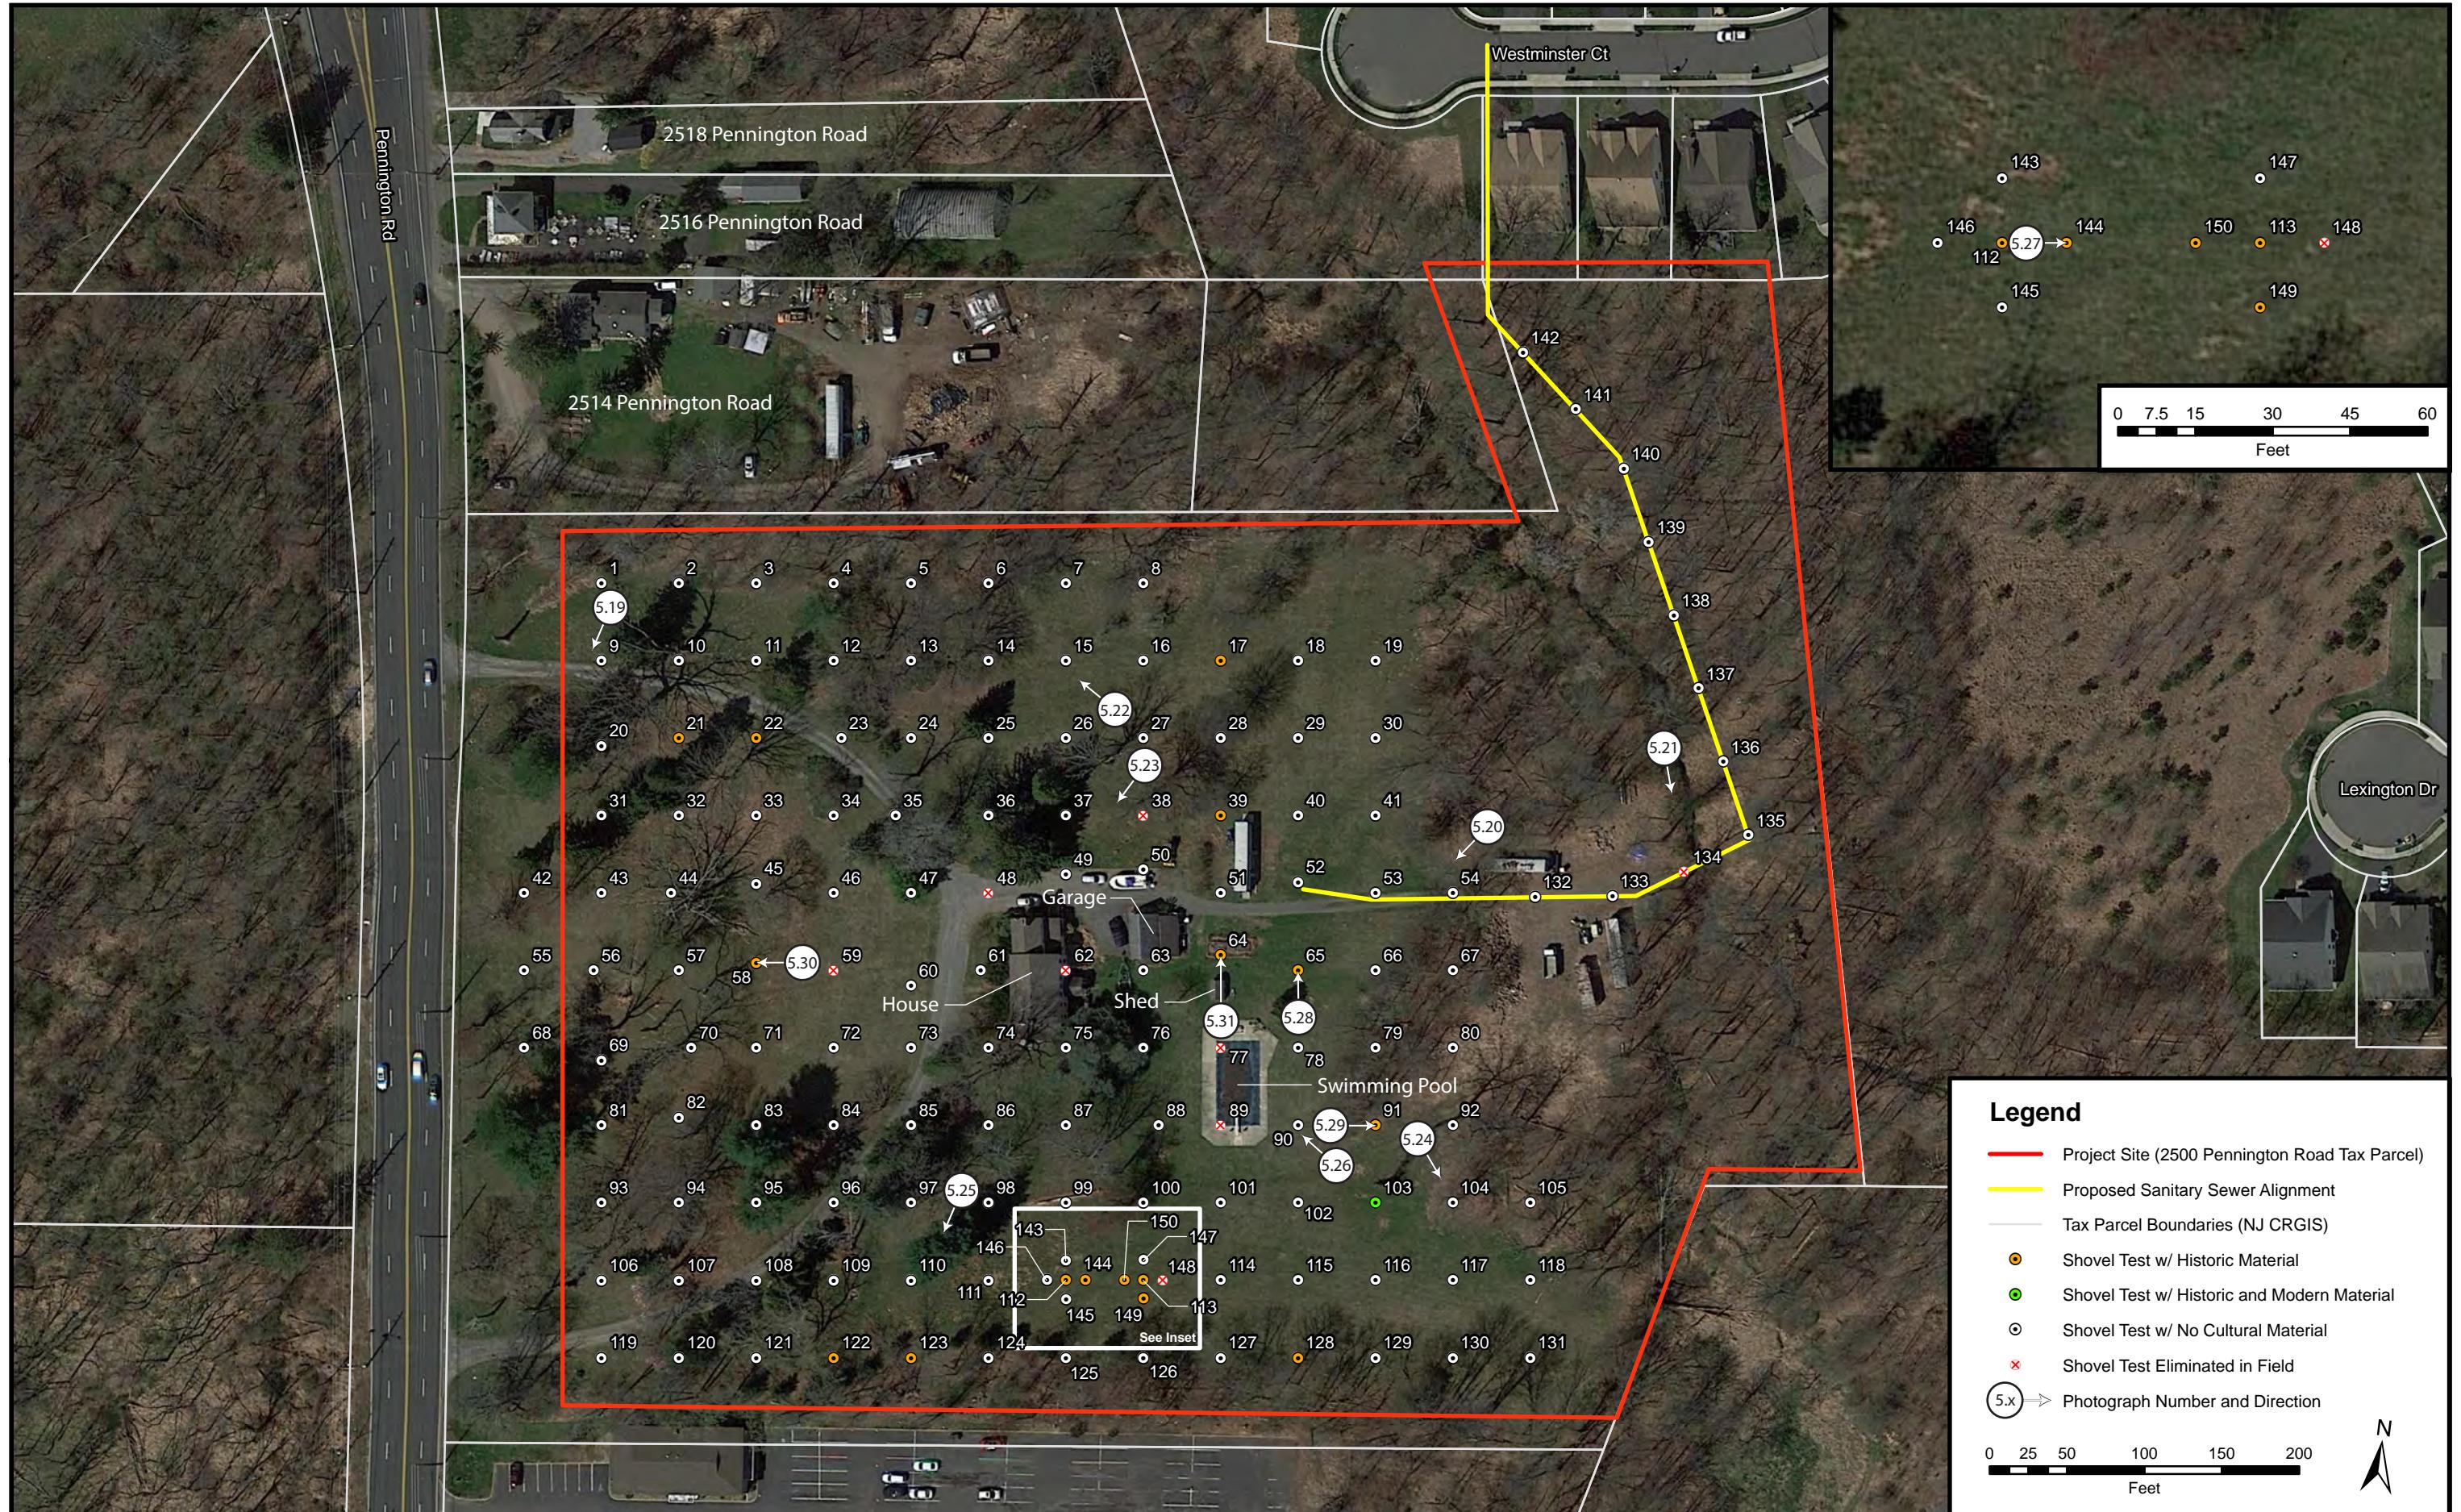
Figure 5.2. Aerial Map of Project Site Showing Locations of Archaeological Tests and Photographic Views.
