**INTENSIVE-LEVEL ARCHITECTURAL SURVEY
AND PHASE IB ARCHAEOLOGICAL SURVEY
2500 PENNINGTON ROAD
BLOCK 78, LOT 17
HOPEWELL TOWNSHIP
MERCER COUNTY, NEW JERSEY**

**DLUR #1106-08-0012.1
HPO PROJECT #18-0614-1**

APRIL 2023

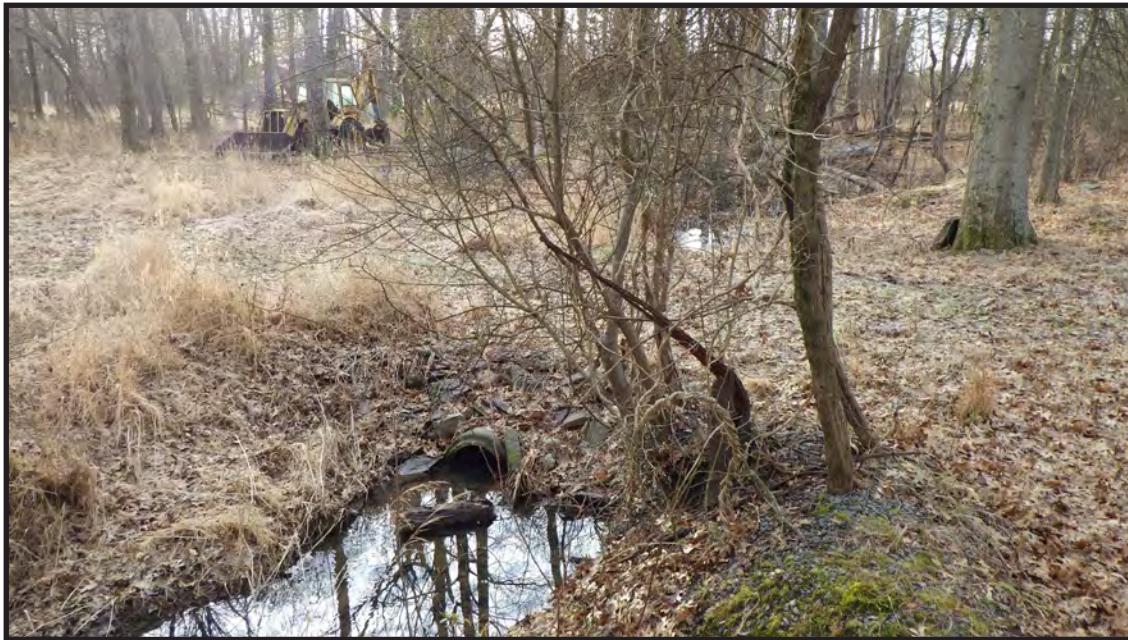
Photograph 5.21. View looking southeast upstream showing the rough stone bridge and concrete culvert straddling the unnamed stream that flows from south to north across the eastern section of the property (Photographer: Michael Brown, February 2023) [HRI Neg. # 23011/D2:119].

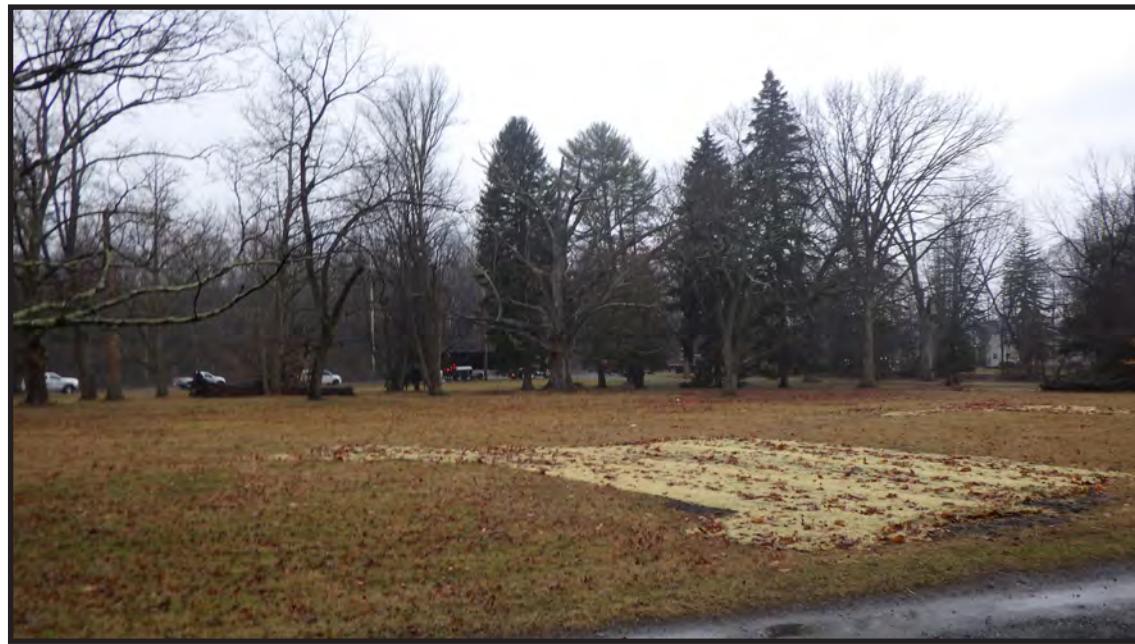
The landscape surrounding the house is mostly open lawn with trees of varying type and size (Photograph 5.22 and 5.23). The lawn is flat, with no major topographic irregularities or depressions. There is a low, manmade berm along the southeastern boundary of the site, also noted in the 2017 Phase IA reconnaissance survey, which is thought to be stockpiled soil from construction of the swimming pool (Photograph 5.24) (Tomaso and Cooperman 2017:3-3). In the eastern section of the yard, adjacent to the woodland, there was some pooling of surface water and the ground was slightly wet likely due to recent heavy rainfall and poorly drained, saturated soils (Photograph 5.24).

Photograph 5.22. View looking northwest showing the ground conditions in the western section of the 2500 Pennington Road property and a backfilled and reseeded geotechnical test trench (Photographer: Michael Brown, February 2023) [HRI Neg. # 23011/D2:019].

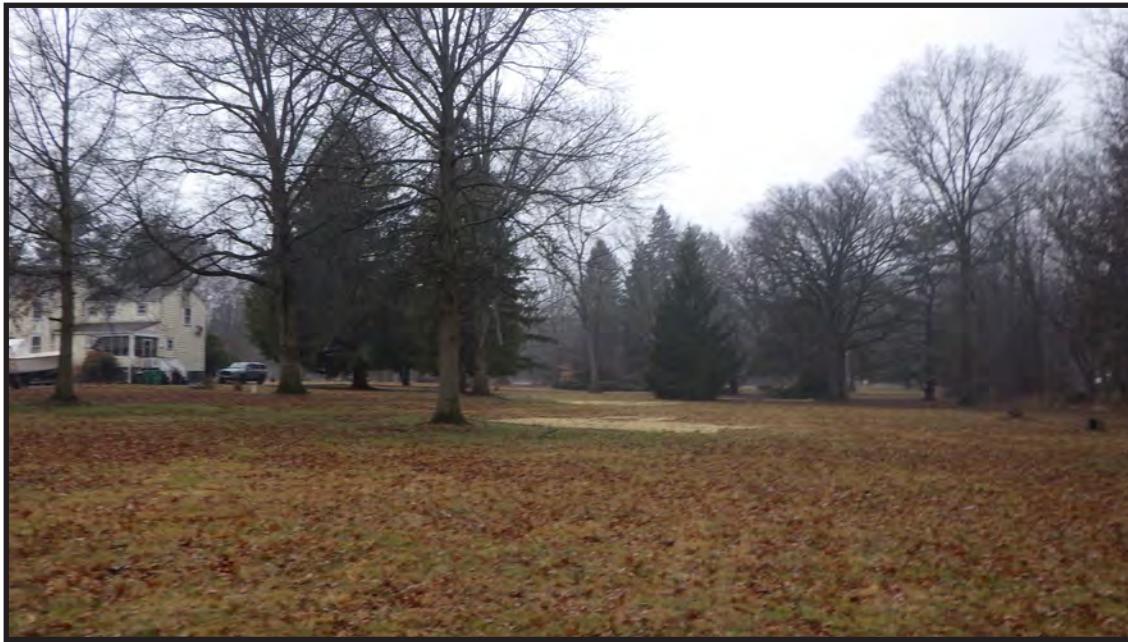
Photograph 5.23. View looking southwest showing the ground conditions in the northern section of the 2500 Pennington Road property and recent ground disturbance from geotechnical testing (Photographer: Michael Brown, February 2023) [HRI Neg. # 23011/D2:035].

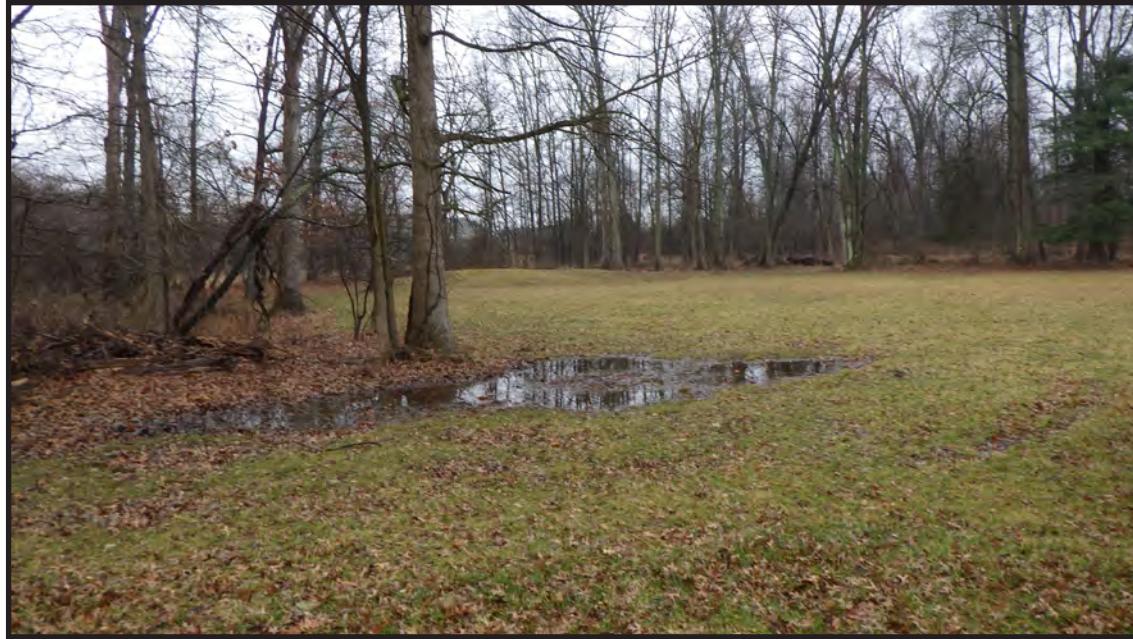
Photograph 5.24. View looking southeast showing ground conditions in the southeastern section of the 2500 Pennington Road property with the pooling of surface water and an artificial berm thought to be stockpiled soil from construction of the swimming pool (Photographer: Michael Brown, February 2023) [HRI Neg. # 23011/D2:069].

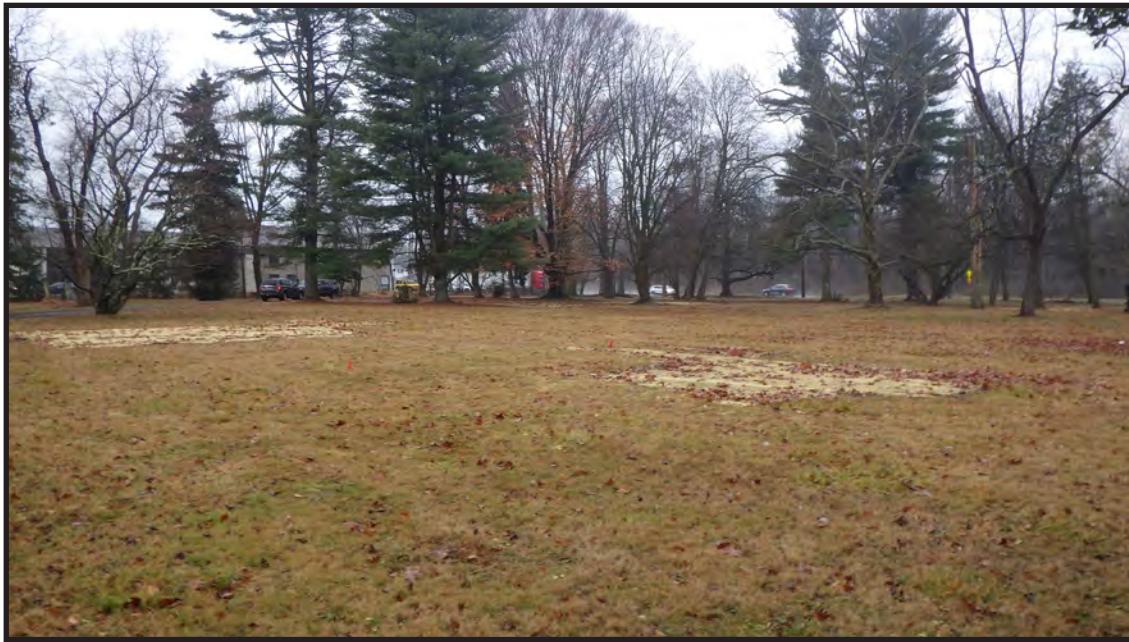
Inspection of the landscape surrounding the house observed recent ground disturbance from geotechnical testing (Photograph 5.25). Approximately 12 trenches of varying size were observed across the property that had been backfilled, seeded and covered with hay. Two utility line mark-outs (gas and fiber optic) were observed extending east from Pennington Road, leading to the house. A PVC monitoring well was also identified approximately 60 feet north of the garage. There are two outbuildings on the property, the previously noted garage and a smaller storage shed, both of which sit behind the house. A small fenced garden sits directly east of the garage and north of the storage

Photograph 5.25. View looking southwest showing the ground conditions in the western yard and a recent backfilled, reseeded geotechnical test trench (Photographer: Michael Brown, February 2023) [HRI Neg. # 23011/D2:016].

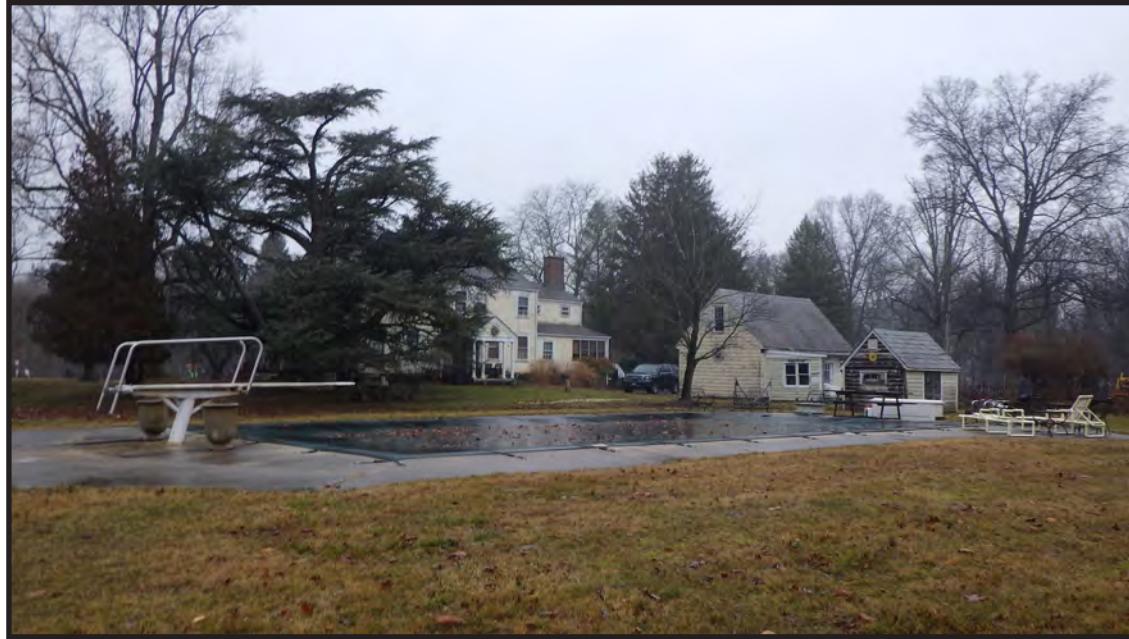
shed. Additionally, there is the above-noted swimming pool located to the southeast of the house (Photograph 5.26).

Photograph 5.26. View looking northwest showing the swimming pool, storage shed and three-door garage located to the rear of the house (Photographer: Michael Brown, February 2023) [HRI Neg. # 23011/D2:029].

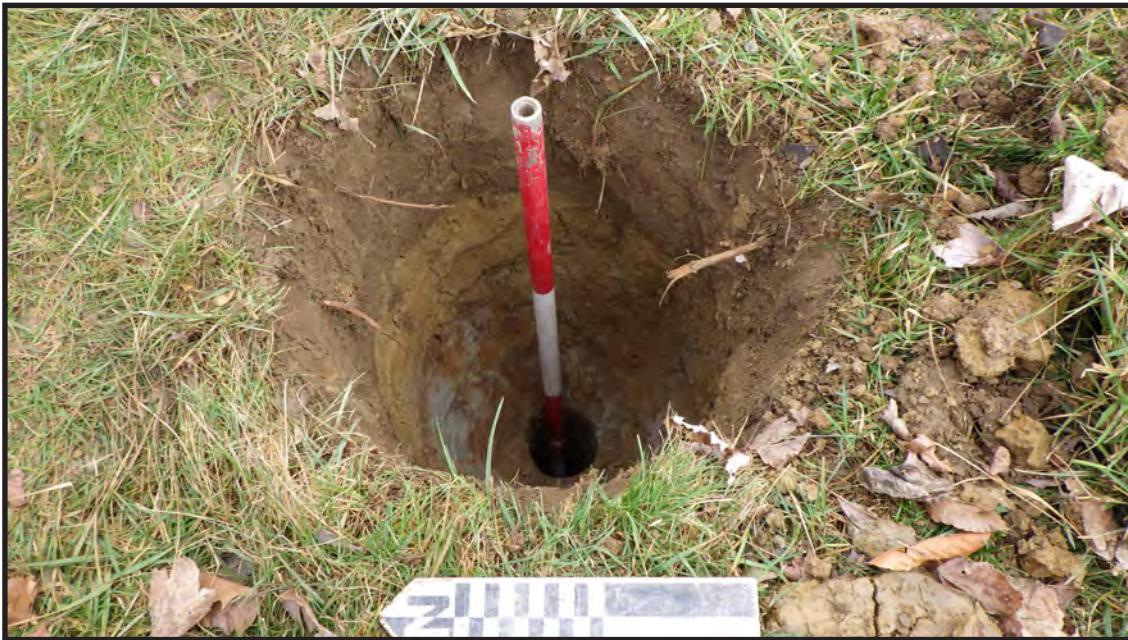
The shovel testing survey revealed a generally consistent soil profile with some variation noted in the subsoil. A typical soil profile commenced with a 0.1 to 0.4-foot-thick, dark brown silty loam [Context 1], which is interpreted as a modern topsoil. The topsoil typically overlaid a brown silty loam [2] which terminated at a depth of 0.8 to 1.4 feet below the ground surface. This soil horizon [2], interpreted as an Ap horizon (or plowzone), overlaid a strong brown silty loam or clayey silt [3], which is interpreted as a natural, culturally sterile B horizon subsoil. The B horizon was identified at depths ranging between 0.7 and 3.5 feet below the ground surface and overlaid a strong brown mottled with a pinkish grey and reddish yellow silty loam or clayey silt [4] which is interpreted as a natural B2 horizon (Photograph 5.27). In some cases, the B2 horizon [4] was a reddish brown

Photograph 5.27. View looking east showing the profile of Shovel Test 144, a typical profile (Photographer: Michael Brown, February 2023) [HRI Neg. # 23011/D2:157].

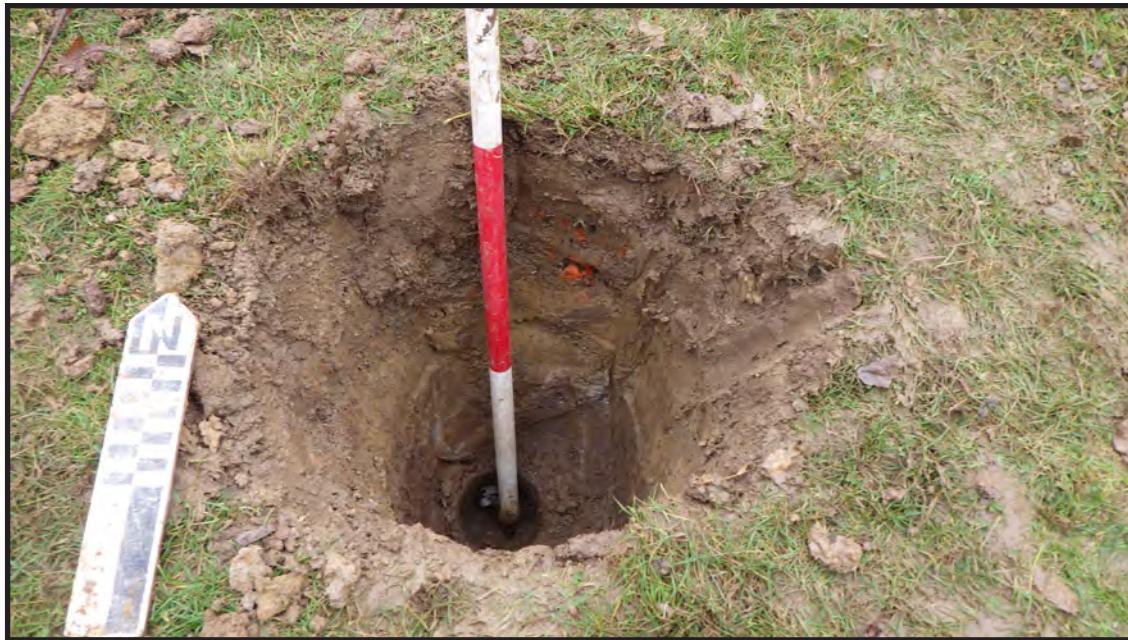
Photograph 5.28. View looking north showing the profile of Shovel Test 65, a typical profile with a darker B2 horizon (Photographer: Michael Brown, February 2023) [HRI Neg. # 23011/D2:072].

mottled with a pinkish grey, reddish yellow, grey and or brown (Photograph 5.28). The B2 horizon was typically identified at a depth of 1.7 to 2.7 feet below the surface, but was also identified at shallower depths, around 0.8 to 1.4 feet below the surface, likely as a result of the Ap horizon completely removing the B horizon (Photograph 5.29).

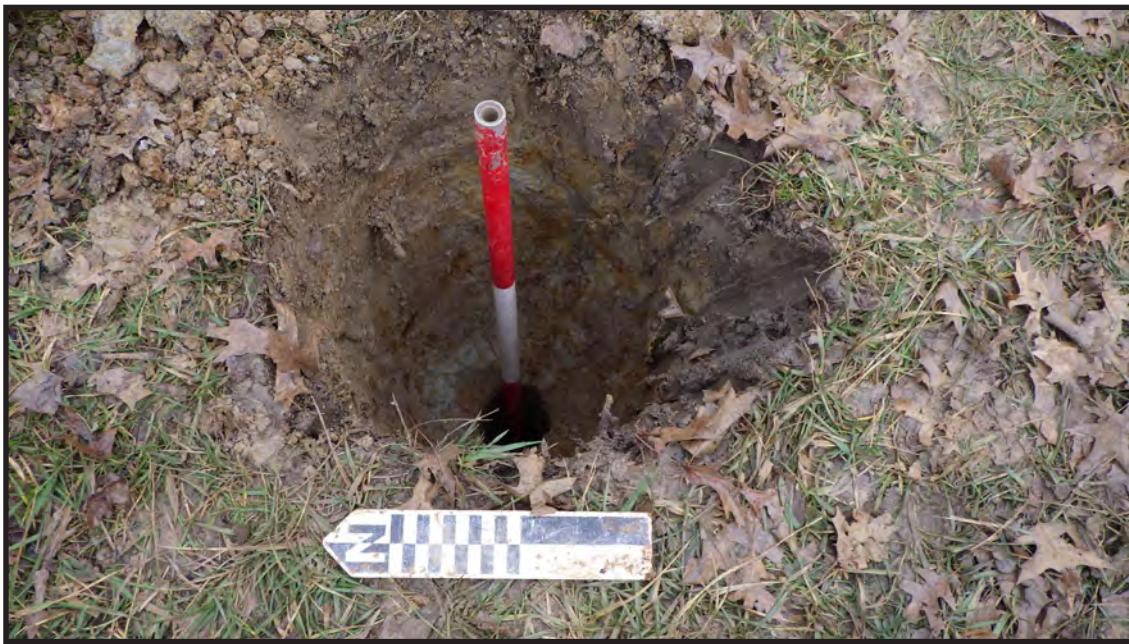
Photograph 5.29. View looking east showing the profile of Shovel Test 91, a profile with the Ap horizon overlaying the mottled B2 horizon (Photographer: Michael Brown, February 2023) [HRI Neg. # 23011/D2:064].

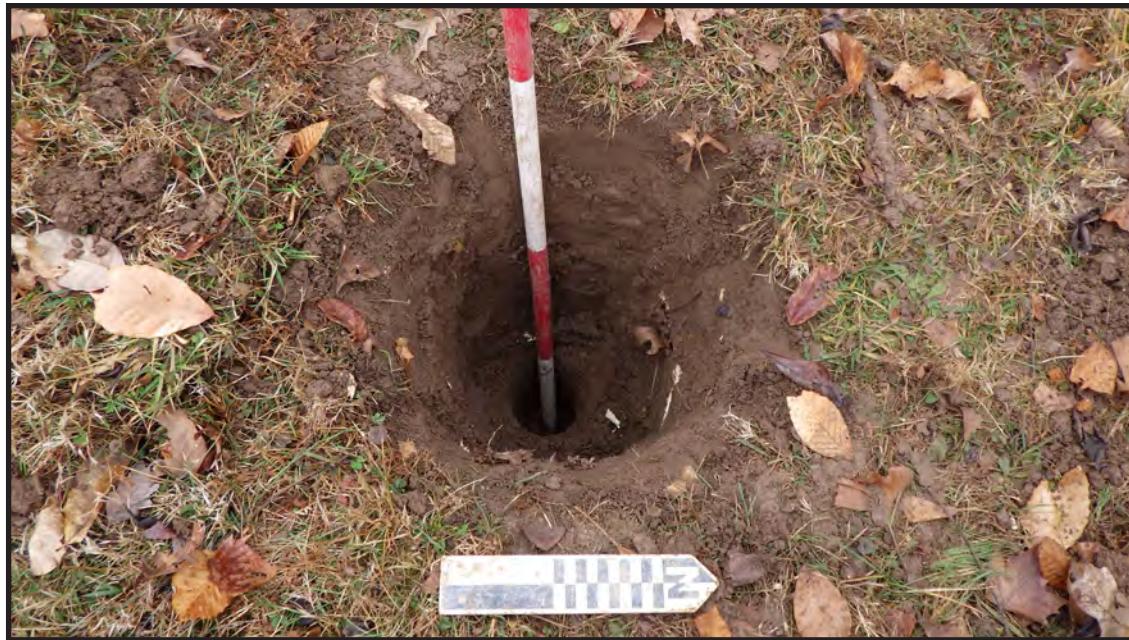
Photograph 5.30. View looking west showing the profile of Shovel Test 58, a profile with a brownish red B horizon (Photographer: Michael Brown, February 2023) [HRI Neg. # 23011/D2:096].

In some shovel tests, a darker B horizon was identified. In these cases, the Ap horizon [2] overlaid a reddish-brown clayey silt or silty loam [3] which is interpreted as a natural, culturally sterile B horizon (Photograph 5.30). The B horizon typically had shale inclusions and was identified at depths ranging between 0.9 and 1.7 feet below the surface. It typically overlaid a compacted reddish brown mottled with grey/pinkish grey silty clay or clayey silt [4], which is interpreted as a natural B2 horizon. The B2 horizon was identified at depths ranging between 1.2 and 3.1 feet below the ground surface. Both series of B/B2 horizons overlaid a reddish brown (at times mottled with a pinkish grey) silty loam with shale gravels [5] which is interpreted as a natural C horizon. The C horizon was observed at depths of between 1.4 and 4.7 feet below the surface.

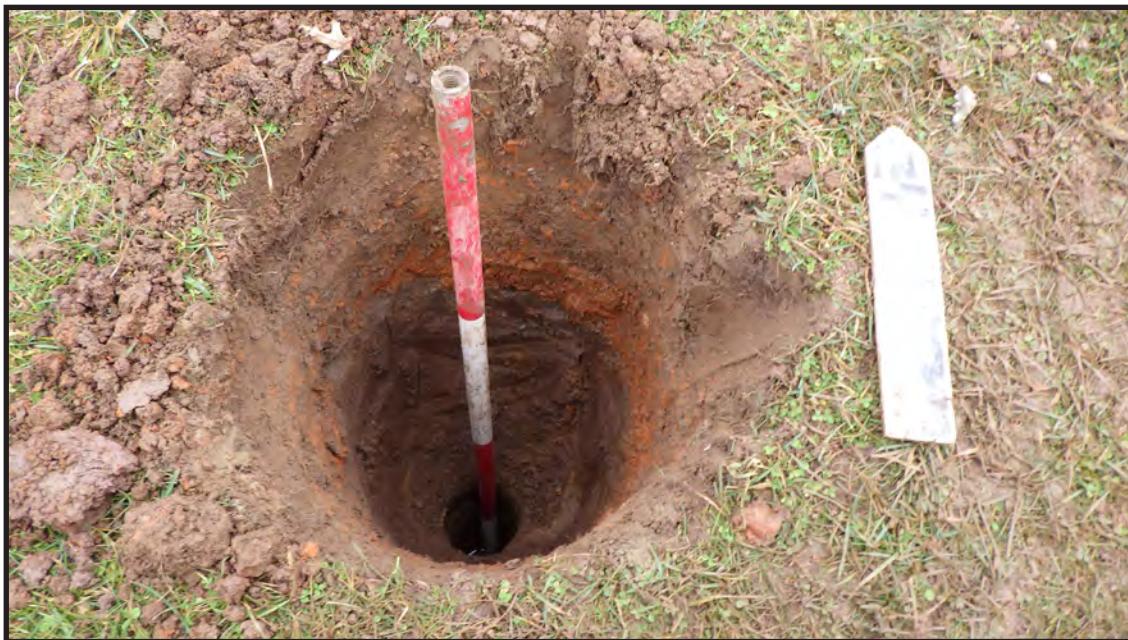
Photograph 5.31. View looking north showing the profile of Shovel Test 64, a profile disturbed by landscaping fill episodes (Photographer: Michael Brown, February 2023) [HRI Neg. # 23011/D2:077].

loam with shale gravel [6], interpreted as a natural C horizon. The test was terminated at 3.9 feet below the surface in a shale bedrock impasse.

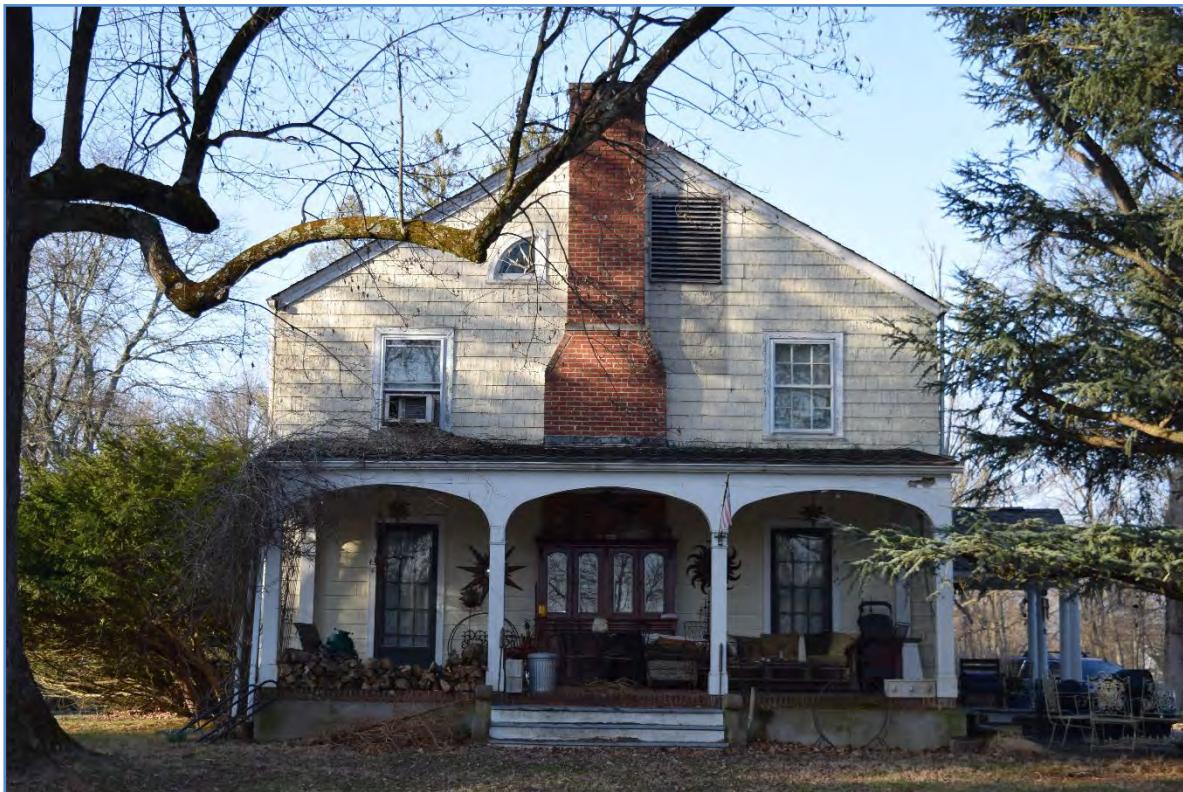
Photograph 2: The side (south) elevation of the dwelling at 2500 Pennington Road, looking north (Rachel Craft, photographer February 2023; HRI Negative #23011_D1:69).

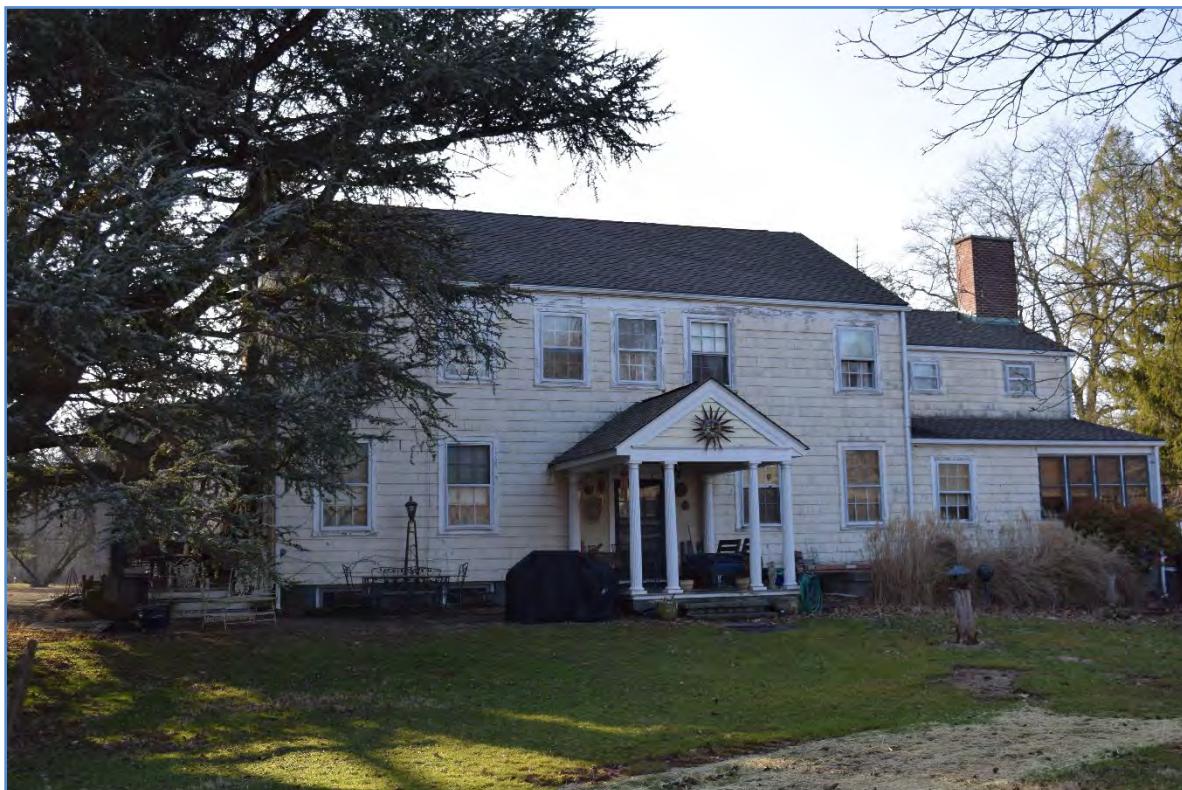
**Photograph 3: The rear (east) elevation of the dwelling at 2500 Pennington Road, looking northwest
(Rachel Craft, photographer February 2023; HRI Negative #23011_D1:68).**

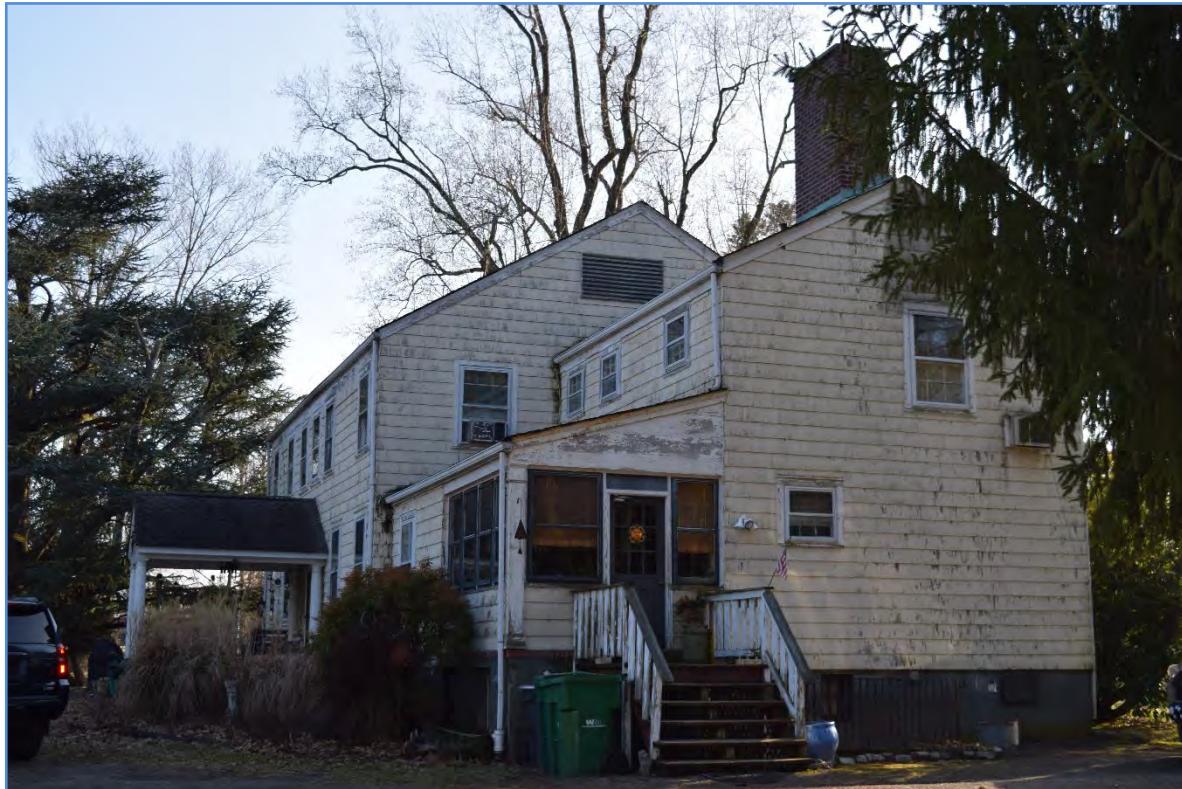
Photograph 4: The side (north) and rear (east) elevations of the dwelling at 2500 Pennington Road, looking southwest (Rachel Craft, photographer February 2023; HRI Negative #23011_D1:67).

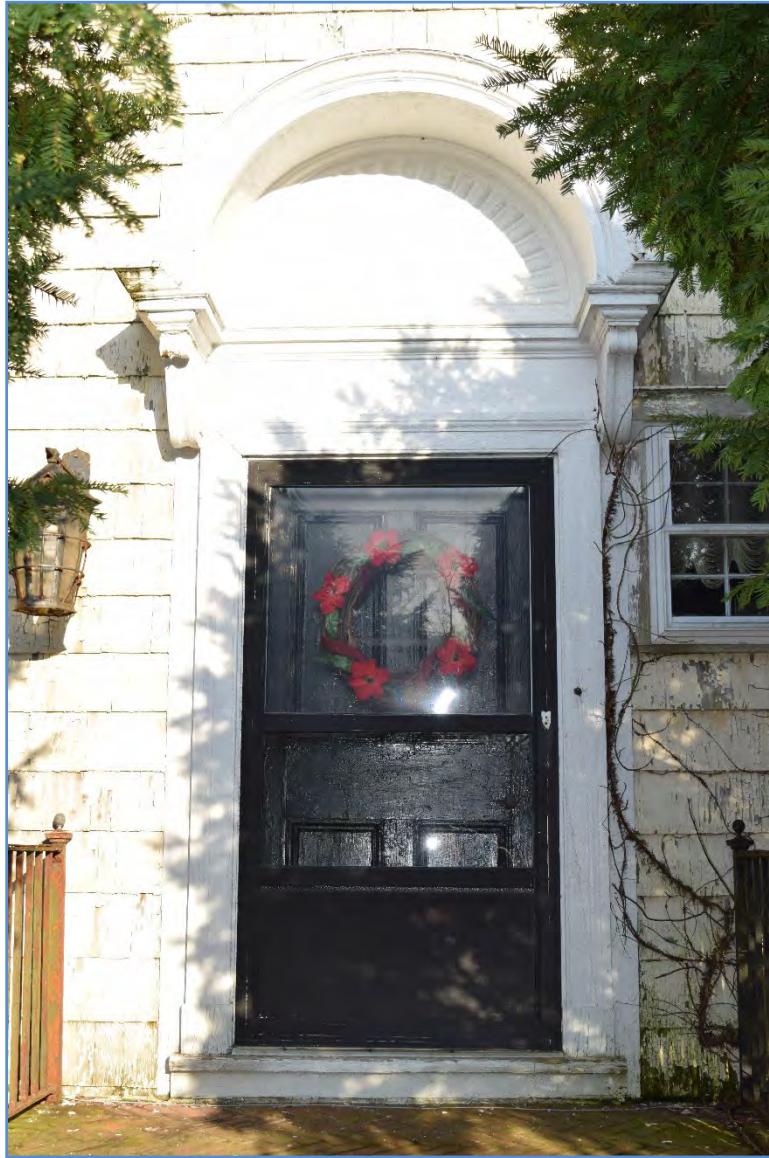
Photograph 5: The main entry and its Colonial Revival-style surround, looking east (Rachel Craft, photographer February 2023; HRI Negative #23011_D1:74).

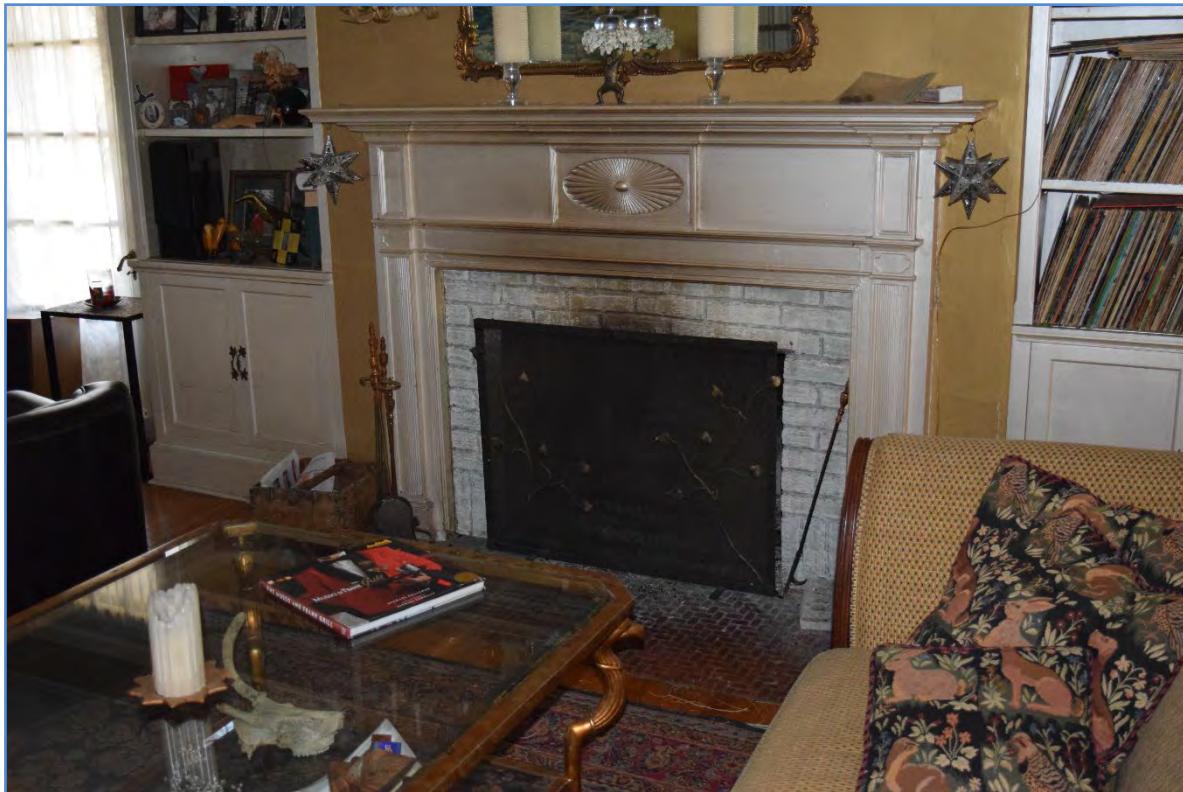
Photograph 10: The fireplace in the living room, looking southeast (Rachel Craft, photographer February 2023; HRI Negative #23011_D1:56).

The southern living room located off of the main hallway spans the depth of the dwelling (Photographs 8-9). It features the dwelling's fireplace at the center of its southern wall, which is accentuated by a molded mantel and surround (Photograph 10). An oval fan design is centered on the frieze of the surround. Radiators are set in front of the windows.

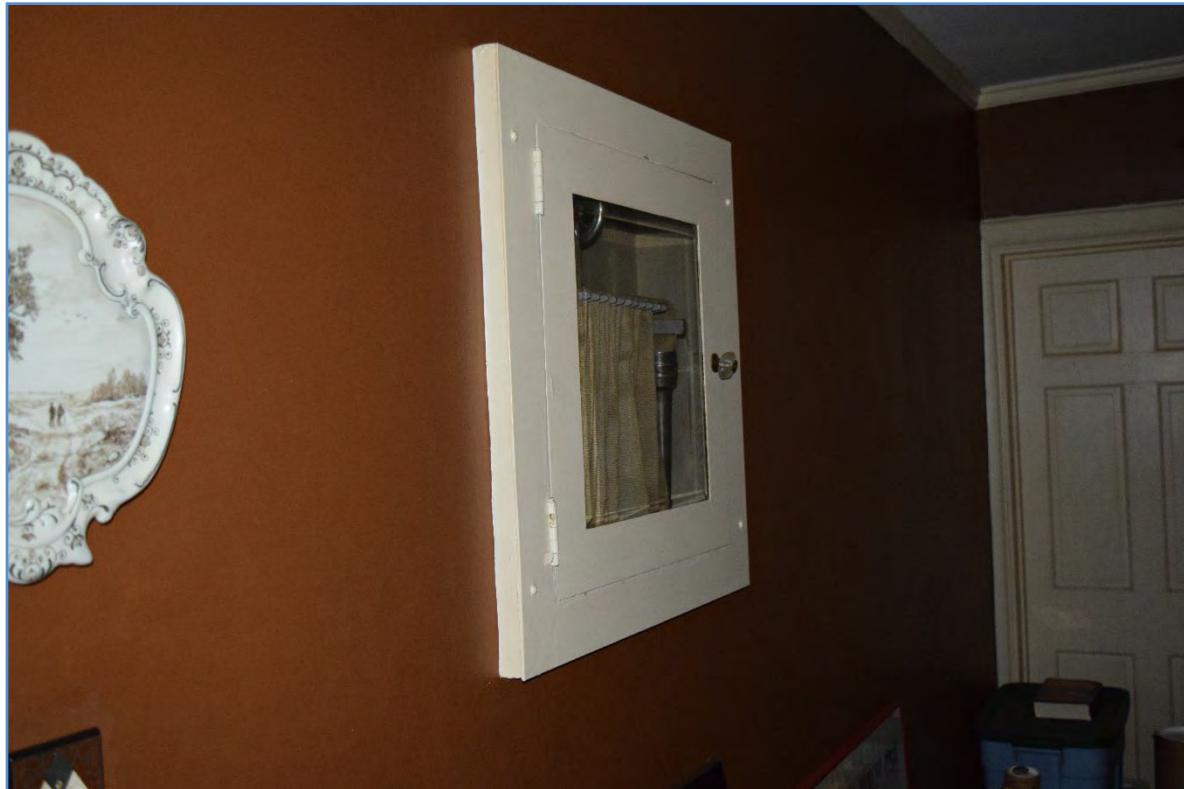
Photograph 14: The fire extinguishing system in the hallway dividing the dining and sitting rooms, looking southeast (Rachel Craft, photographer February 2023; HRI Negative #23011_D1:64).

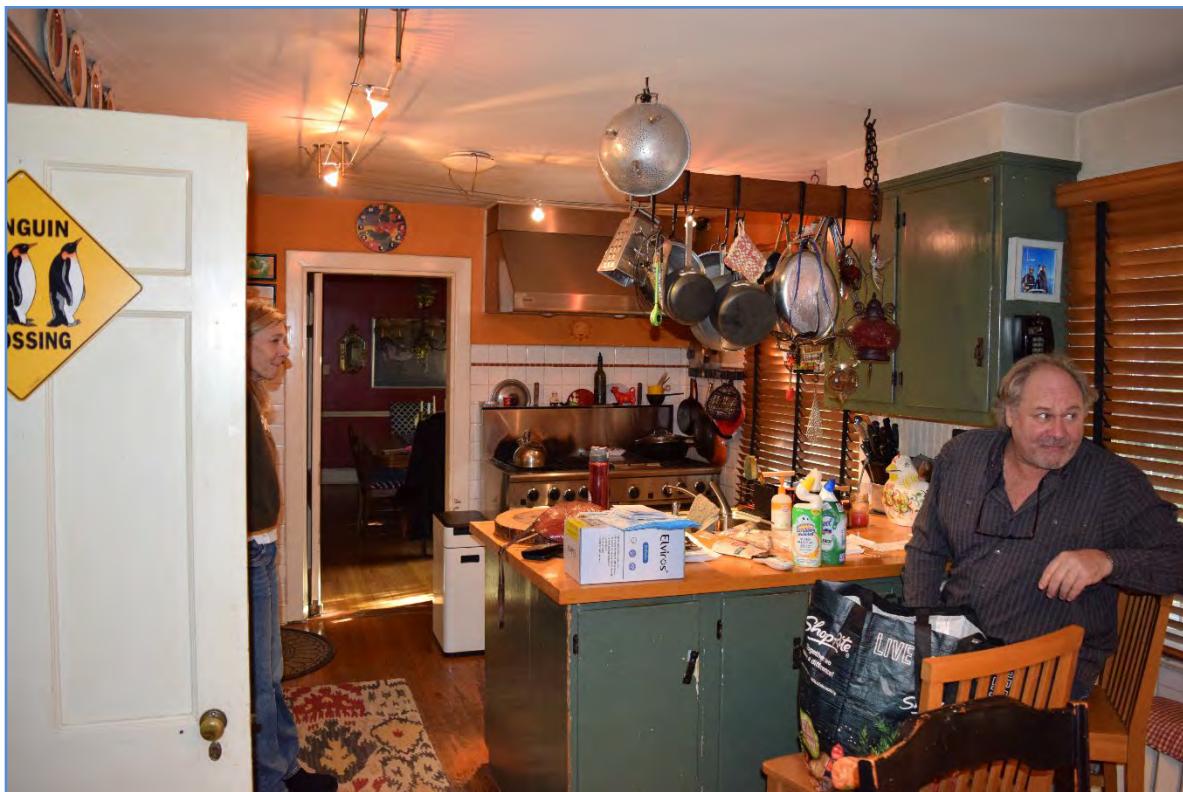
Photograph 15: The kitchen, looking southwest with the dining room visible through the far doorway
(Rachel Craft, photographer February 2023; HRI Negative #23011_D1:65).

The kitchen occupies the front-facing three bays of the first story (Photograph 15). It has been updated with modern appliances and finishes, including square ceramic tiles and wainscoting. Paneled doors separate the kitchen from the dining room, the hallway containing the secondary staircase, and an additional room that serves as storage.

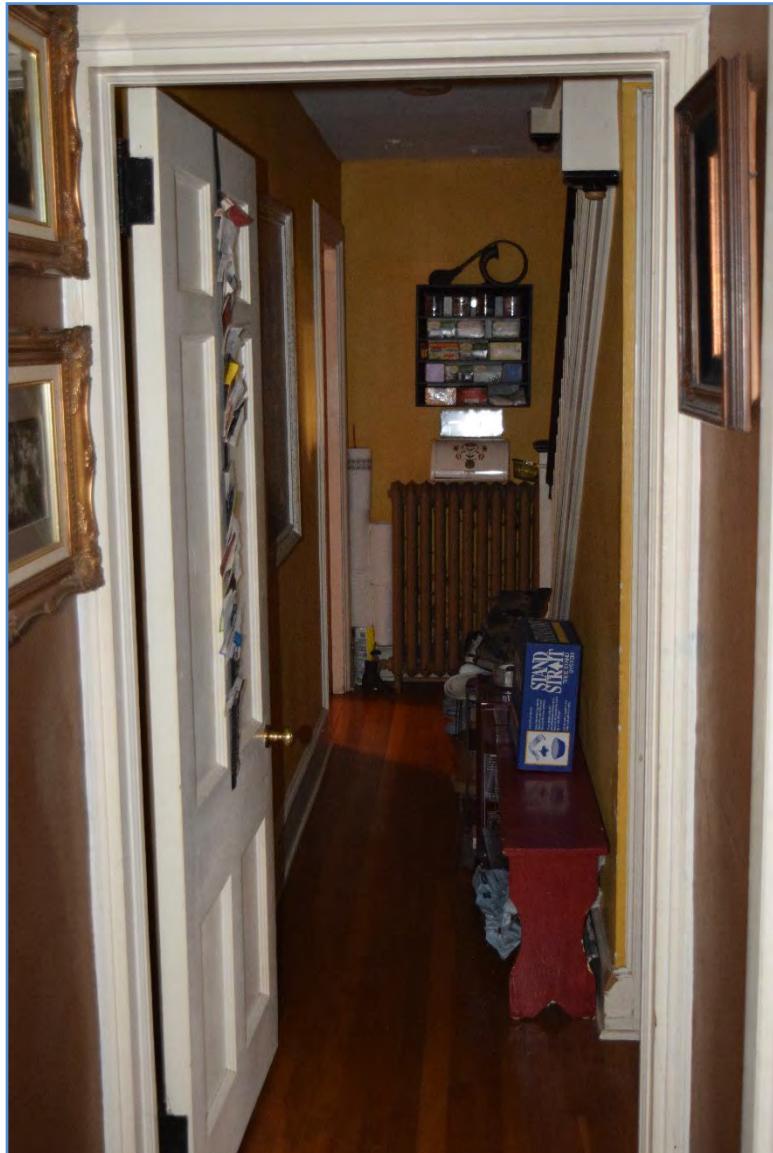
Photograph 16: The hallway housing the secondary staircase (Rachel Craft, photographer February 2023; HRI Negative #23011_D1:63).

The hallway containing the secondary staircase is accessed from the kitchen through a six-paneled wood door with brass hardware (Photograph 16). While it has some molded details, the secondary staircase is much plainer in design and ornamentation than that of the main staircase. The hallway has the same base boards as the rest of the first floor, but it does not have crown molding.

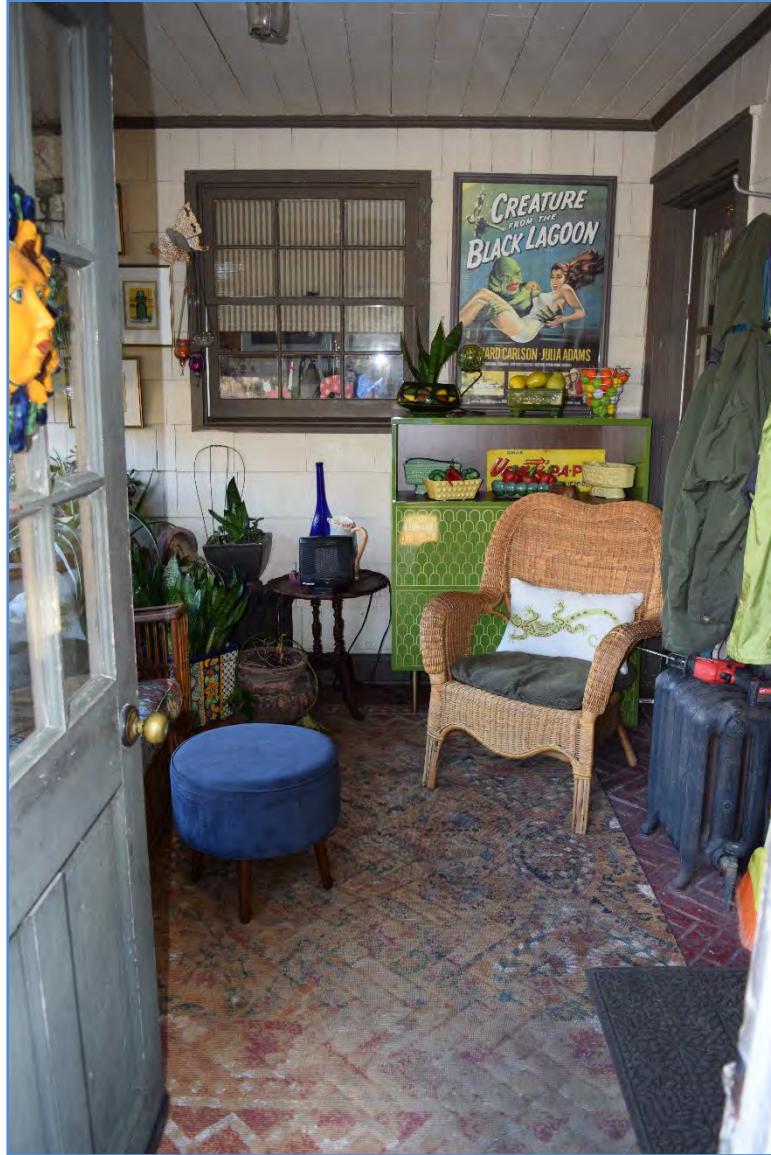
Photograph 18: The enclosed porch in the addition, looking south (Rachel Craft, photographer February 2023; HRI Negative #23011_D1:66).

An enclosed porch is also located in the one-story addition to the rear (Photograph 18). The dwelling's exterior wood shingles are visible in the porch's interior, along with a once-exterior window. The paneled ceiling is separated from the shingles by thin, plain crown molding. The porch's deck is comprised of herringbone-patterned brick.

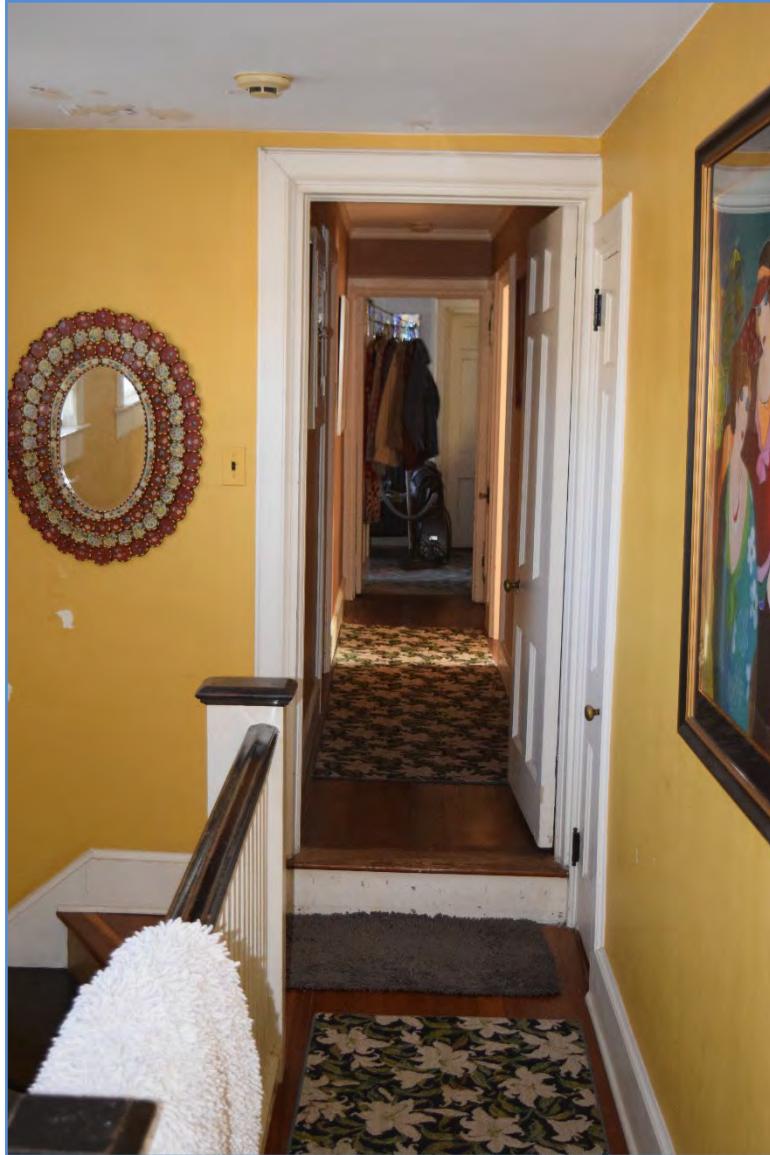
Photograph 22: The hallway connecting the main block and side wing, looking south. Note the step at the junction of the main block and side wing (Rachel Craft, photographer February 2023; HRI Negative #23011_D1:51).

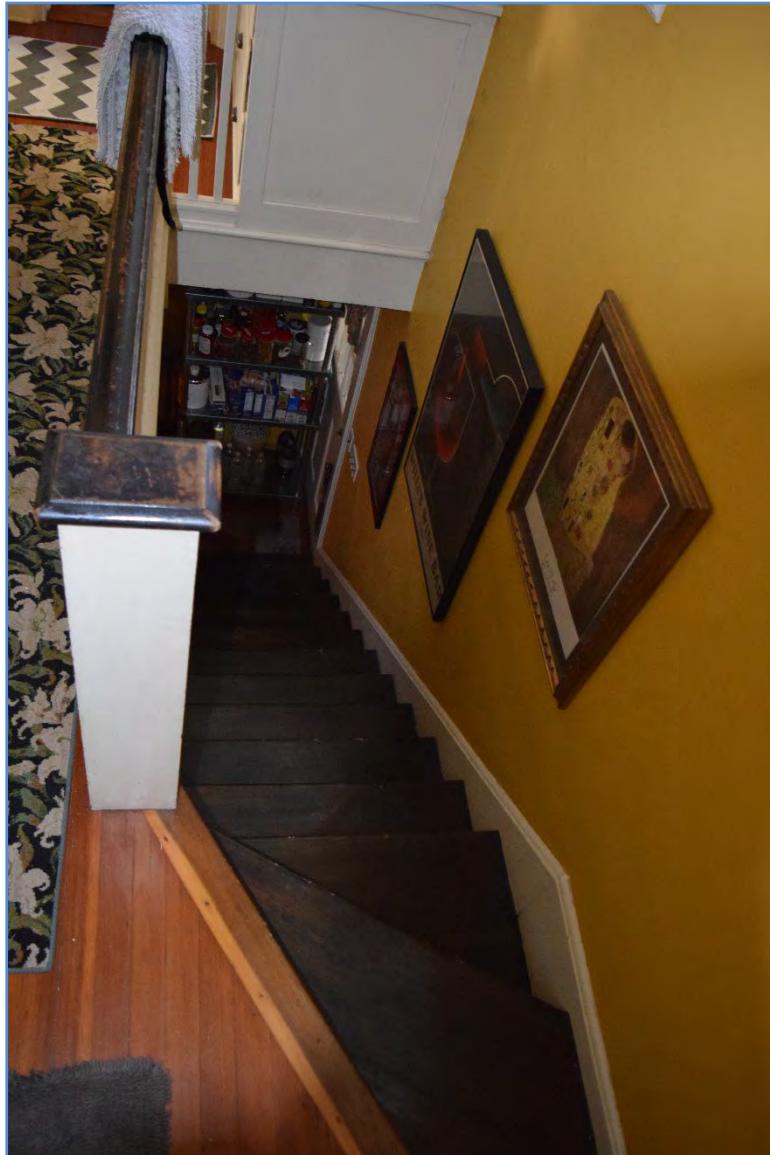
Photograph 24: The secondary staircase, looking north (Rachel Craft, photographer February 2023; HRI Negative #23011_D1:

The second floor of the side wing contains three rooms: the hallway containing the secondary staircase, a full bathroom and a bedroom (Figure 2) (see Photograph 23). The secondary staircase winds slightly from the hallway to meet the rear wall (Photograph 24). The bathroom has been refinished including an aluminum-frame shower, wainscoting and large, ceramic floor tiles. The bathroom is situated under the chimney on the roof ridge.

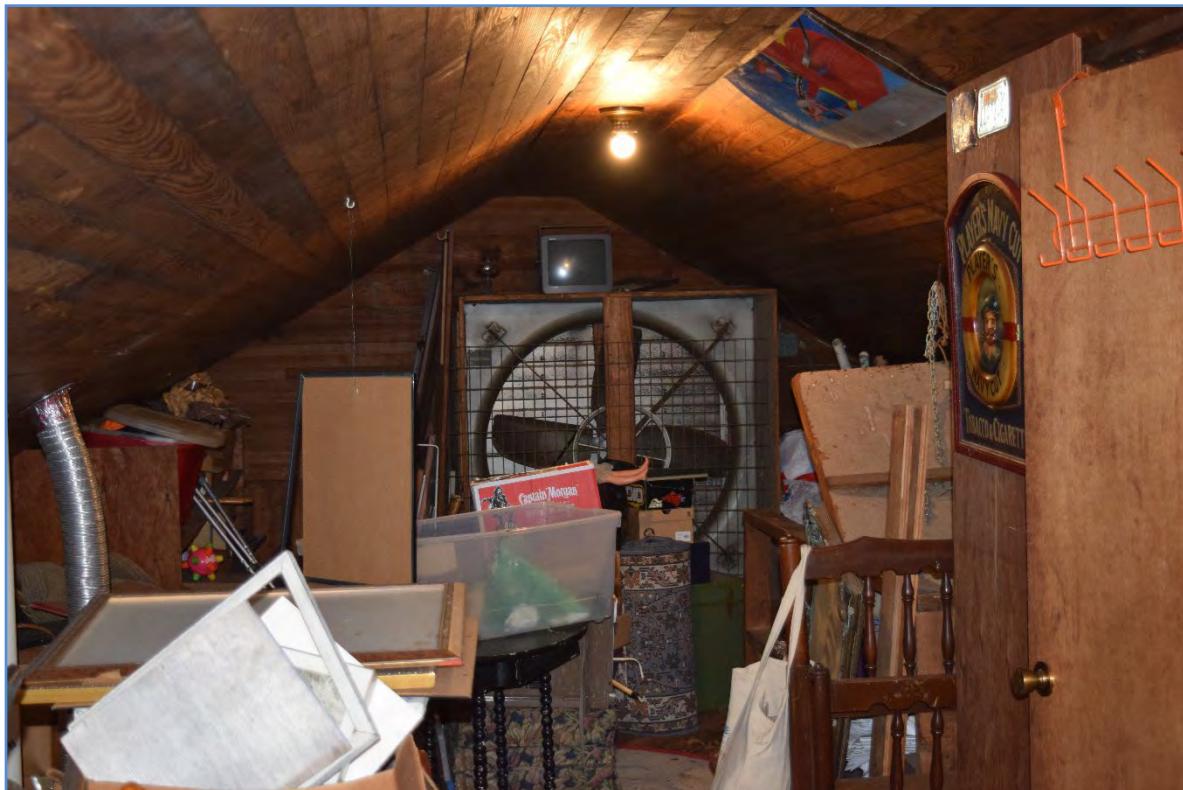
Photograph 25: The attic, looking north and showing the closet at the right (Rachel Craft, photographer February 2023; HRI Negative #23011_D1:46).

Attic. The attic, which is accessible by a staircase in the second-floor hallway, is found in the main block only (Figure 3). The space is entirely paneled and open, except for a cedar closet against the staircase opening along the rear (east) wall (Photographs 25-26). The brick chimney on the side (south) elevation is visible in the attic. One surviving wood fanlight flanks the chimney.

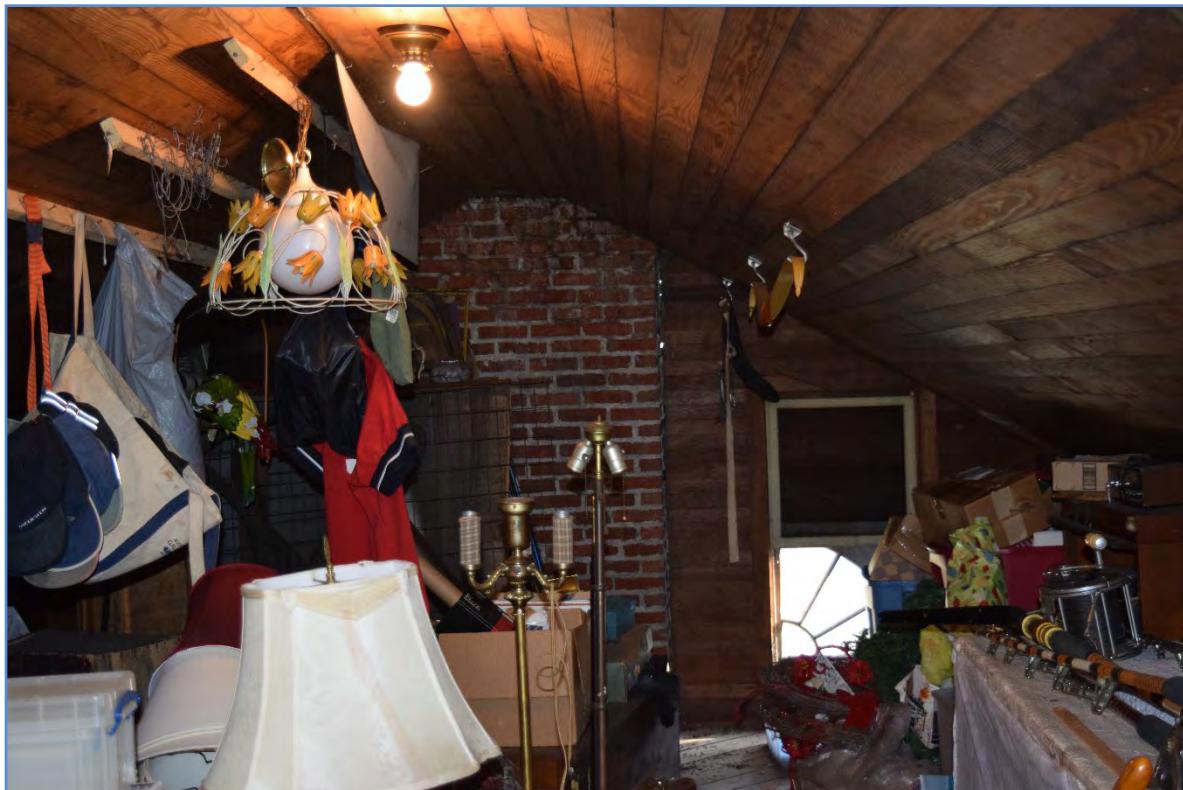
Photograph 26: The attic, looking south and showing the chimney and fanlight (Rachel Craft, photographer February 2023; HRI Negative #23011_D1:47).
