**INTENSIVE-LEVEL ARCHITECTURAL SURVEY
AND PHASE IB ARCHAEOLOGICAL SURVEY
2500 PENNINGTON ROAD
BLOCK 78, LOT 17
HOPEWELL TOWNSHIP
MERCER COUNTY, NEW JERSEY**

**DLUR #1106-08-0012.1
HPO PROJECT #18-0614-1**

APRIL 2023

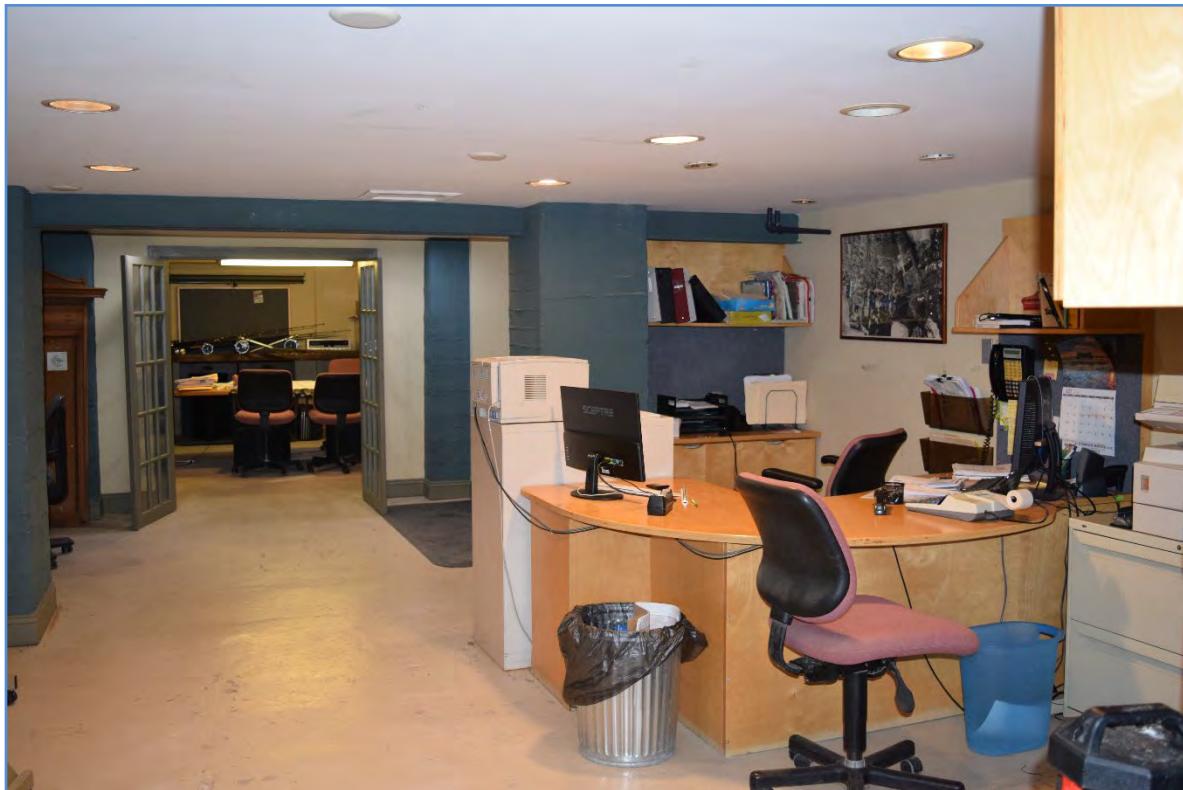
Photograph 27: The office space in the basement, looking southwest (Rachel Craft, photographer February 2023; HRI Negative #23011_D1:42).

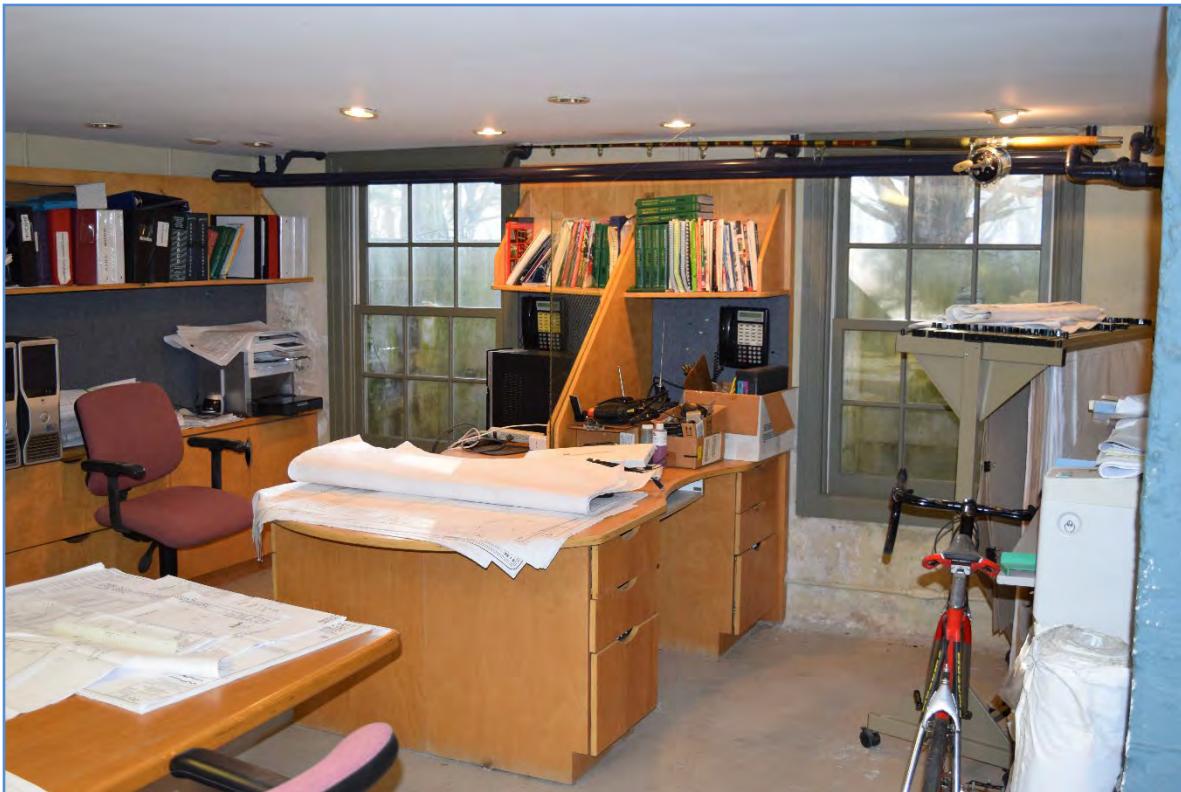
Photograph 28: The office space in the basement, looking southwest (Rachel Craft, photographer February 2023; HRI Negative #23011_D1:45).

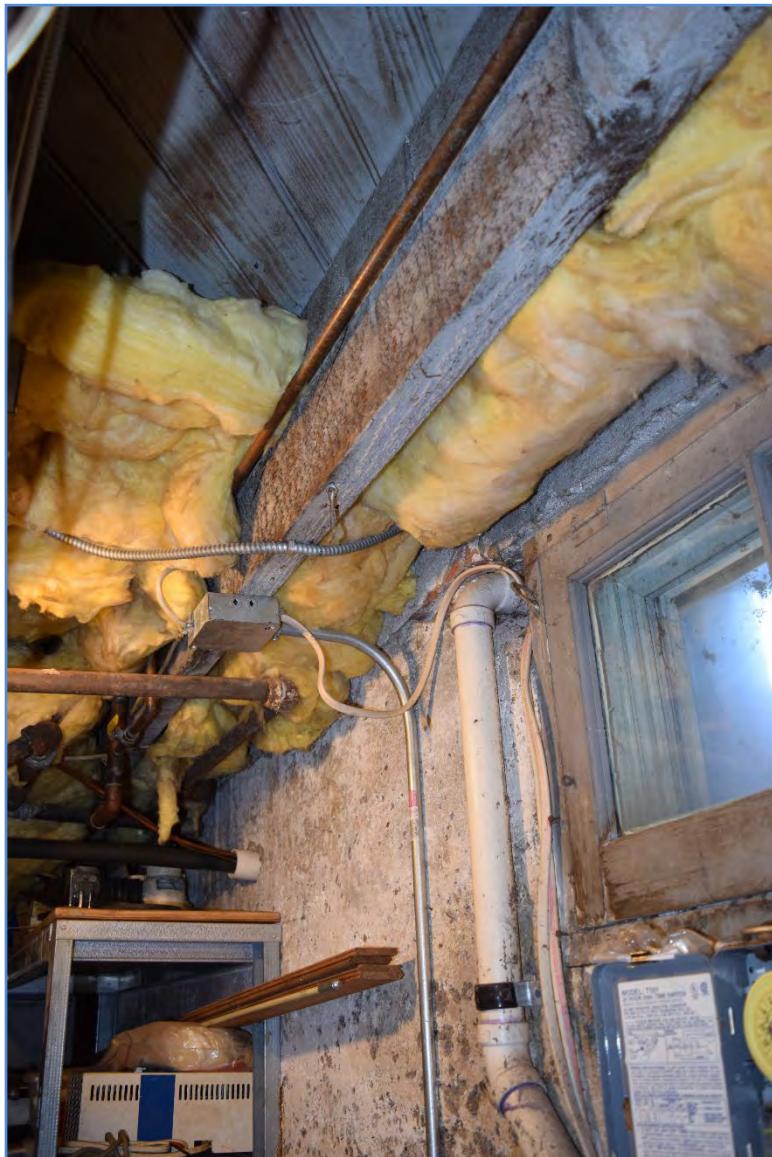
Photograph 29: The floor boards, joists and foundation visible in a storage closet in the basement, looking northeast (Rachel Craft, photographer February 2023; HRI Negative #23011_D1:41).

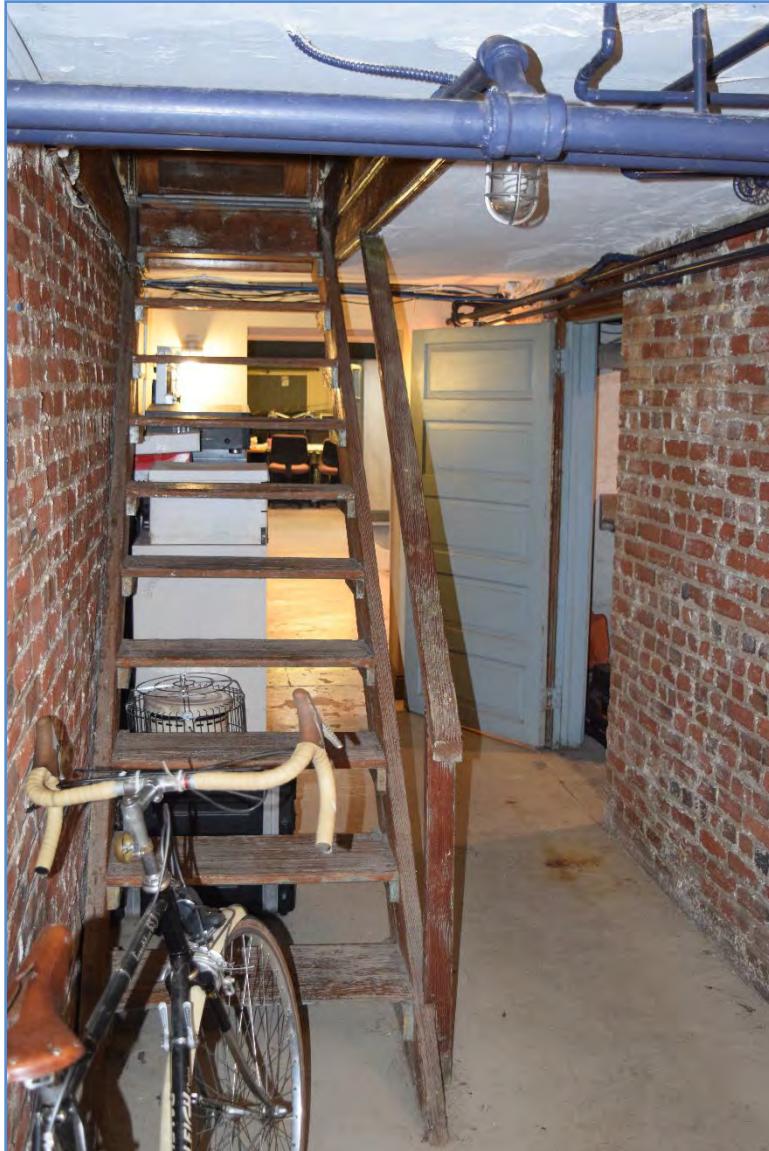
Photograph 31: The hallway formed by interior brick walls in the basement, looking south (Rachel Craft, photographer February 2023; HRI Negative #23011_D1:37).

Some areas in the basement under the side wing have been equally refinished (Figure 4) (Photograph 30). Others retain older materiality, including the brick interior walls that create a central hallway under the side wing (Photograph 31). Doors that appear to be original to the dwelling are found in this section of the basement, and are wood with five horizontal panels (Photograph 32). Steel I-beams also support the side wing (Photograph 33). A coal chute, which is accessed from the exterior via a small door on the side (north) of the foundation, leads to a furnace that appears to be original, though no longer functional (Photograph 34).

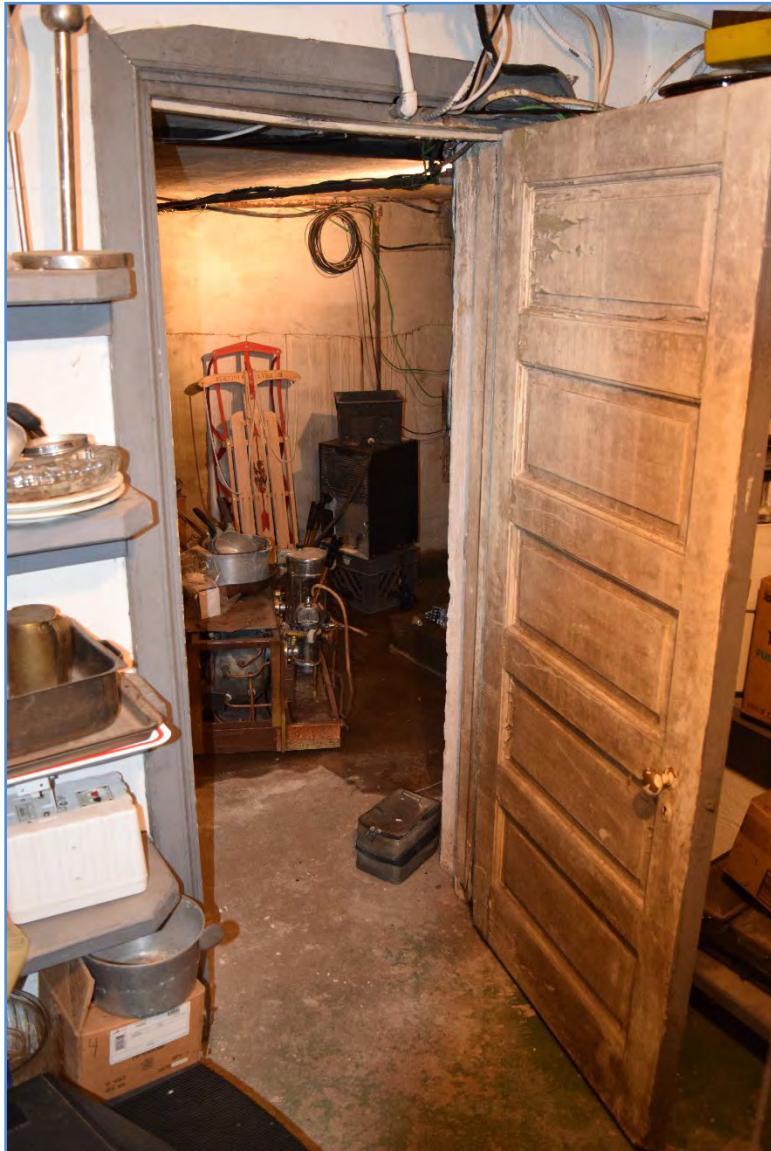
Photograph 32: The storage room housing the dwelling's well access in the basement, looking southeast (Rachel Craft, photographer February 2023; HRI Negative #23011_D1:38).

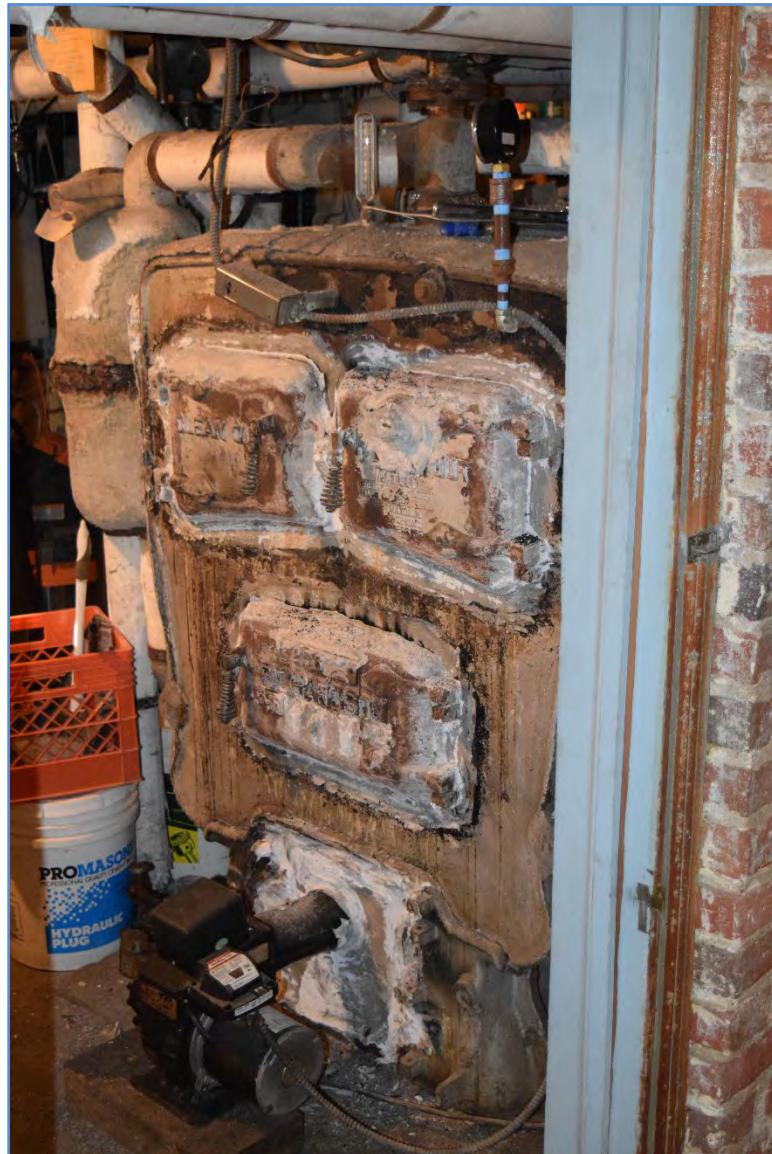
Photograph 34: The coal furnace in the basement, looking northwest (Rachel Craft, photographer February 2023; HRI Negative #23011_D1:34).

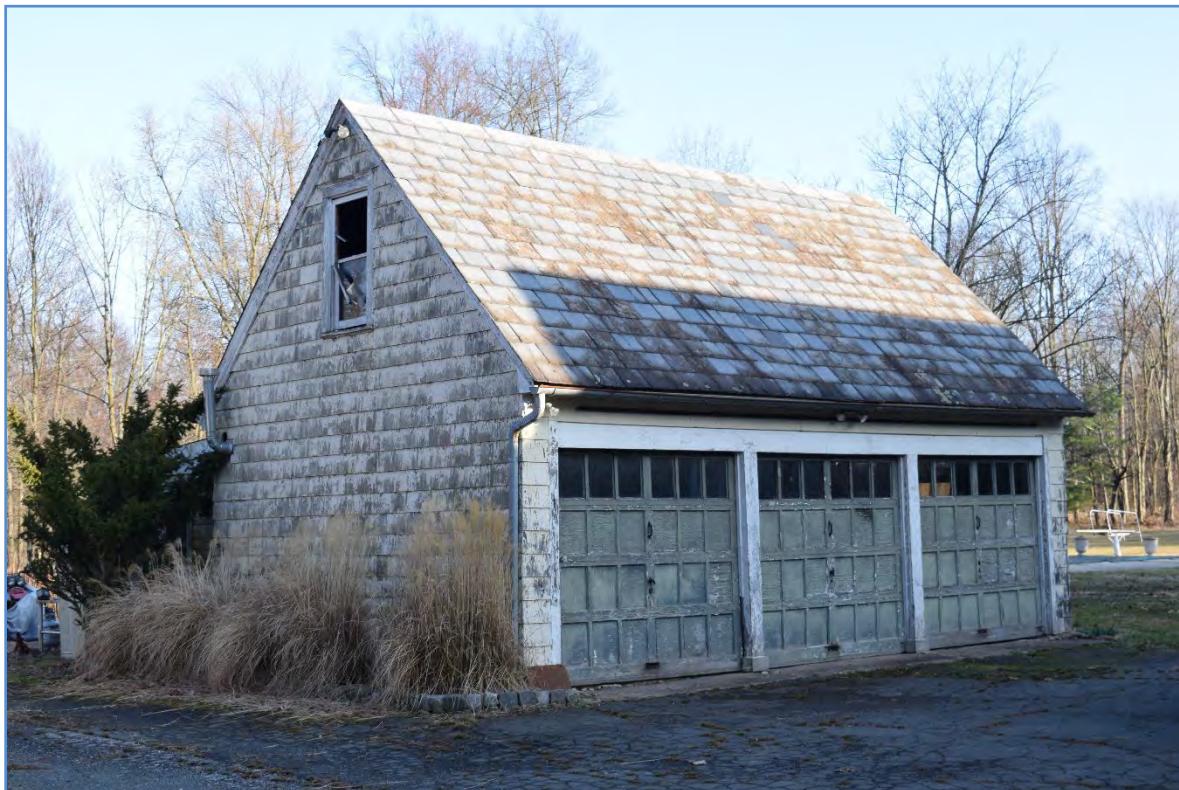
Photograph 35: The front (west) and side (north) elevations of the one-story, three-bay garage, looking southeast (Rachel Craft, photographer February 2023; HRI Negative #23011_D1:76).

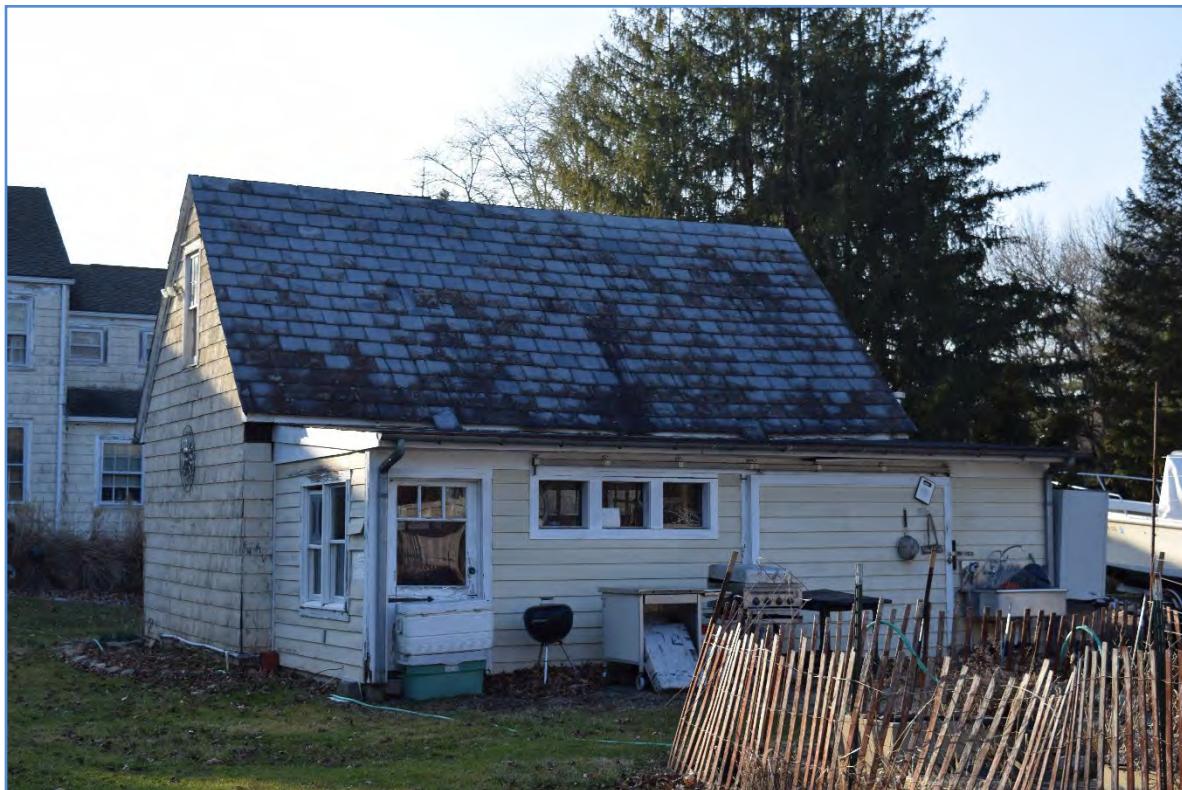
Photograph 36: The rear (east) and side (south) elevations of the one-story, three-bay garage, looking northwest (Rachel Craft, photographer February 2023; HRI Negative #23011_D1:81).

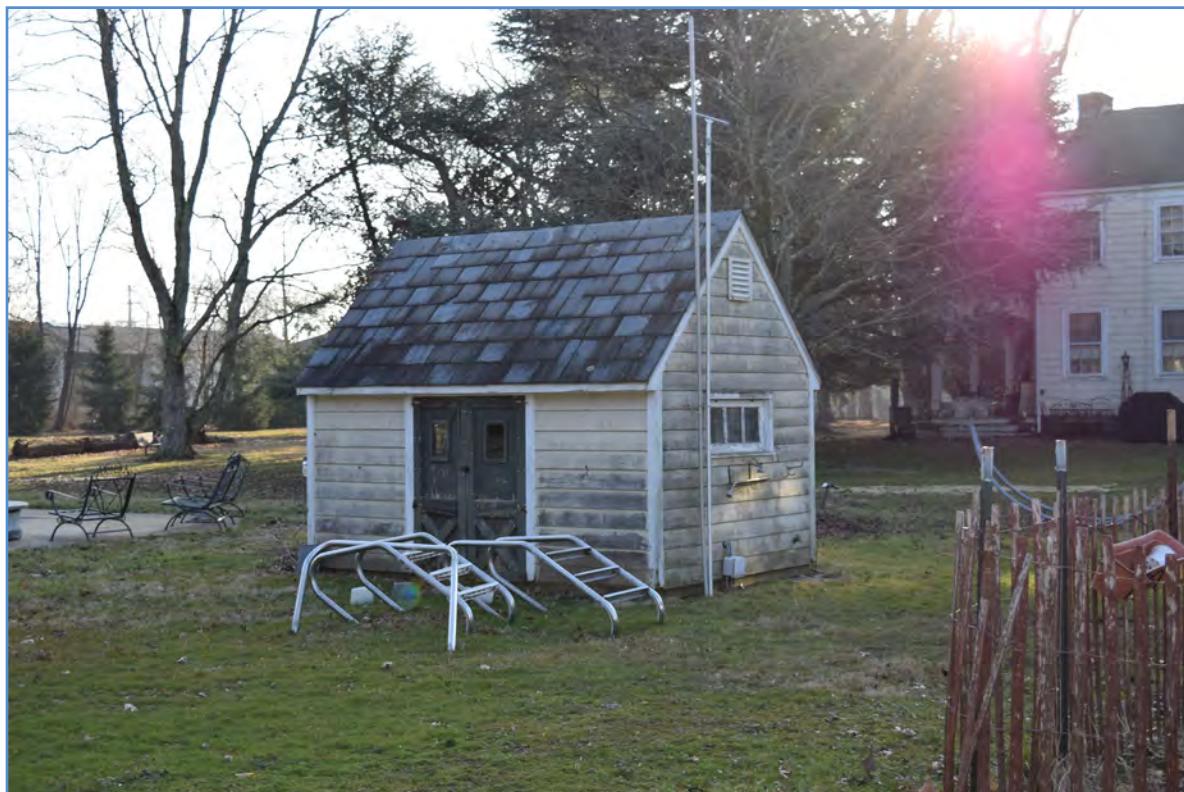
Photograph 37: The front (east) and side (north) elevations of the shed, looking southwest (Rachel Craft, photographer February 2023; HRI Negative #23011_D1:79).

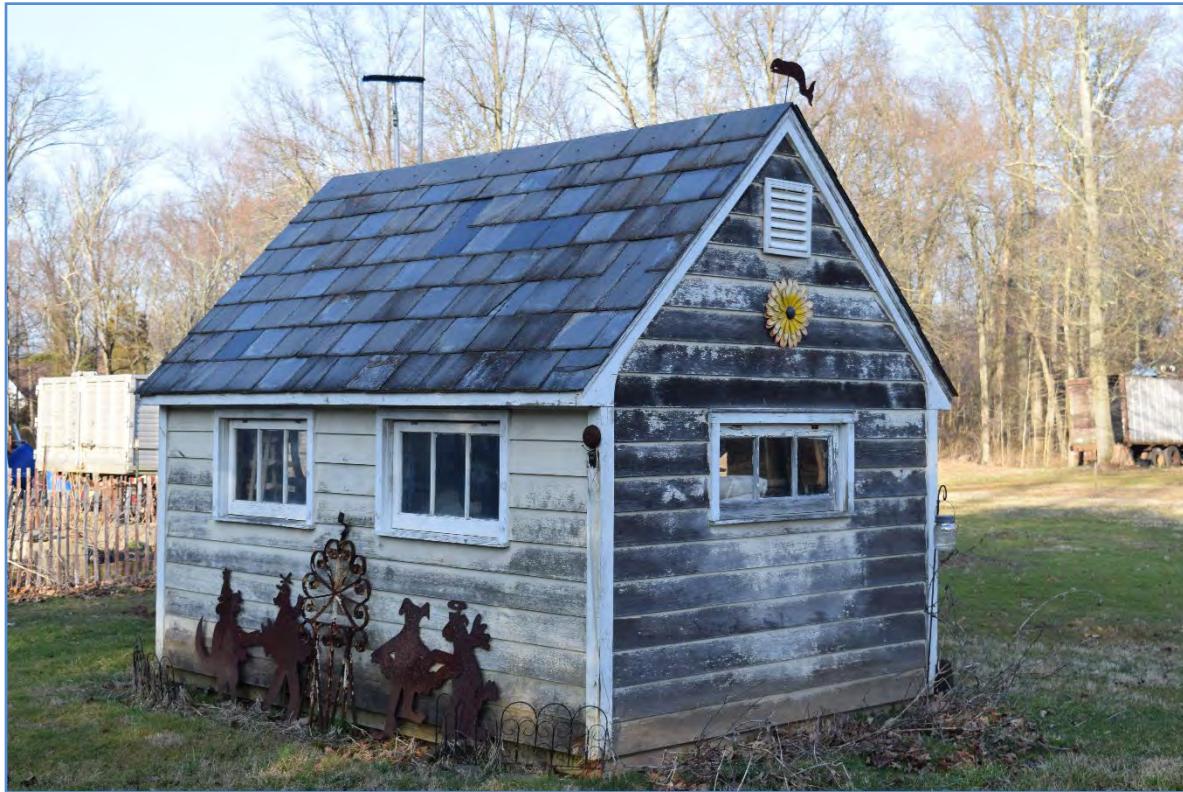
Photograph 38: The rear (west) and side (south) elevations of the shed, looking northeast (Rachel Craft, photographer February 2023; HRI Negative #23011_D1:78).

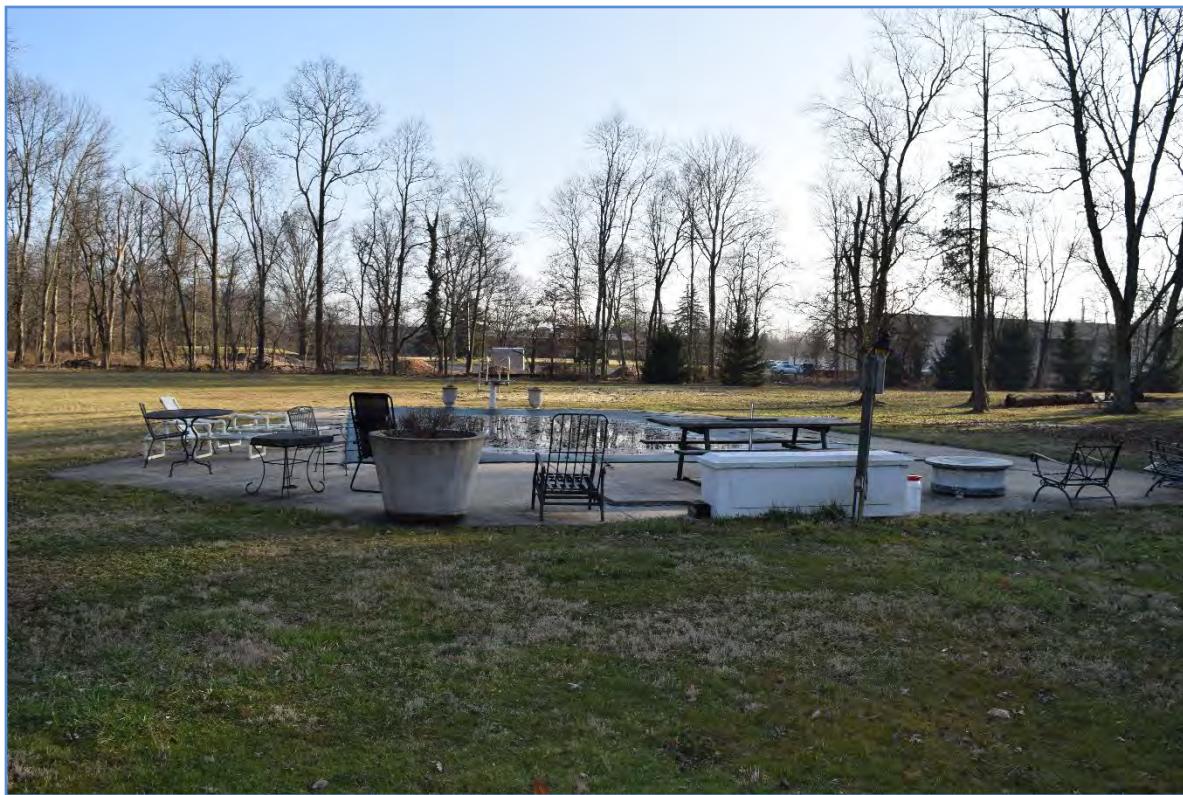
Photograph 39: The in-ground swimming pool, looking south (Rachel Craft, photographer February 2023; HRI Negative #23011_D1:80).

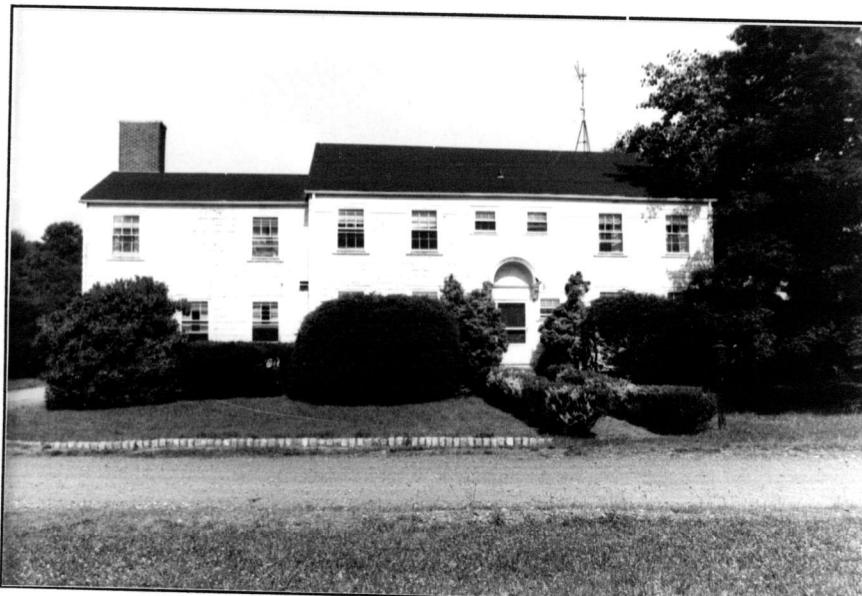
John Ogden Winner III
House
Block 78 Lot 17
West Facade.

The property comprising the John Ogden Winner III House consists of over eleven acres, and extends 240.52 feet along New Jersey State Route 31 (Pennington Road). The property includes a house and garage. The house is a two-and-one-half-story, five-bay, frame Colonial Revival-style dwelling, constructed circa 1927. It has a two-and-one-half-story, three-bay addition on the north (side) facade. The exterior siding is painted wood shingles, and the foundation is concrete. The side-gabled roof is covered with asphalt shingles, and has a molded cornice and plain frieze. The north (side) addition has a massive interior brick chimney located on the roof ridge, and an exterior brick chimney is located on the south facade of the main section. Window openings are rectangular, with six-over-six double-hung wood sash. An arched door hood, with scrolled brackets, marks the primary central entrance on the west (front) facade. The south (side) facade contains a porch, with porch posts supporting an arcaded entablature and shed roof.

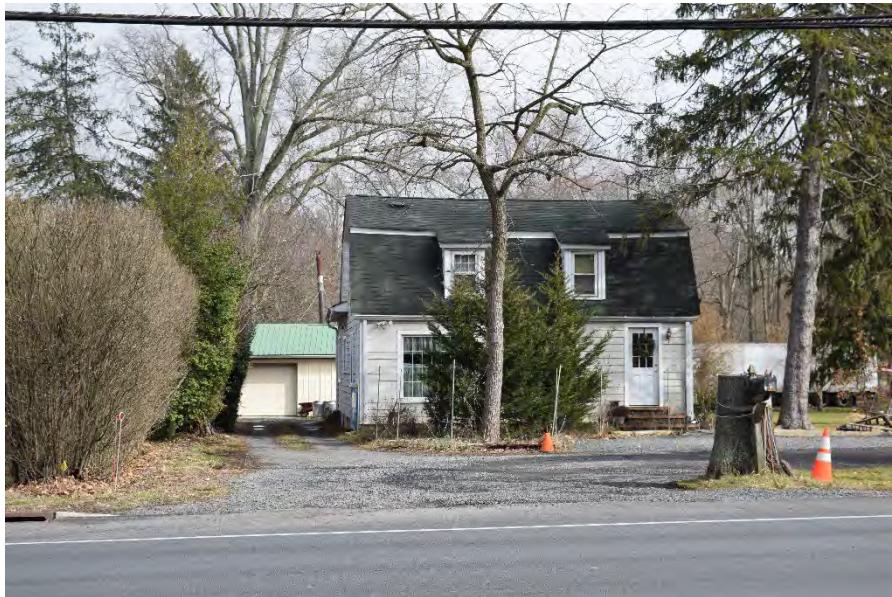
2514 Pennington Road (Block 78, Lot 5) (Photograph 5.13) is a modest, one-and-one-half-story, two-bay, side-gambrel, side-hall, Dutch Colonial Revival-style dwelling that was constructed *circa* 1950 based on aerial photographs and architectural style. Its roof is covered with asphalt shingles and its exterior is clad with non-original vinyl siding. The dwelling's side-gambrel roof is punctured by two shed-roof dormers on its front (west) elevation. Windows are mostly comprised of vinyl replacements, and a replacement door fills the right-bay entry. The dwelling rests on a concrete foundation. A one-story, shed-roof addition to the dwelling's rear (east) elevation was completed

Photograph 1: 2514 Pennington Road, view looking east
(Rachel Craft, photographer, February 23, 2023; HRI Negative # 23011_D1_27).

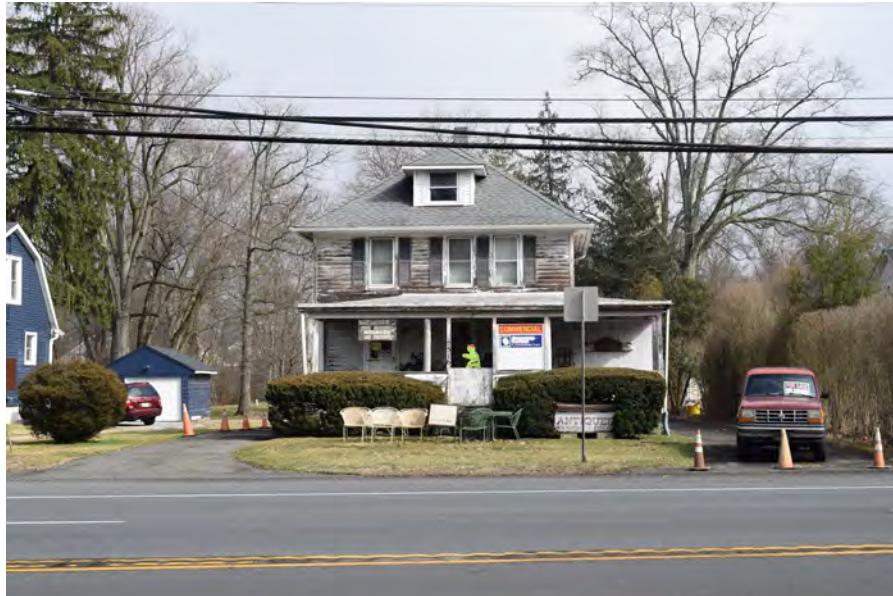
2516 Pennington Road (Block 78, Lot 3) (Photograph 5.14) is a two-and-one-half-story, three-bay, pyramidal-roof, Four Square-form dwelling that was constructed *circa* 1920 based on its architectural form. Its roof is covered with replacement asphalt shingles and its exterior is clad with wood clapboard siding. A hipped dormer sided with vinyl and containing a 1/1 vinyl sash punctures the front (west) roof elevation. A parged brick chimney is located on the rear (east) roof slope. Other windows are 1/1 wood sashes. The dwelling's front elevation features a wraparound, open, wood porch that has been partially enclosed on its southern side. The main entry in the left bay is concealed by a modern storm door. The dwelling rests on a parged foundation. Two outbuildings are located on the property to the rear of the dwelling. Outbuilding #1 is a one-story, two-bay, front-gabled building that appears to have been constructed contemporaneously with the dwelling. Outbuilding #2 is a one-story, one-bay, prefabricated metal building with an arched roof that was added to the property *circa* 1990. See Appendix B for an Intensive-Level Architectural Survey Form and Eligibility Worksheet for 2516 Pennington Road.

Photograph 1: 2516 Pennington Road, view looking east
(Rachel Craft, photographer, February 23, 2023; HRI Negative # 23011_D1_22).

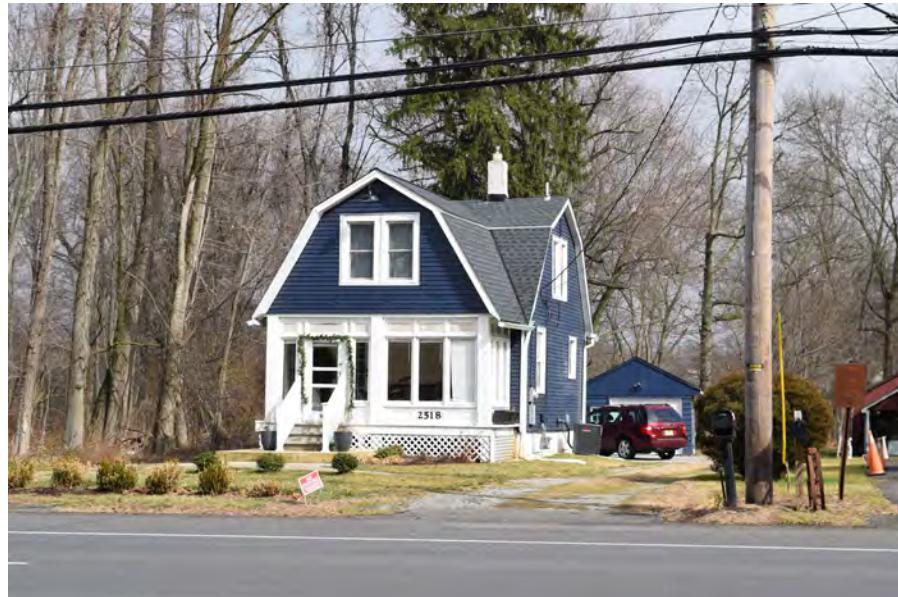
2518 Pennington Road (Block 78, Lot 4) (Photograph 5.15) is a modest, one-and-one-half-story, two-bay, cross-gambrel dwelling with Dutch Colonial Revival-style influences that was constructed *circa* 1920 based on architectural style. Its roof is covered with asphalt shingles and its exterior is clad with non-original vinyl siding. A parged chimney is located on the roof ridge of its south-facing cross-gable. Windows are paired at the half-story level and are filled by double-hung, 1/1, replacement vinyl sashes. The front elevation features a full-width porch enclosed with fixed panes set in wood frames and surmounted by wood panels. The windows and doors are separated into segments of

three by plain, square columns. A glazed door with a wood frame is set in the left-bay entry. The dwelling rests on a parged foundation. A one-story, two-bay, front-gabled garage is located off of the southeast corner of the dwelling and appears to have been constructed contemporaneously with the dwelling. See Appendix B for an Intensive-Level Architectural Survey Form and Eligibility Worksheet for 2518 Pennington Road.

Photograph 1: 2518 Pennington Road, view looking northeast
(Rachel Craft, photographer, February 23, 2023; HRI Negative # 23011_D1_17).

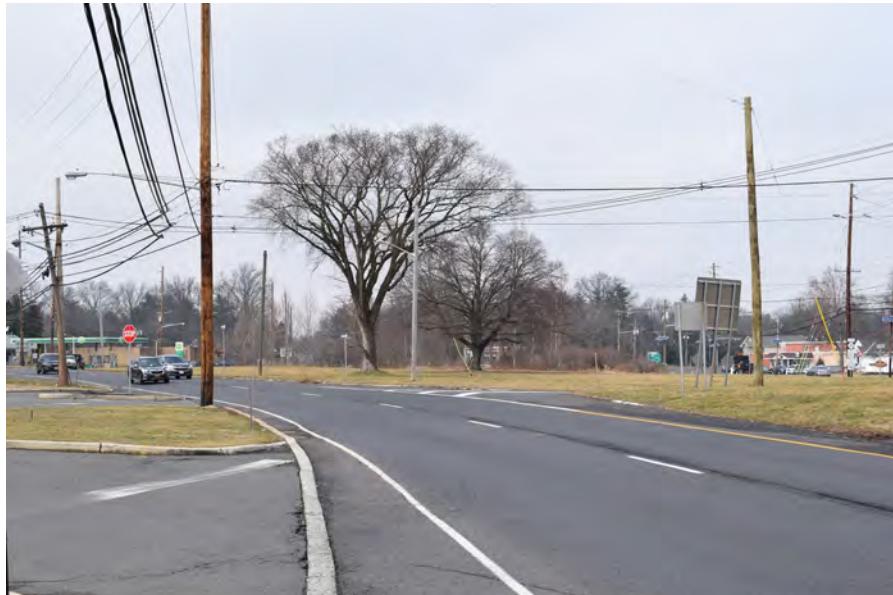
Photograph 1: New Jersey Route 31 Circle (Pennington Circle), view looking north (Rachel Craft, photographer, February 23, 2023; HRI Negative # 23011_D1_08).

Description: This is an updated form for the New Jersey Route 31 Circle (Pennington Circle) received a New Jersey Historic Preservation Office Opinion of Eligibility in September 2010. The opinion concluded that the circle was eligible for National Register listing under Criteria A and C as “a good representative example of some of the many innovative traffic control concepts and forms designed by Harold W. Giffin, to whom many twentieth century advances in traffic engineering are attributed” (McCormick Taylor 2010).

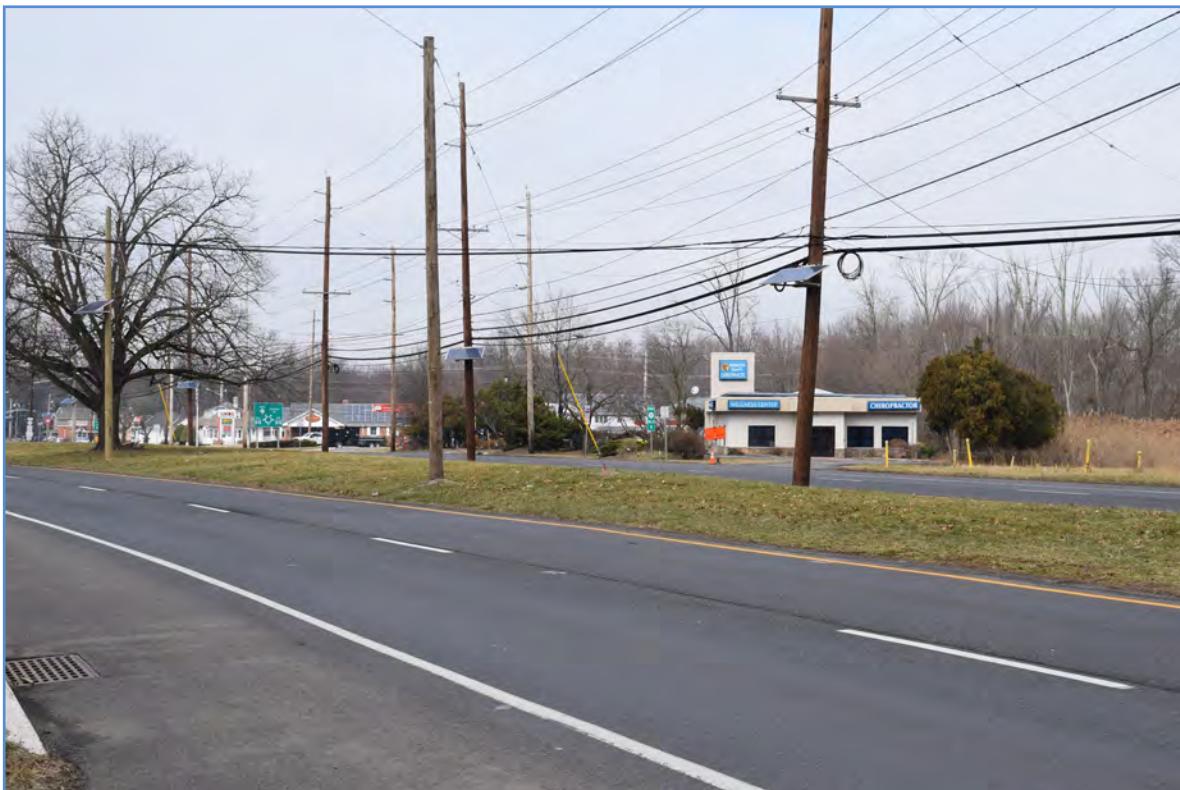
Photograph 2: New Jersey Route 31 Circle (Pennington Circle), view looking northeast and showing modern development fronting the northbound lanes (Rachel Craft, photographer February 2023; HRI Negative #23011_D1:04).

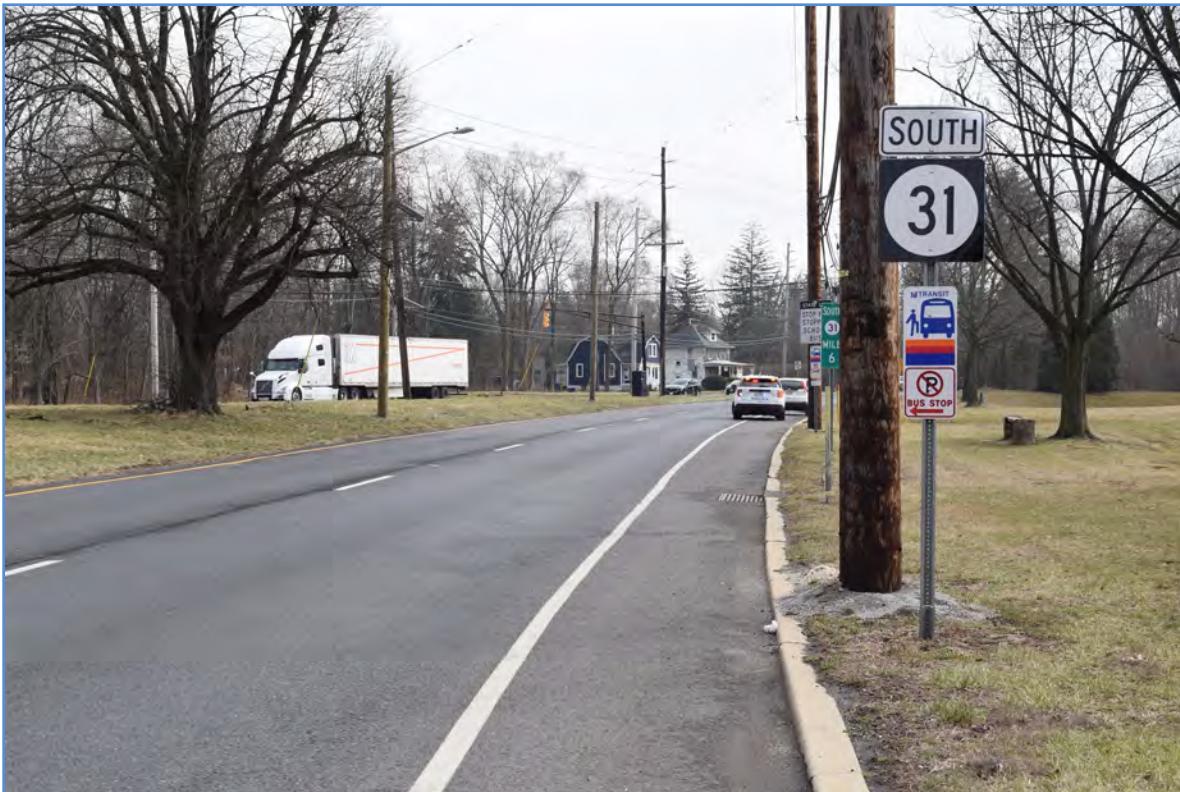
Photograph 3: New Jersey Route 31 Circle (Pennington Circle), view looking southeast toward the junction of New Jersey Route 31 and Pennington Road (Rachel Craft, photographer February 2023; HRI Negative #23011_D1:10).
